NONDESTRUCTIVE EVALUATION OF METAL MATRIX COMPOSITES.(U)

## NONDESTRUCTIVE EVALUATION OF METAL MATRIX COMPOSITES

May 1982

FINAL REPORT

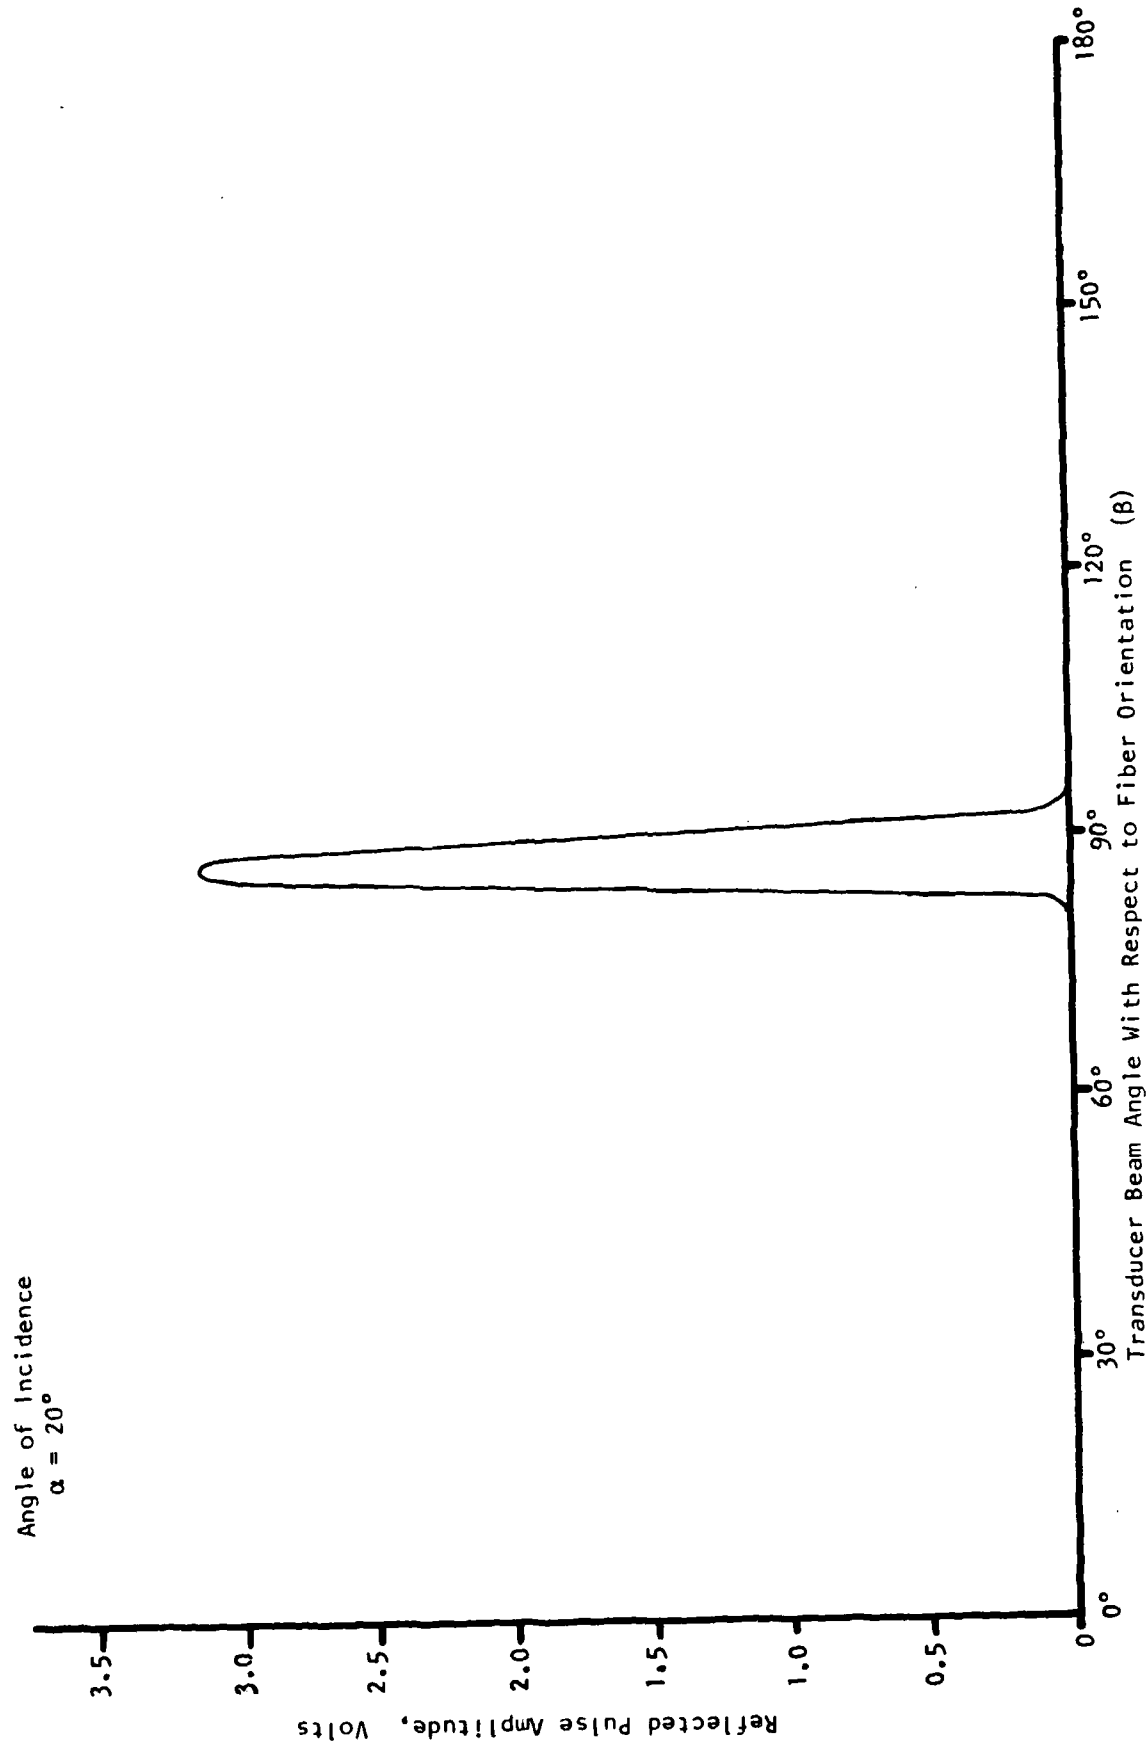
Figure 26 is a characteristic backscatter curve of Specimen 1-1. The incident angle ( $\alpha$ ) of the 5 MHz immersion transducer operated in the pulse-echo mode was  $20^\circ$  with respect to a line normal to the front-face surface plane of the specimen. The curve shows activity only as the focal axis of the transducer sweeps near and through the plane normal to the fiber orientation. Any activity shown away from  $\theta = 90^\circ \pm 5^\circ$  would be due to a material defect, since all the specimens, with the exception of Type 4, had a uniaxial fiber orientation. The curve in Figure 26 indicates no material defects in the area of inspection of Specimen 1-1.

Figure 26. Ultrasonic backscattering curve of FP/Mg specimen with no intentional flaws (Specimen 1-1).

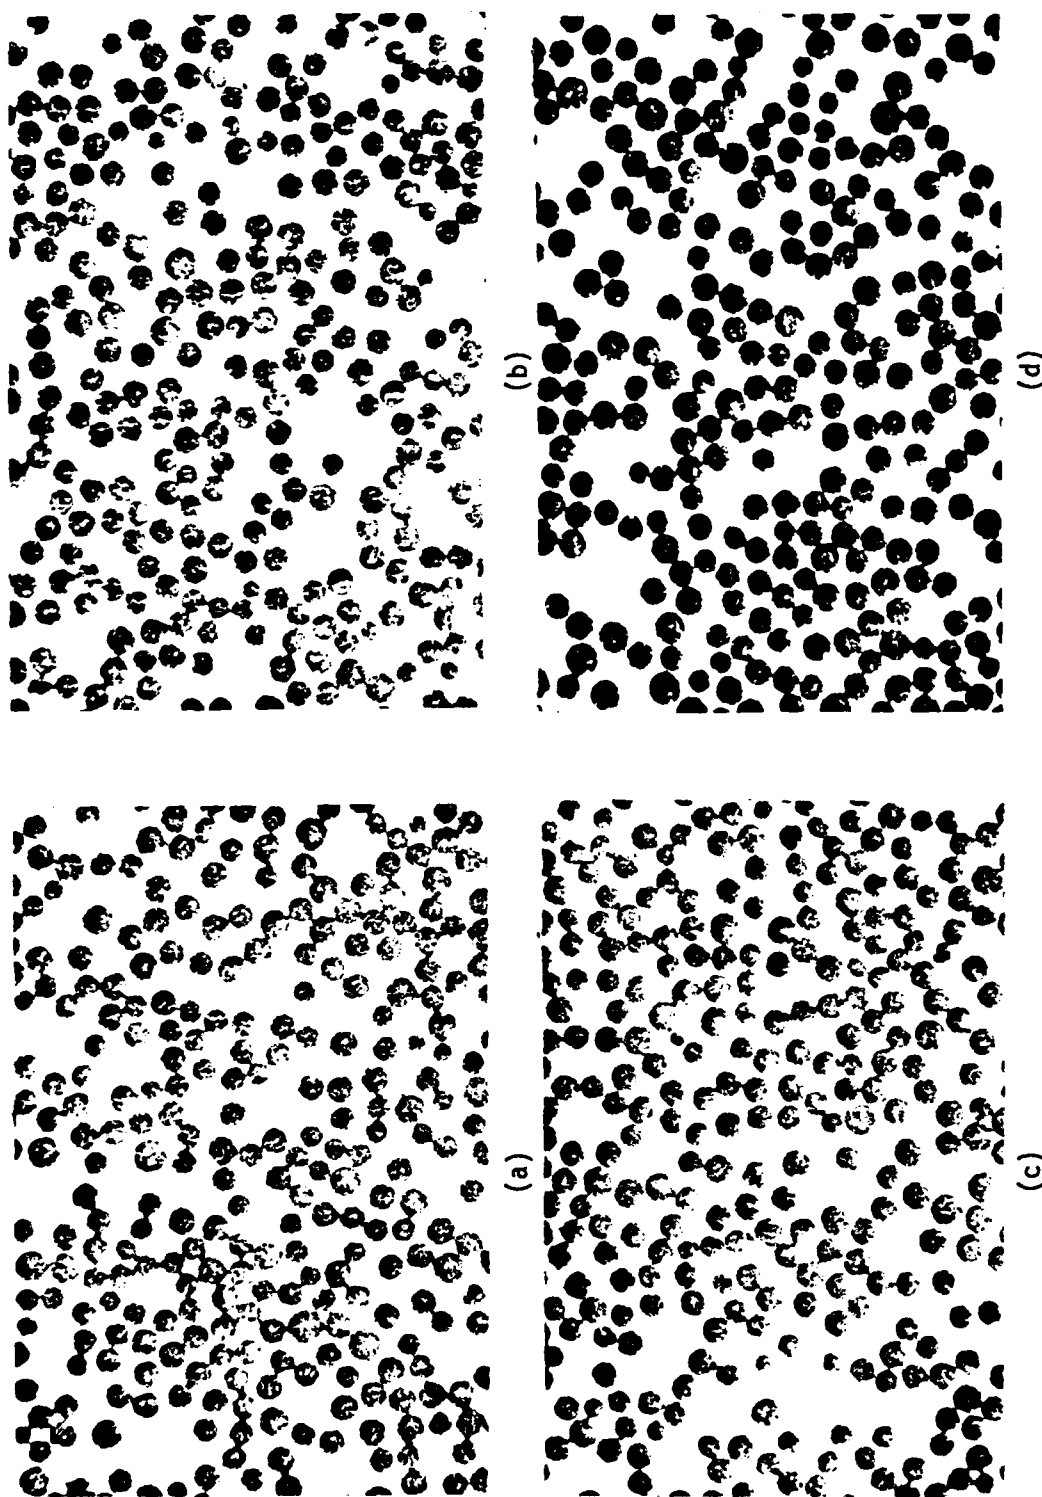
Figures 27 and 28 show four micrographs each of sections cut and polished from Specimen 1-1. The sections indicated on Figures 27 and 28 correspond to the inspection locations shown on Figure 20. These micrographs indicate the specimen had uniform material integrity, as expected for a specimen with no intentional flaws. There are no indications of gross defects in the material at any of the inspection locations. At the 200X magnification, individual fiber bundles can be seen as dark circles, but no gross material defects are

Figure 28. Micrographs (200X) of FP/Mg Specimen 1-1 (no intentional flaws) at four section locations: (a) Location 1-1-1, (b) Location 1-1-2, (c) Location 1-1-3, and (d) Location 1-1-4.

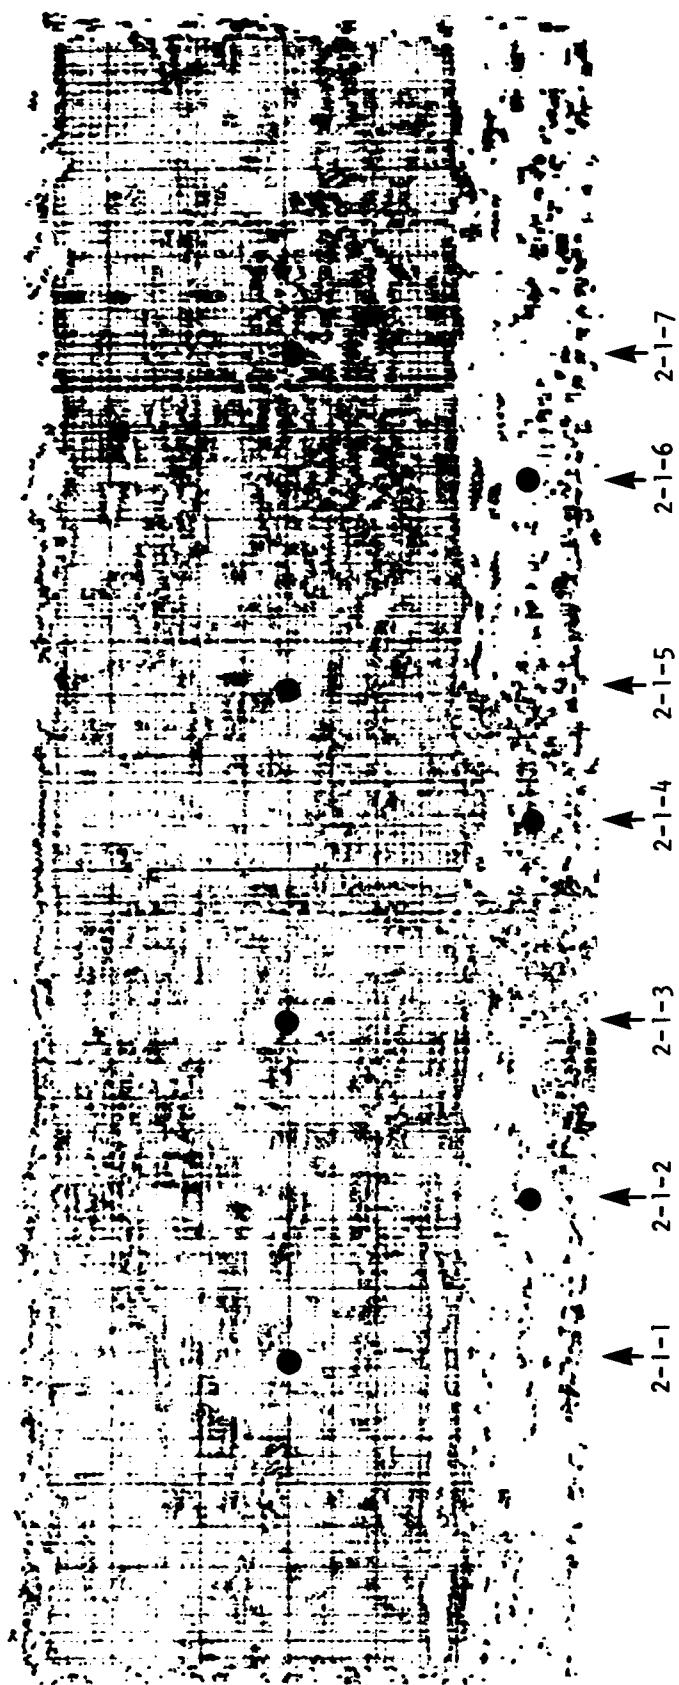
Both C-scans show a strip of apparently flawed material running the length of the specimen adjacent to the lower edge. The strip was 1.47 cm

Figure 29. Pen-lift C-scan of FP/Mg Specimen 2-1 (fiber-matrix debonding),  
15 MHz transducer in pulse-echo mode.

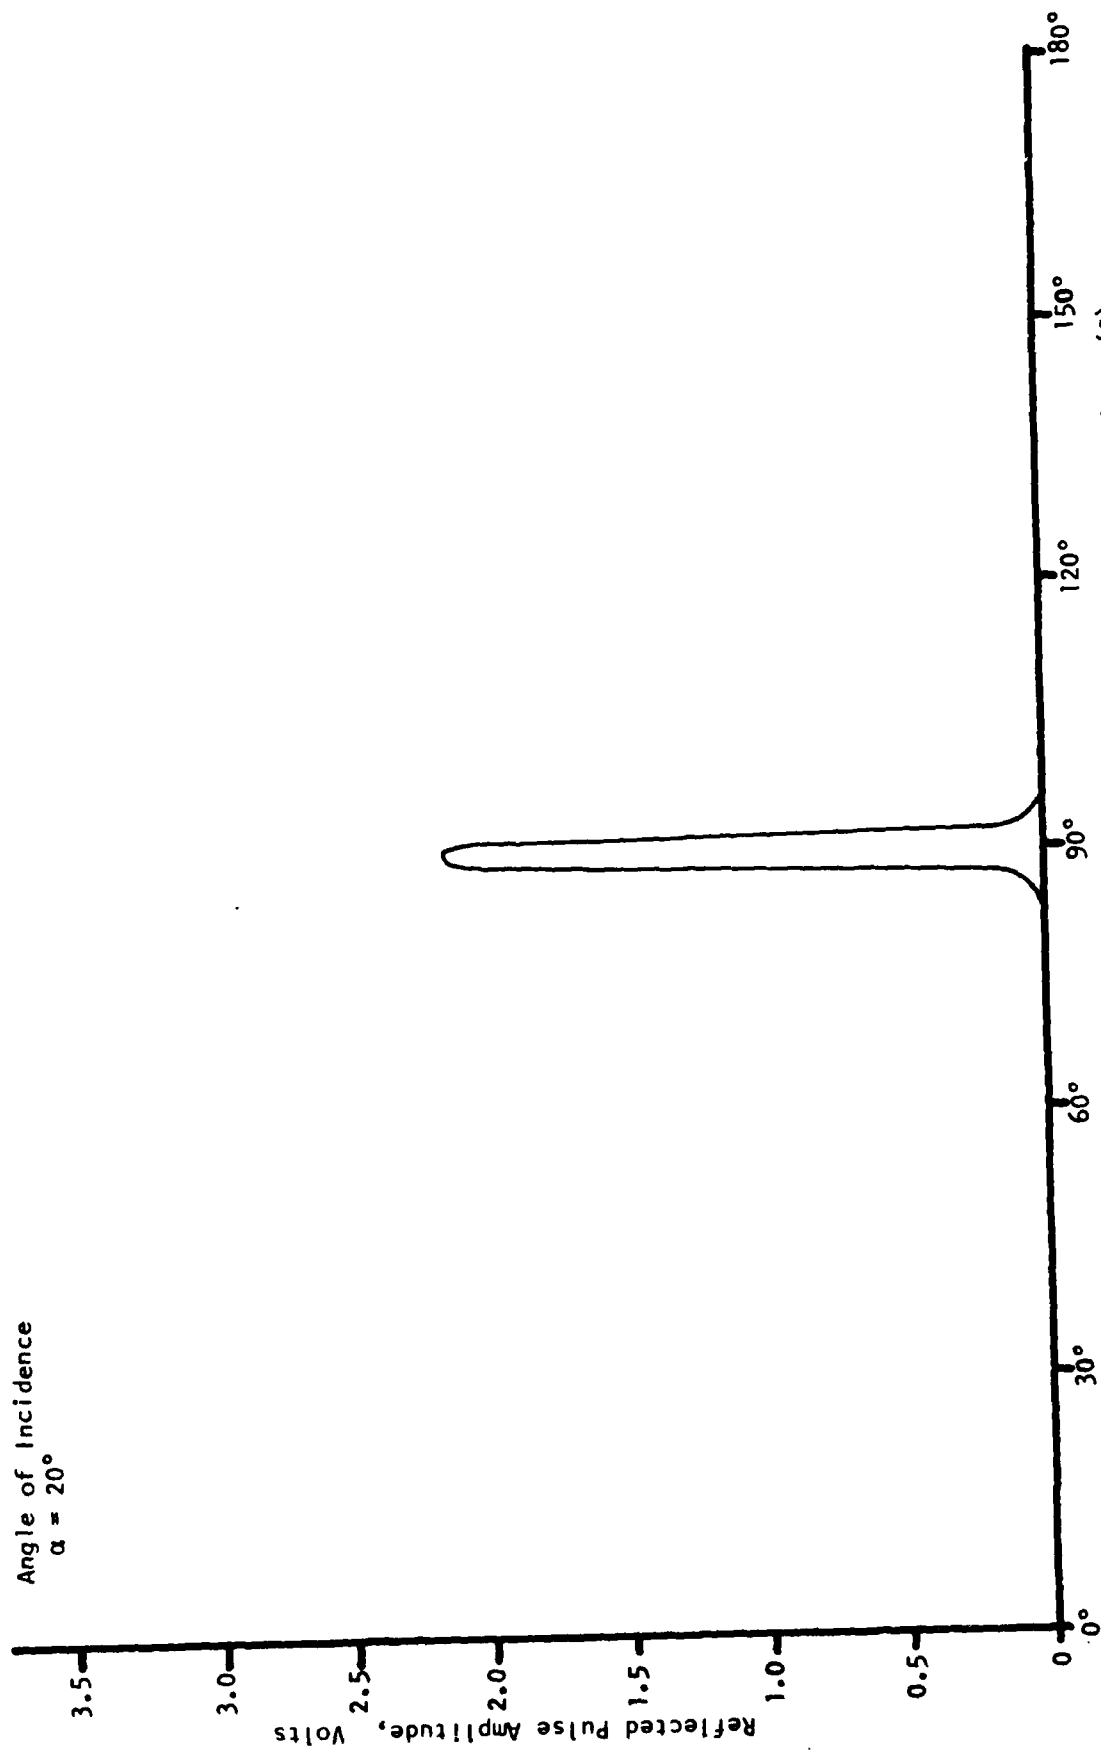
The only apparent effect of the defect area is the reduction of the reflected pulse amplitude from that of Specimen 1-1 (Figure 26). This is because of the attenuative nature of the delamination in that multiple internal reflections occur between the delamination and free surfaces causing a reduction of reflected pulse amplitude.

Figure 33. Ultrasonic backscattering curve of FP/Mg specimen with fiber-matrix debonding (Specimen 2-1).

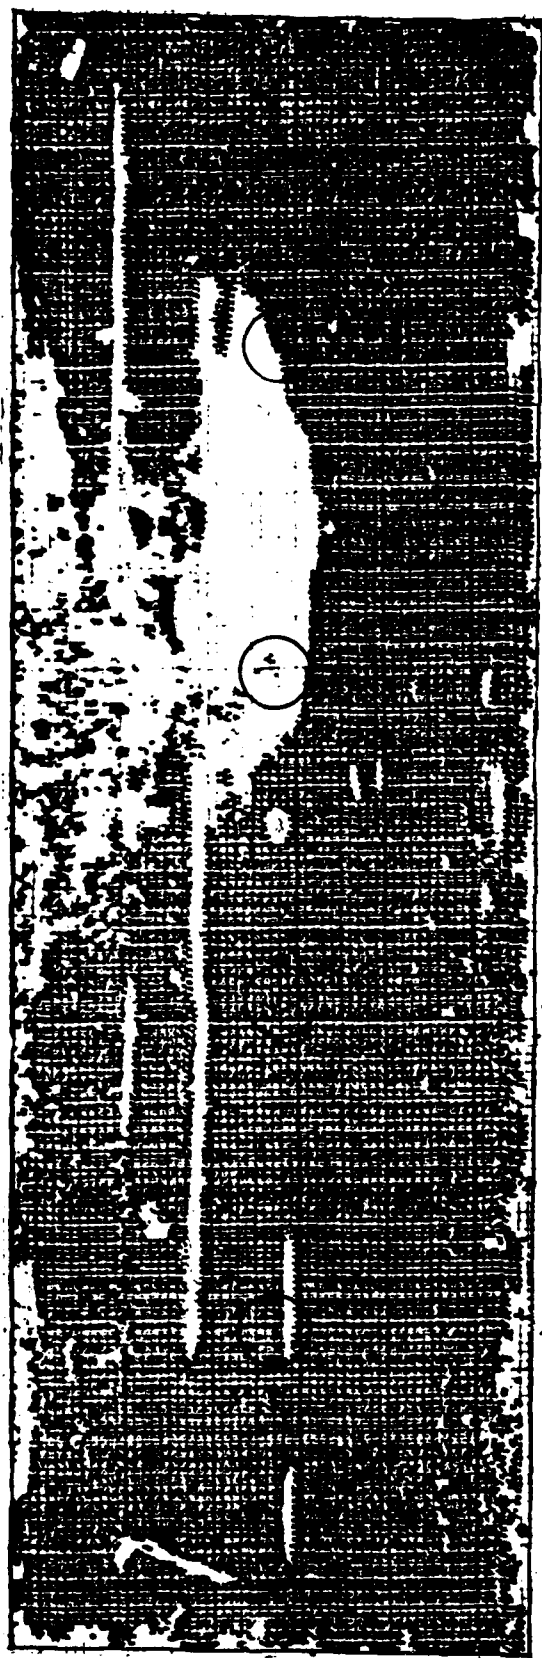
Both C-scans show a well-defined area of apparently flawed material involving approximately 20% of the specimen. The narrow bands of apparent damage running parallel to the fiber direction were identified as surface scratches by A-scan interpretation and visual inspection.

Figure 36. Pen-lift C-scan of FP/Mg Specimen 3-1 (porosity),  
15 MHz transducer in pulse-echo mode.

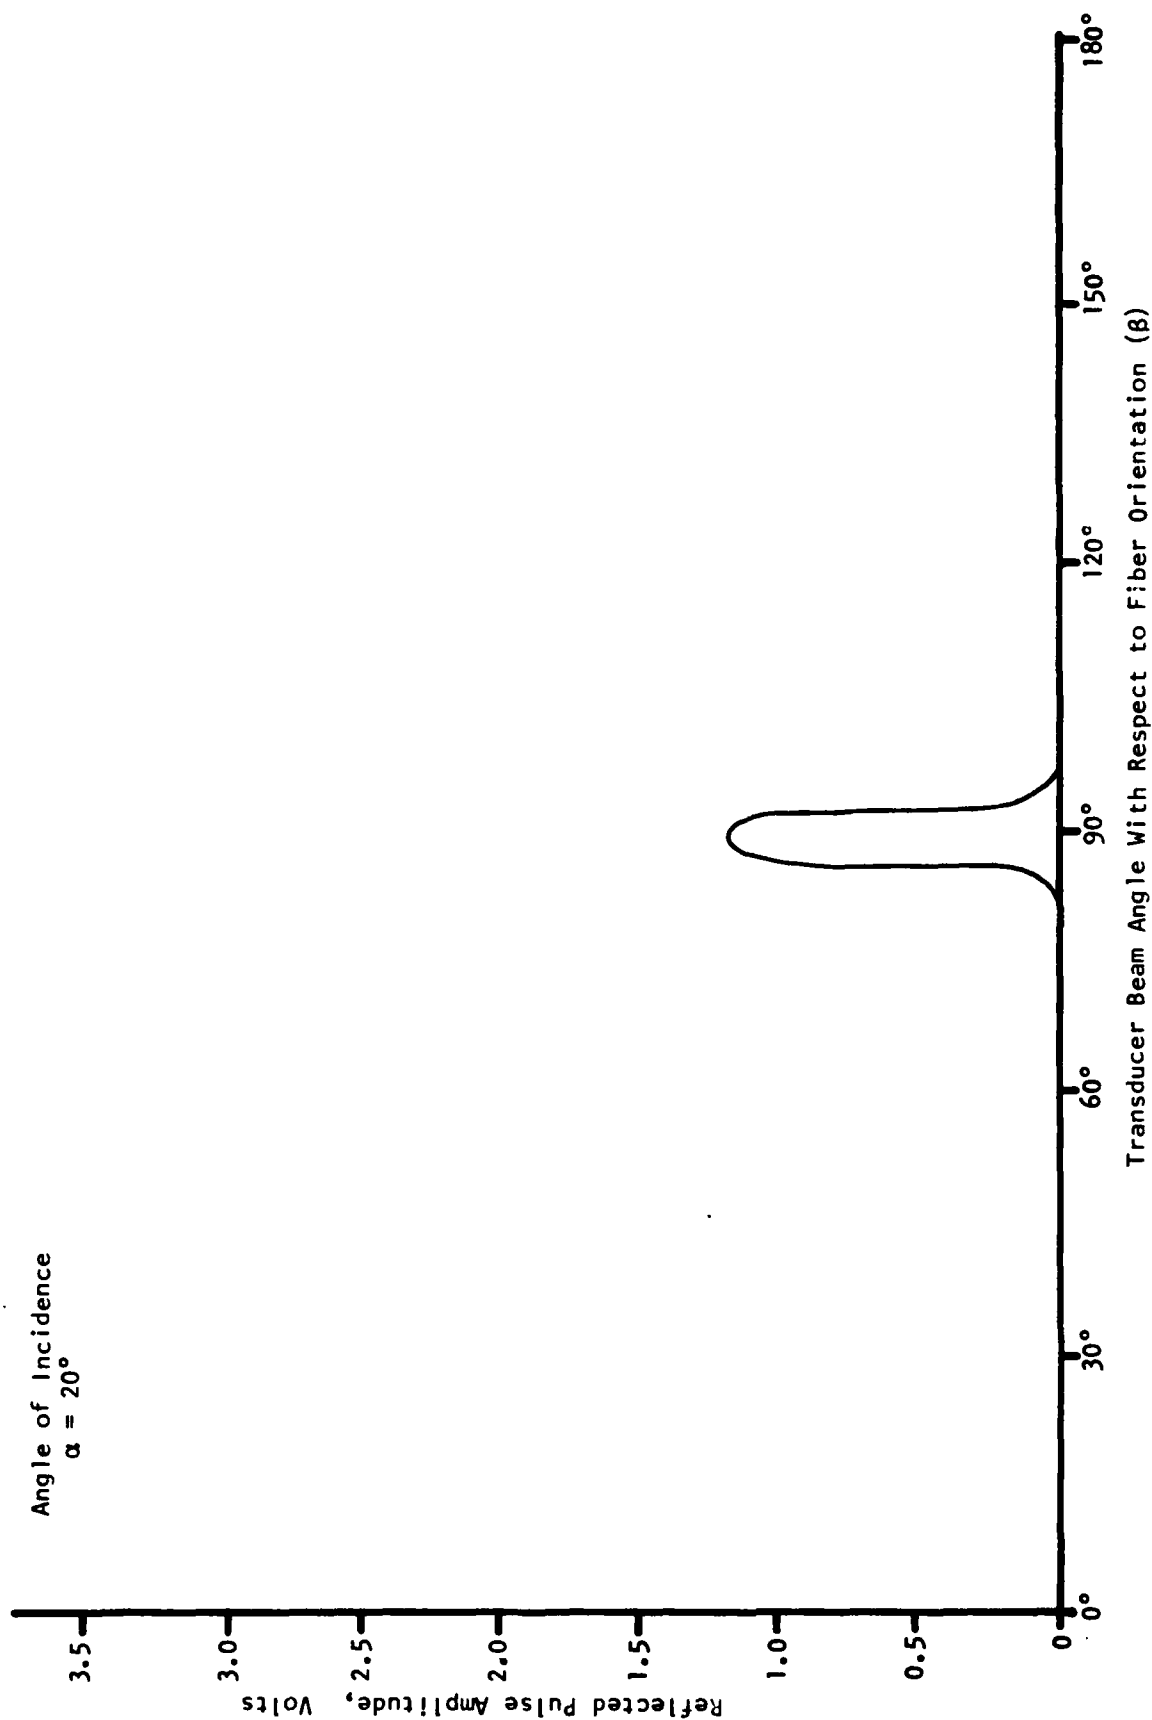
Ultrasonic backscattering does not appear to be applicable for determination of defects such as porosity. This technique gave no appreciable information as to the state of the material integrity of Specimen 3-1.

Figure 40. Ultrasonic backscattering curve of FP/Mg specimen with porosity (Specimen 3-1).

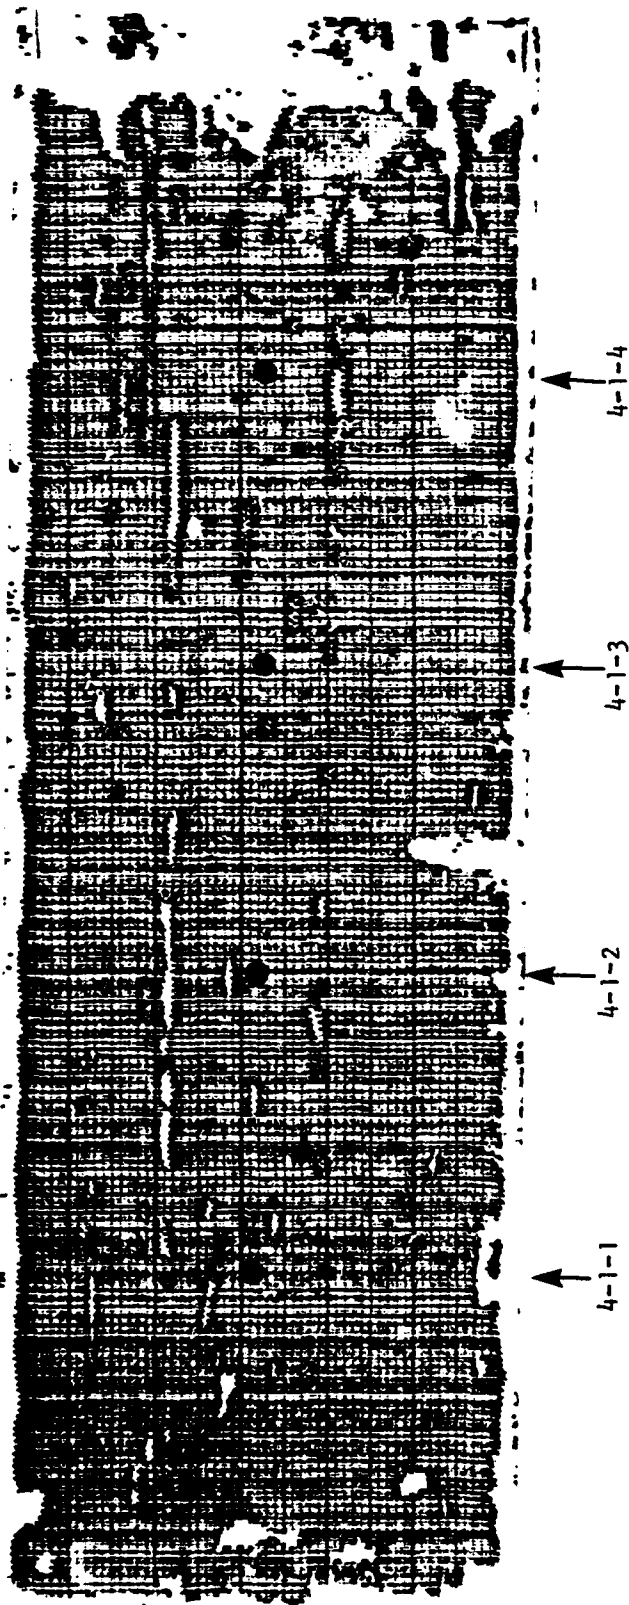
Neither C-scans show any material defect areas which could be interpreted as being misaligned fibers. The strips of defect areas parallel to the principal fiber direction were identified as surface scratches by visual inspection. The apparent defect area near the mid-length of the specimen perpendicular to the fiber direction and in contact with the lower edge was an area of excess sealant which bled onto the specimen after it was inserted in the specimen holder.

Figure 43. Pen-lift C-scan of FP/Mg Specimen 4-1 (fiber misalignment), 15 MHz transducer in pulse-echo mode.

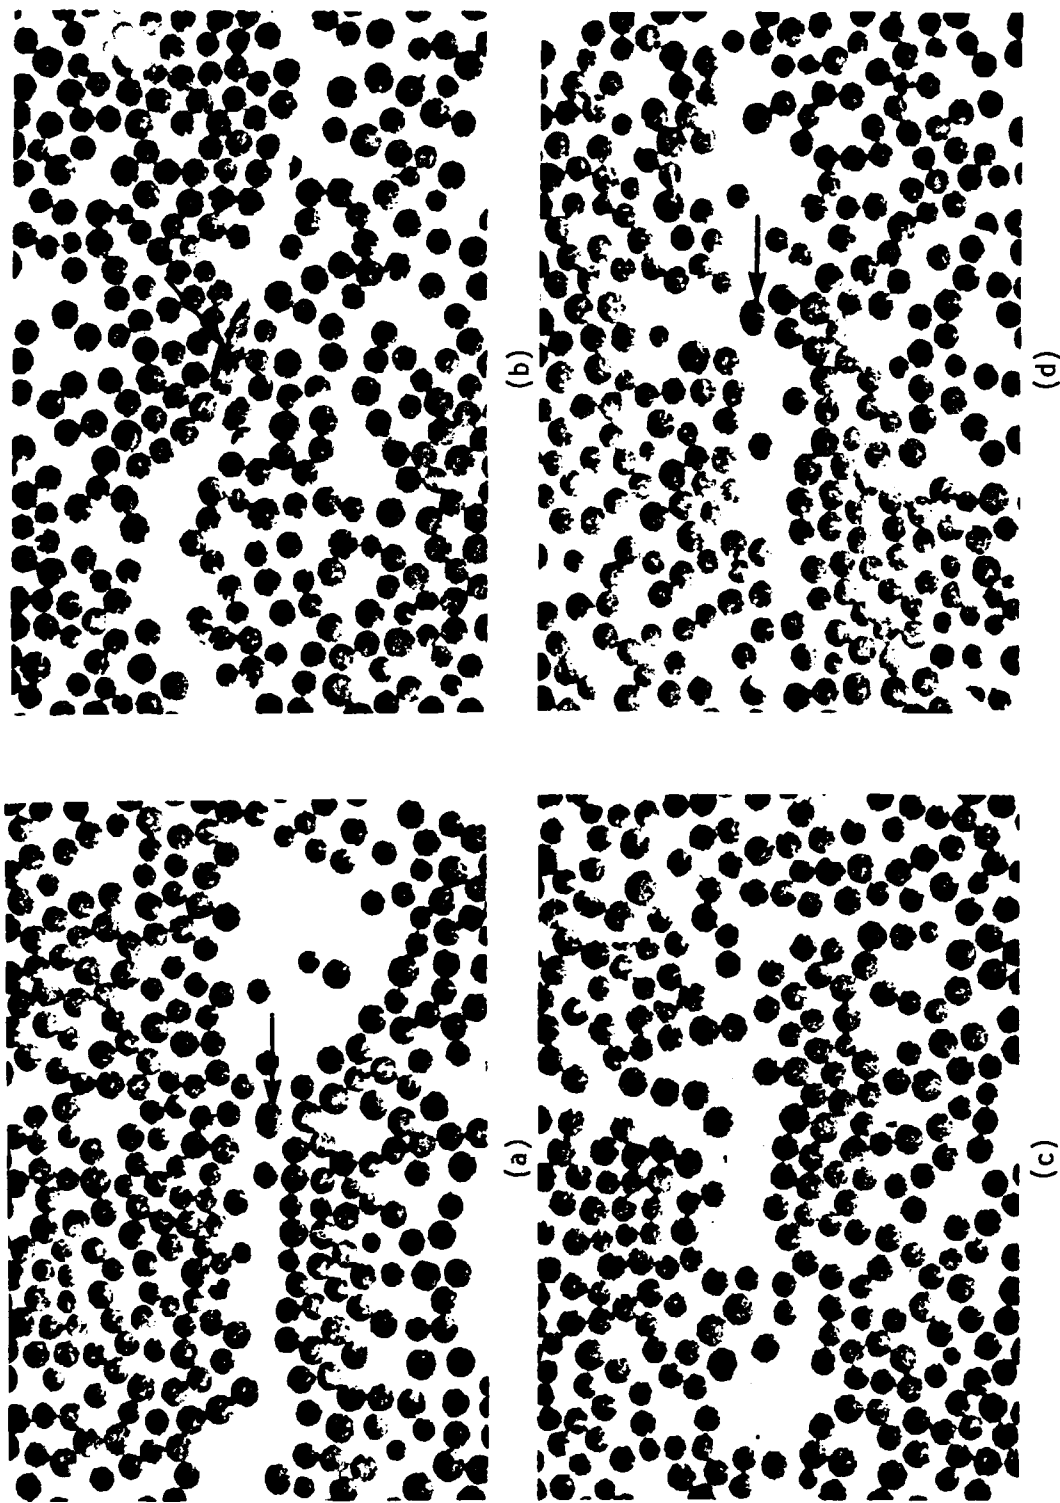
The micrographs do not show, and were not expected to show, the two plies of misaligned fibers. This was because the degree angle of the misalignment is so slight that it barely affected the shape of the exposed fibers. Normally, off-axis fibers can be distinguished because they have an elliptical cross section when viewed along the fiber axis. This can be seen for one fiber bundle each in Figures 49a and 49d (highlighted by arrows), respectively. In

Figure 49. Micrographs (200X) of Fp/Mg Specimen 4-1 (fiber misalignment) at four section locations: (a) Location 4-1-1, (b) Location 4-1-2, (c) Location 4-1-3, and (d) Location 4-1-4.

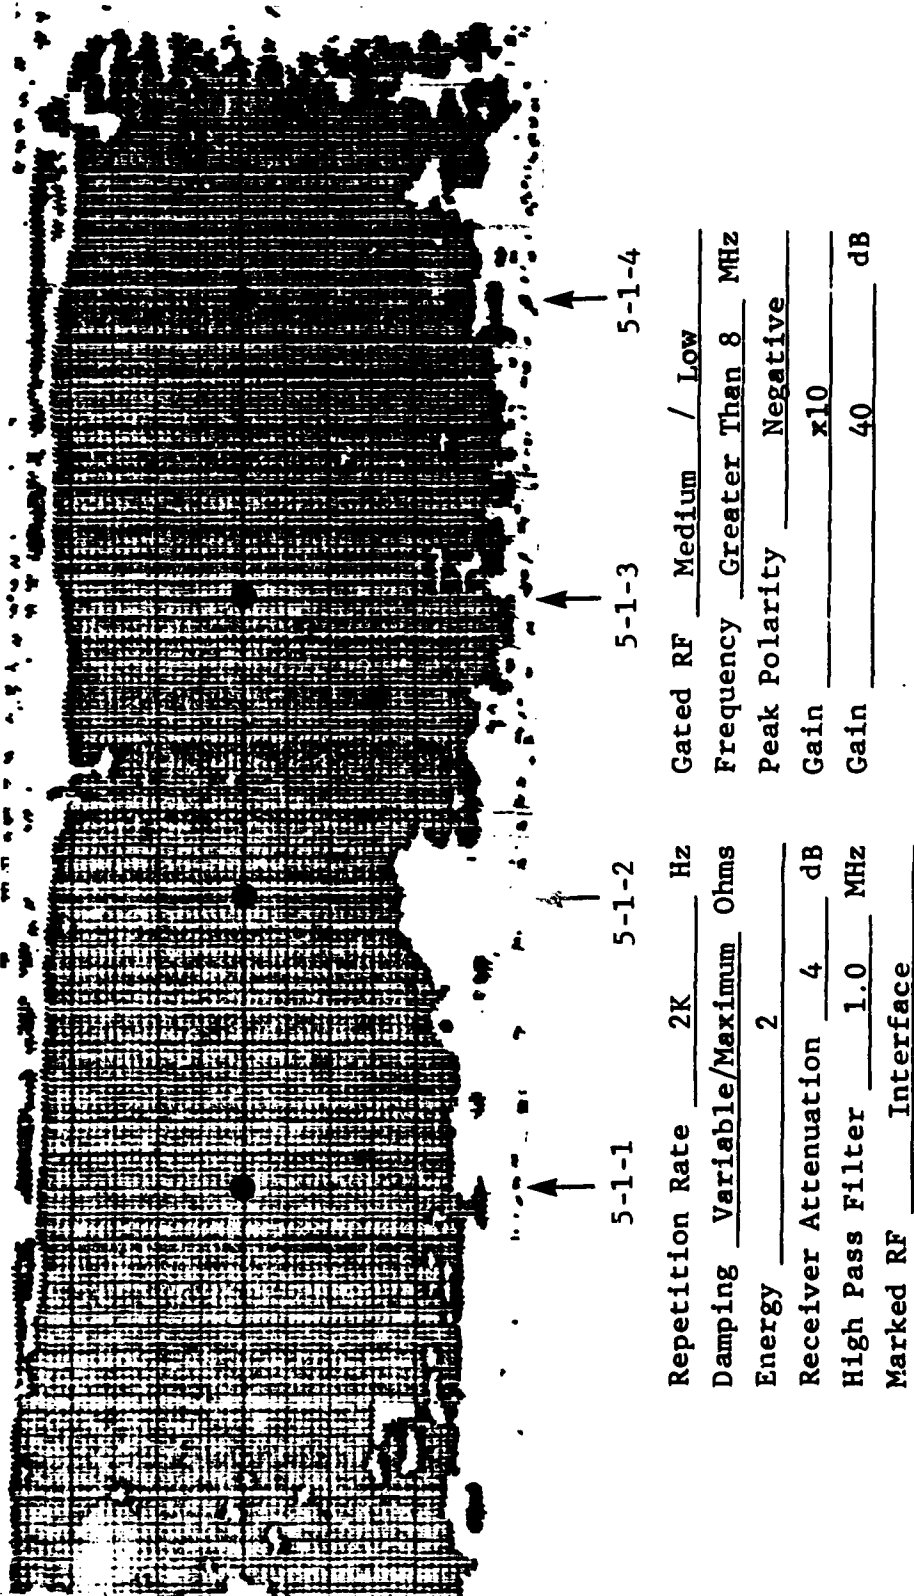
Figures 50 and 51 are pen-lift and analog C-scans, respectively, of Specimen 5-1. Both C-scans were generated using a 15 MHz immersion, compression

Figure 50. Pen-lift C-scan of FP/Mg Specimen 5-1 (fiber fracture),  
15 MHz transducer in pulse-echo mode.

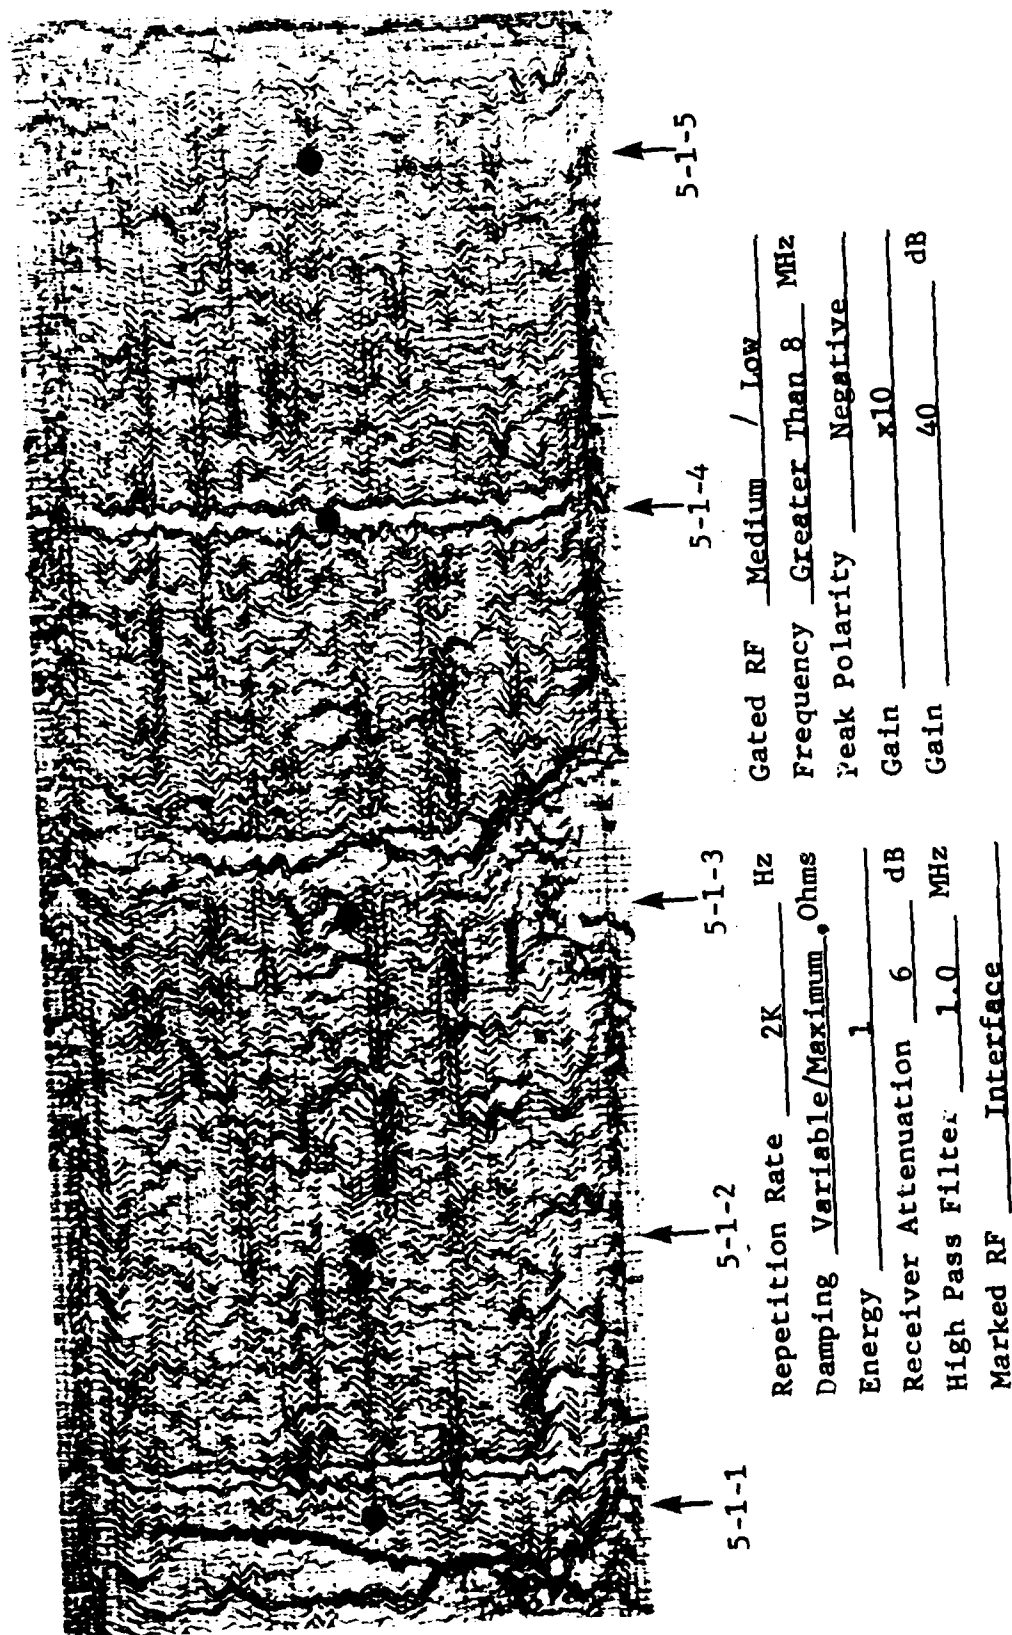
Figure 51. Analog C-scan of FP/Mg Specimen 5-1 (fiber fracture),  
15 MHz transducer in pulse-echo mode.

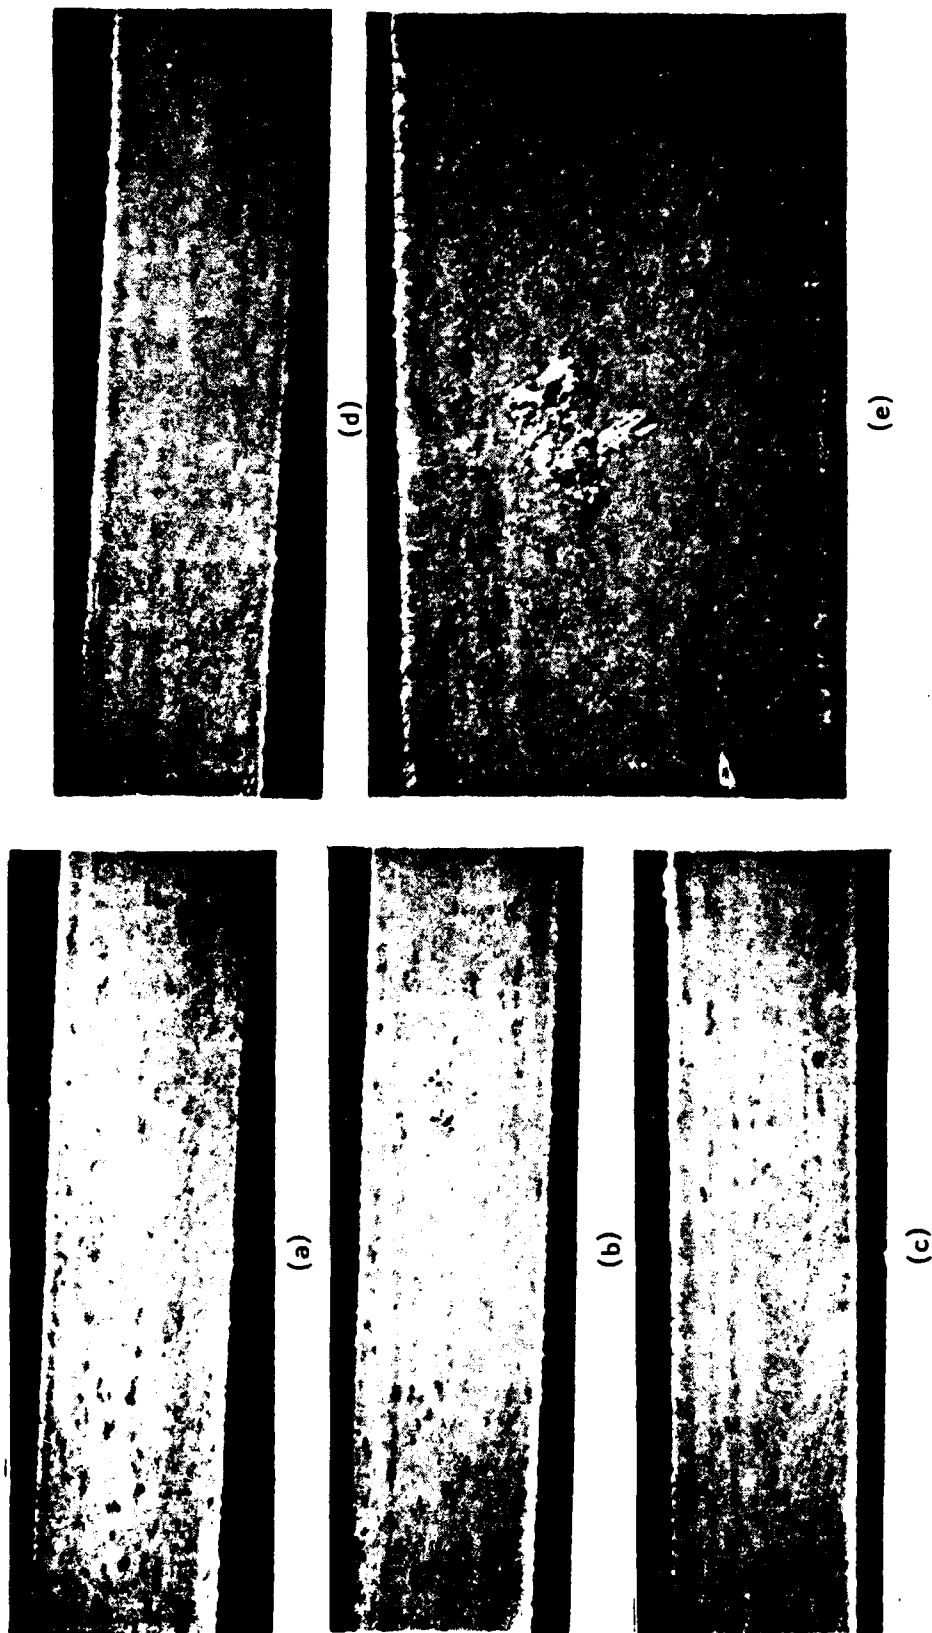
With the exception of section 5-1-2, Figures 55b and 55e, these micrographs show no indications of the presence of any gross material defects. A possible explanation for this is that the defect (i.e., the broken fibers) is in the same plane as the section inspection surface. This means there is no perspective angle available where the defect can be compared against a uniform material background. The defect could be exposed if the section were cut in a plane parallel to the fibers. This is very difficult to execute since the section cut has to be made slightly above the ply interface where the damaged fibers are located. Compounding the problem is that most separating blades

Figure 55. Micrographs of FP/Mg Specimen 5-1 (fiber fracture) at four section locations: At 5X, (a) Location 5-1-1, (b) Location 5-1-2, (c) Location 5-1-3, (d) Location 5-1-4; at 12X, (e) Location 5-1-2.
