# **FRACTURE ANALYSIS OF REACTION-BONDED SILICON NITRIDE TURBINE SHROUDS**

**DONALD R. MESSIER, LISELOTTE J. SCHIOLER,  
GEORGE D. QUINN, and JAMES C. NAPIER**

**JUNE 1982**

**ARMY MATERIALS AND MECHANICS RESEARCH CENTER  
Watertown, Massachusetts 02172**

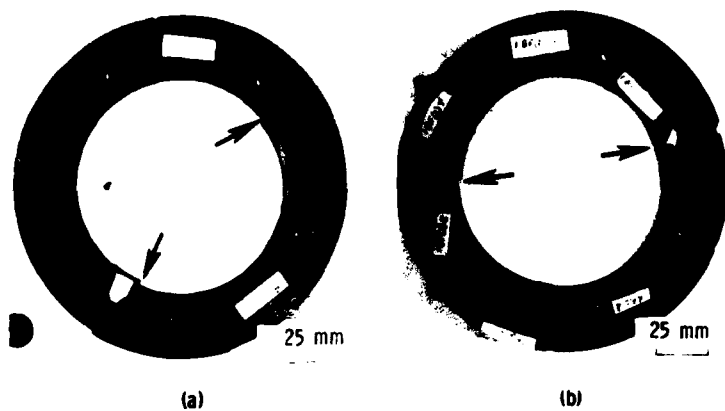
Figures 2 through 6 are photographs of the RBSN shrouds as they appeared after testing in the engine simulator rig. One shroud (1-Ar, Figure 2) survived intact with the remainder showing behavior ranging from subcritical cracking to catastrophic failure.

Figure 2. RBSN forward shrouds after testing in the 10-kW turbo alternator. (a) and (b) were tested in different runs. The arrows point to sites where fracture initiated.

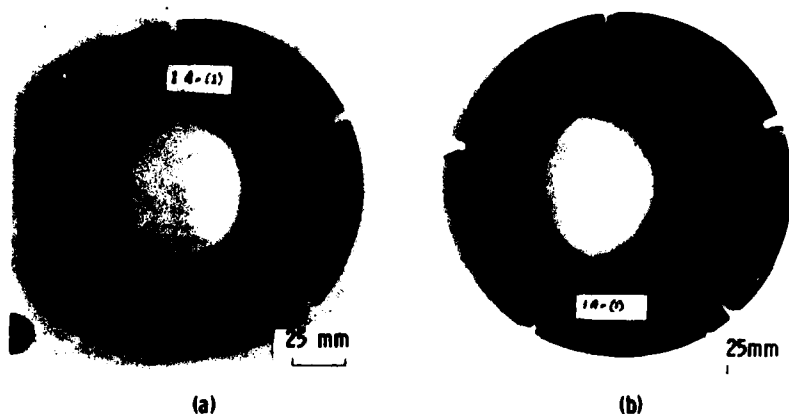
Figure 3. RBSN rear shroud after testing in the 10-kW turbo alternator with (a) front view and (b) rear view. This part was uncracked.

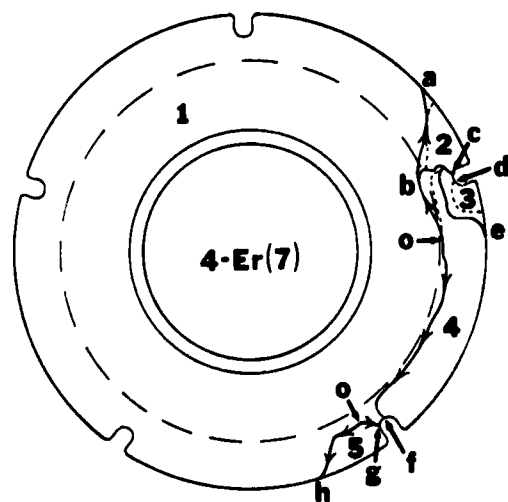
The fracture behavior of shroud 4-Er (7) which endured 50 hours of engine rig testing was markedly different than that described above. Crack initiation sites (if any) and propagation directions in the vicinity of locations "c" and "d" in Figure 12 were impossible to establish with certainty. The two identifiable fracture origins both appeared to be internal ones. It is likely that those failures resulted from thermal stress during heating; such a situation would induce compressive stresses on the outside, and corresponding corresponding tensile stresses on the inside of the part.

Figure 12. Fracture patterns in RBSN rear shroud after 50 hours of testing. The arrows labeled "o" indicate sites where fracture originated. Crack g-h was present after 33 hours of testing.

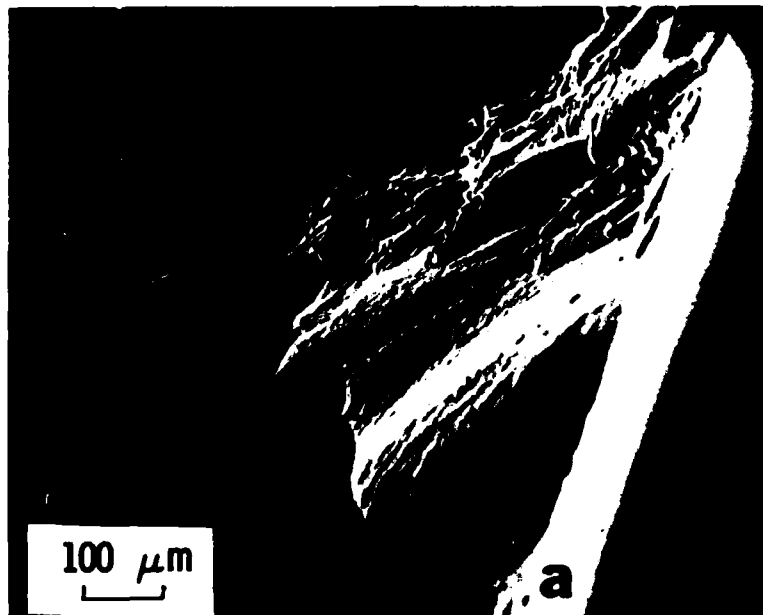
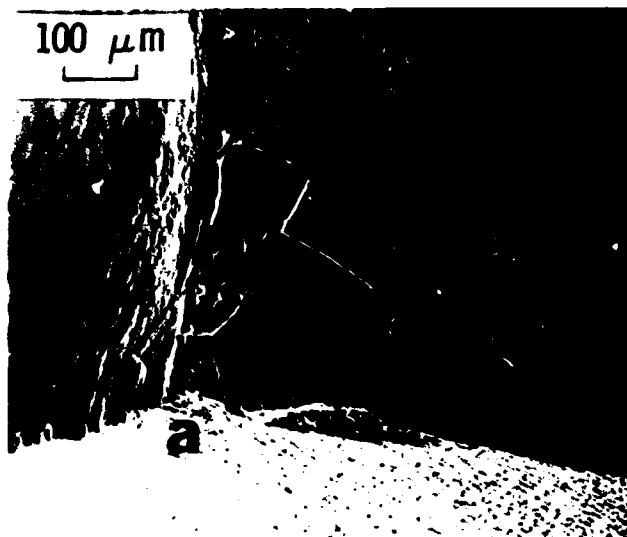
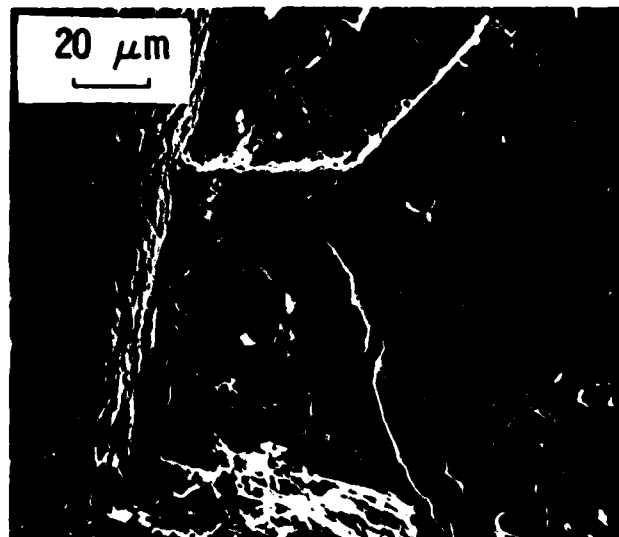
The calculated fracture stress values in Table 5 agree well with the results in Table 2 for bend specimens tested with as-received surfaces. In the case of the shrouds, Figures 13, 15, 17, 21, and 23 show evidence of gross machining defects near fracture origins. Similar defects were suspected, but not observed clearly at fracture origins in bend bars with as-received surfaces. On the other hand, it has already been noted that numerous failures in bend specimens with machined surfaces were related to machining flaws (less severe than the above-mentioned ones), but statistical testing results were inconclusive as to whether or not such relatively minor flaws significantly lowered strength. Jones and Rowcliffe<sup>19</sup> similarly noted that their RBSN specimens frequently had machining grooves at fracture origins. In view of the foregoing discussion it appears that, at some level, the fracture strength of RBSN will be significantly degraded by the presence of surface machining flaws.

Figure 21. Scanning electron photomicrographs of fracture surfaces near fracture origin "a" in shroud 2-Cf (4). The probable fracture origin is the large inclusion evident near the center of (c).
