AD-A121 134

THE STREAMBANK EROSION CONTROL EVALUATION AND  
DEMONSTRATION ACT OF 1974 S. (U) ARMY ENGINEER  
WATERWAYS EXPERIMENT STATION VICKSBURG MS HYDRA.

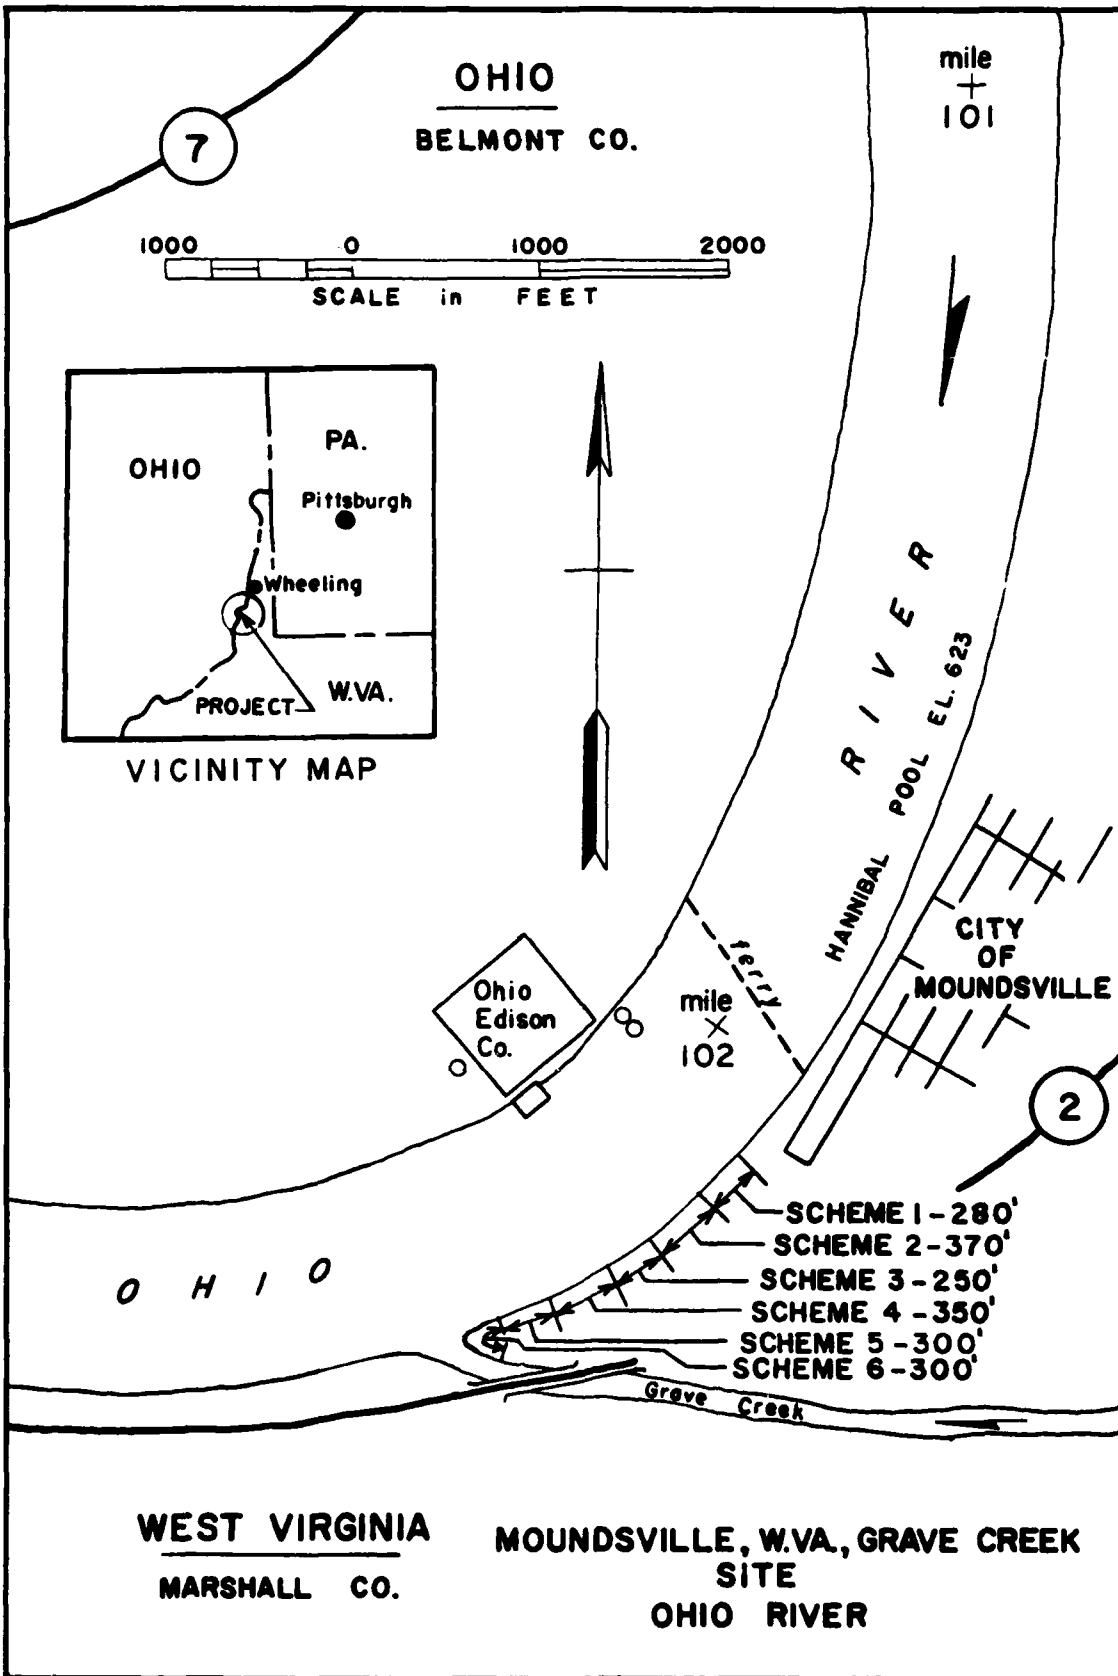
2. Vegetal Features. Of the various grasses, legumes, and shrubs employed at the site, only three of the shrubs and two of the grasses have shown promise of being effective as erosion control plants in the situations experienced. The most successful shrubs are the purple osier willow (*salix purpurea*) and red osier dogwood (*cornus siricea*). Arrowwood viburnum (*viburnum dentatum*) is nearly as effective showing signs of new plants filling in between the original plants. The only grasses that appear effective are the tall fescue (*festuca arundinacea*) and reed canary grass (*phalaris arundinacea*).

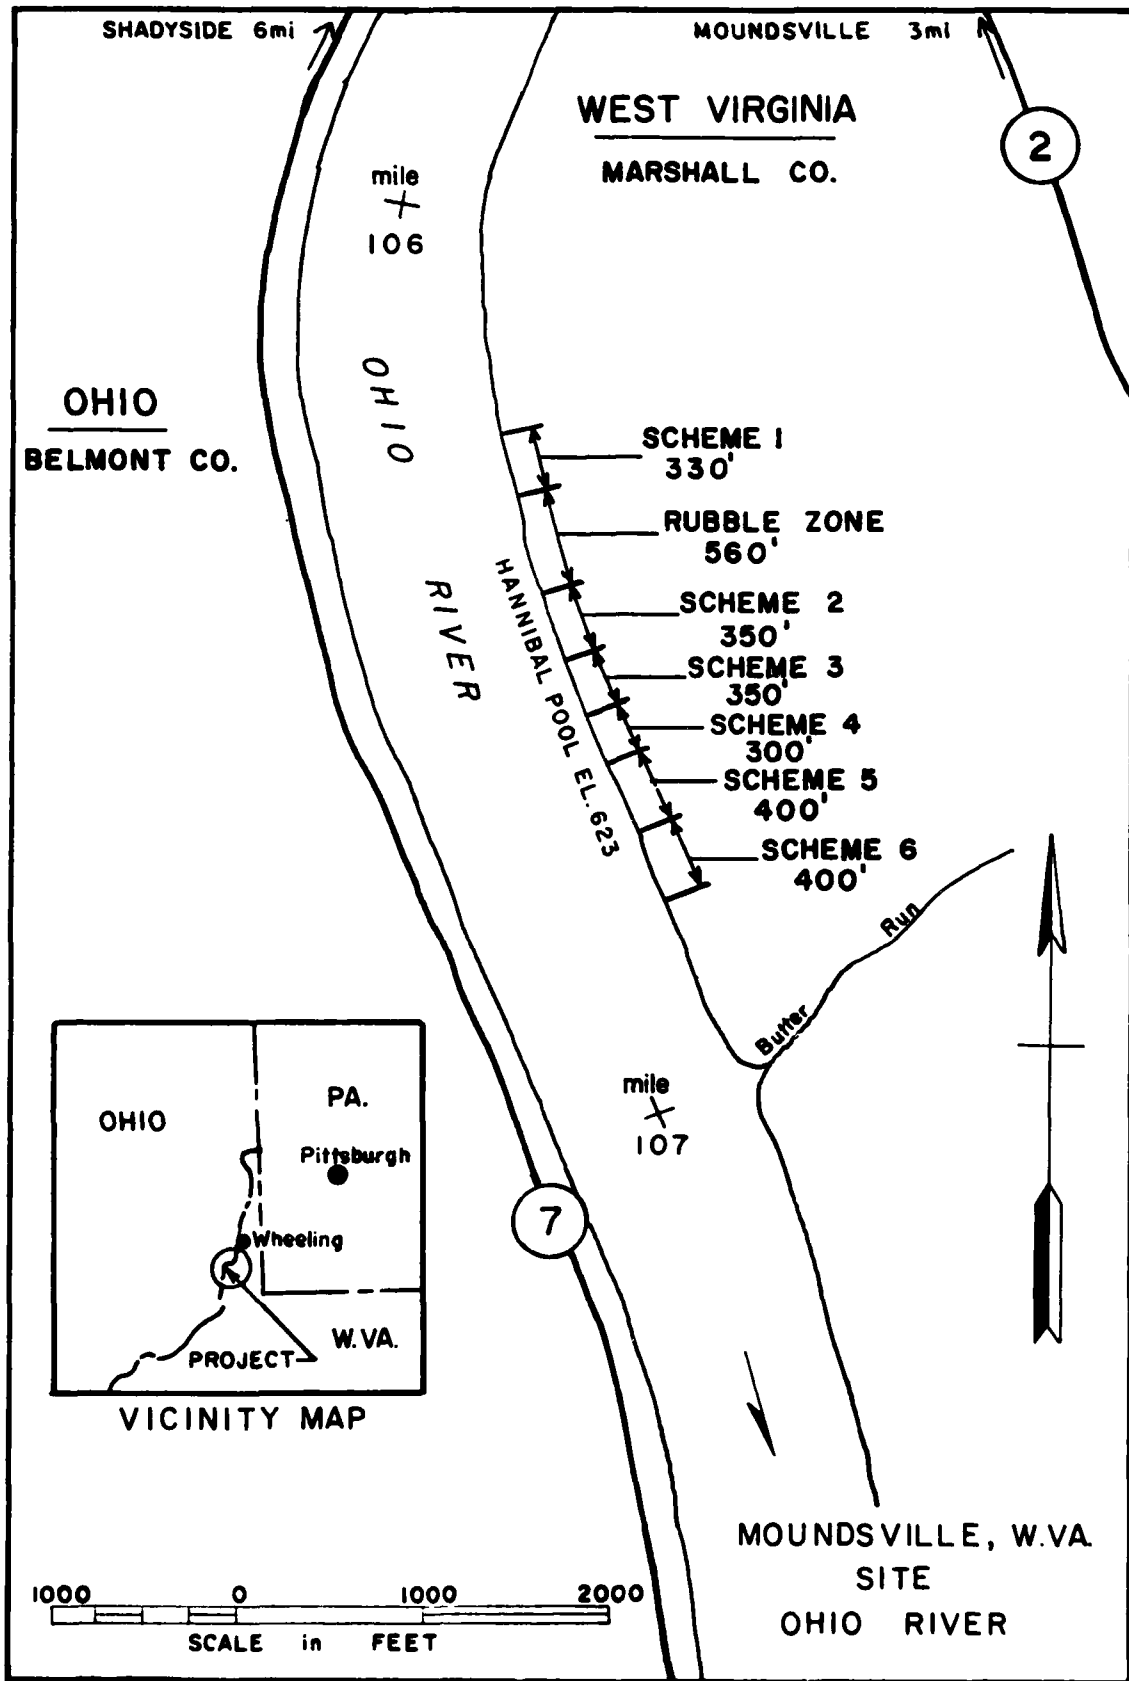
Although other plants registered a relatively high score in evaluation, only Red Osier Dogwood and crown vetch showed the ability to crowd out weeds and "fill-in" between the original plants.

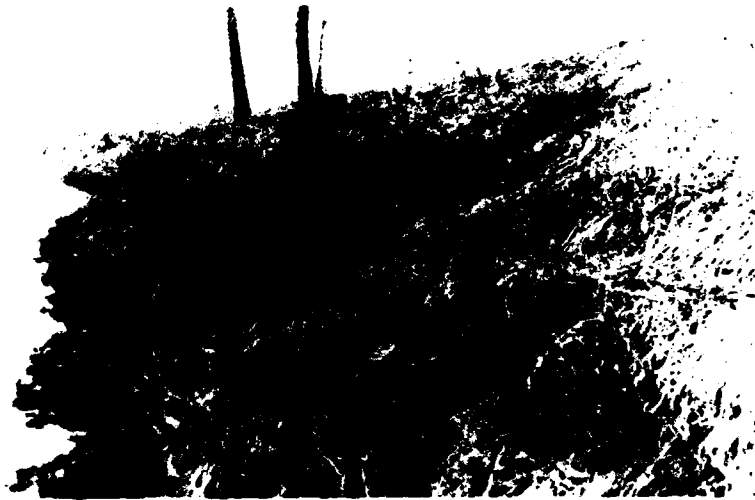
LOOKING UPSTREAM FROM STATION 13+00  
NOTE HIGH WATER DAMAGE TO UPPER BANK  
2 MARCH 1979

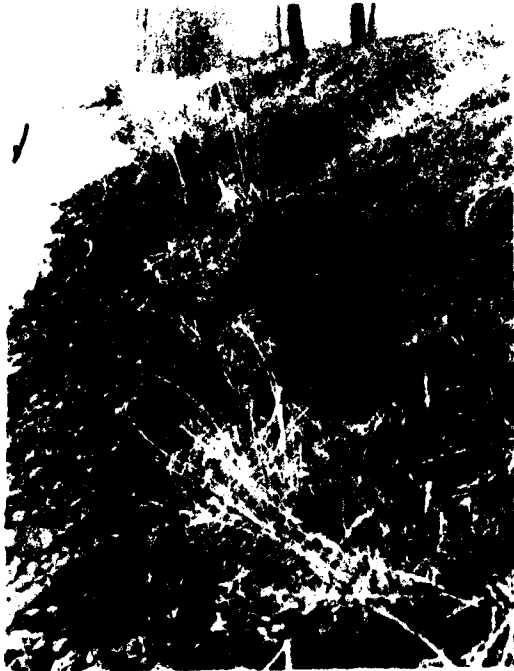
LOOKING UPSTREAM FROM  
STATION 13+00  
8 APRIL 1980

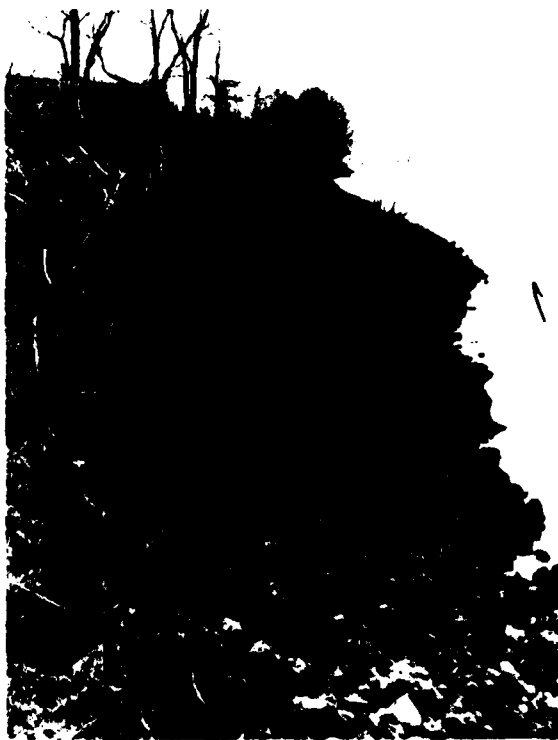
LOOKING DOWNSTREAM FROM  
STATION 13+00, NOTE HIGH  
WATER DAMAGE TO UPPER BANK  
24 MARCH 1978

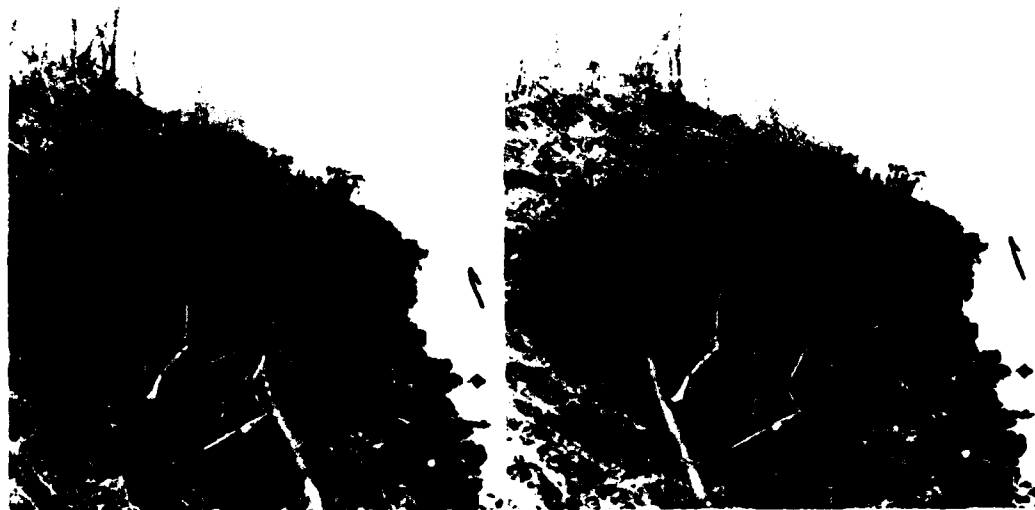
DOWNSTREAM STEROSCOPIC VIEW  
FROM STATION 13+00, NOTE HIGH  
WATER DAMAGE TO UPPER BANK  
2 MARCH 1979

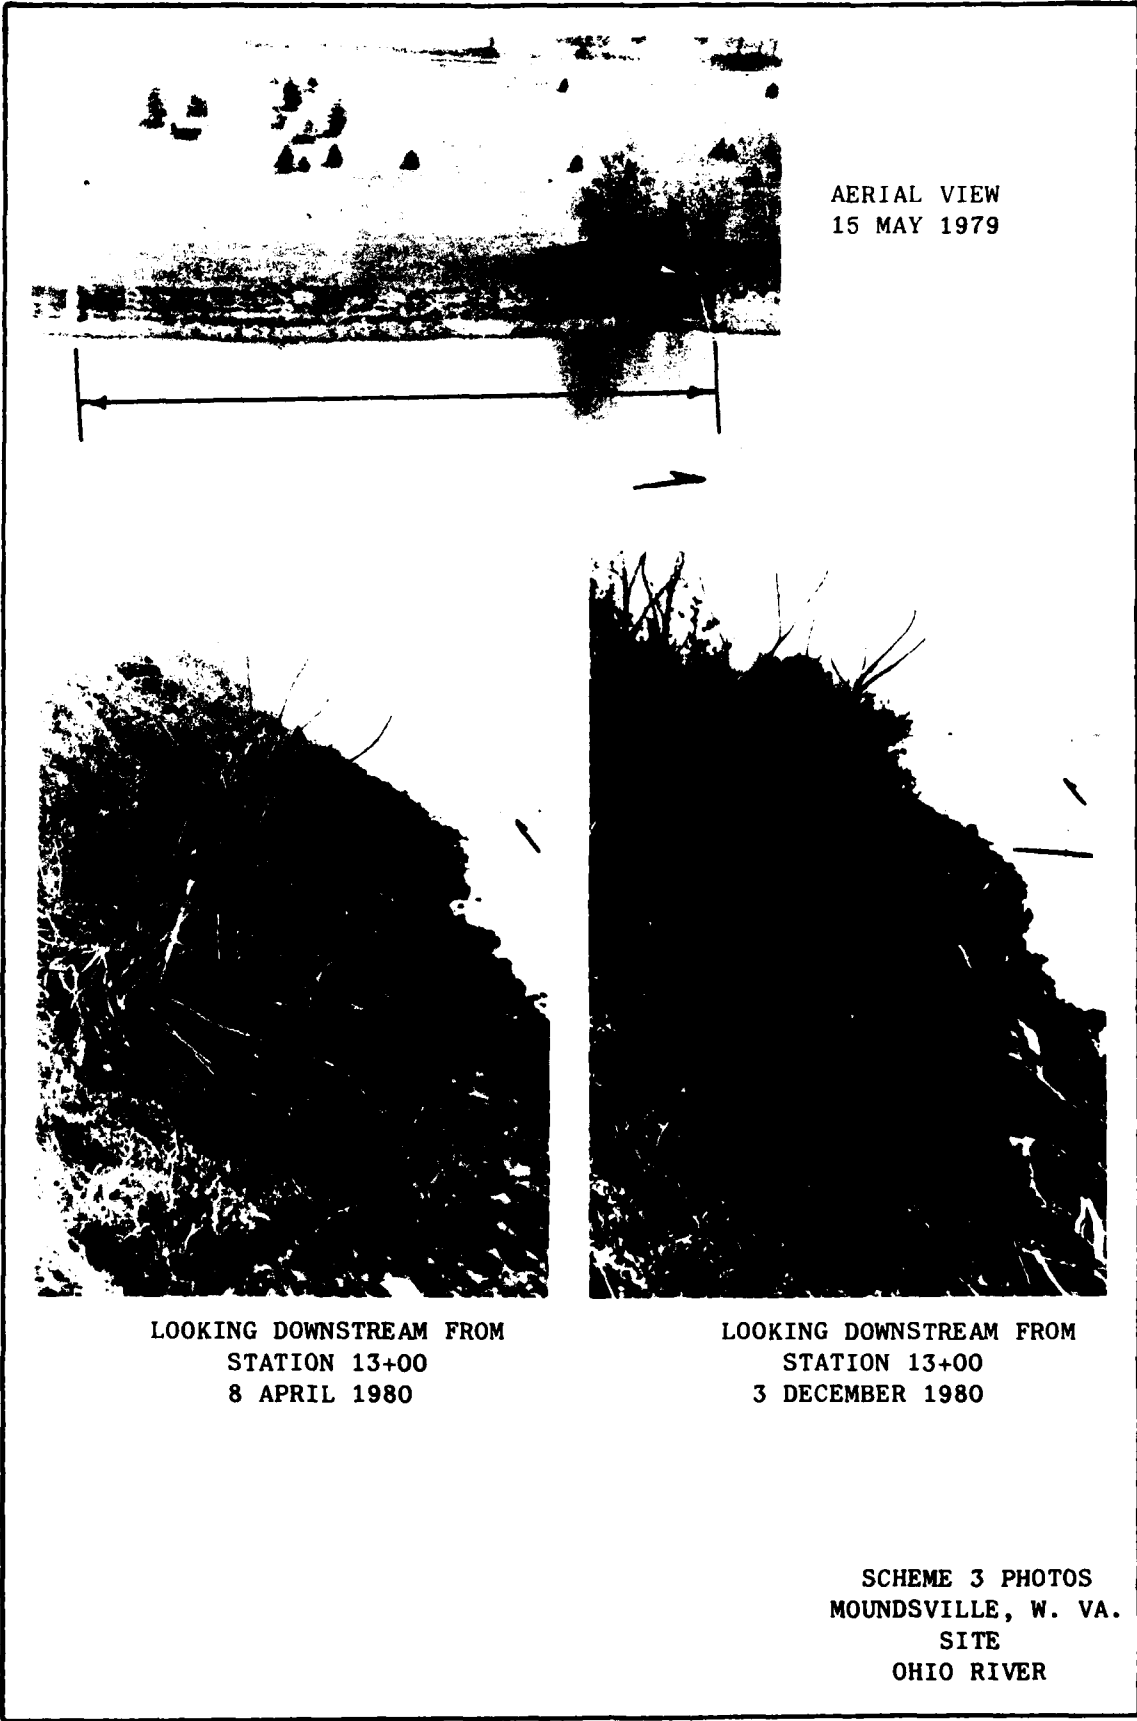
AERIAL VIEW  
15 MAY 1979

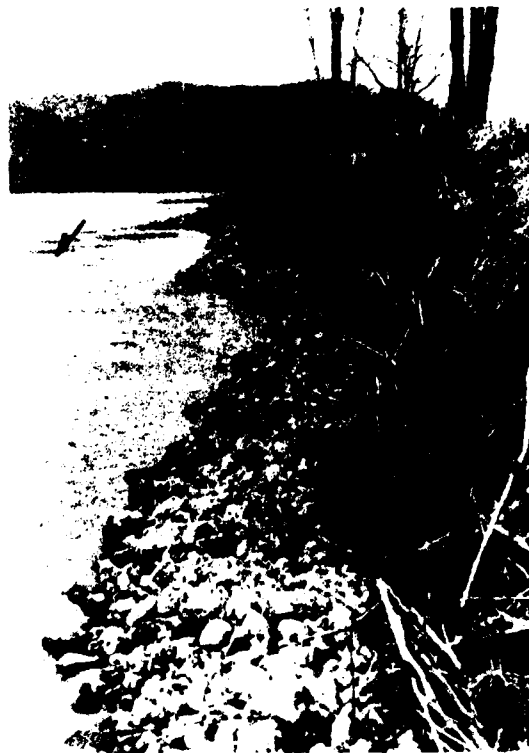
LOOKING UPSTREAM FROM  
STA 27+50, NOTE HIGH  
WATER DAMAGE TO UPPER  
BANK. 24 MARCH 1978

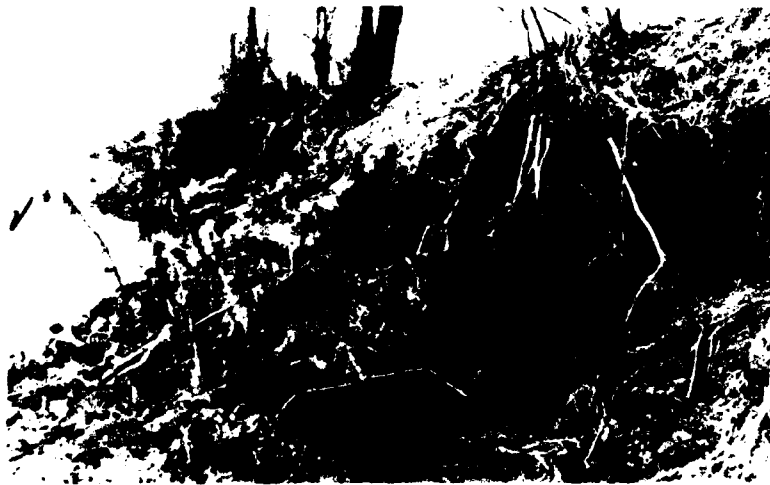
LOOKING UPSTREAM  
FROM STATION 27+50  
NOTE HIGH WATER  
DAMAGE TO UPPER  
BANK. 2 MARCH 1979

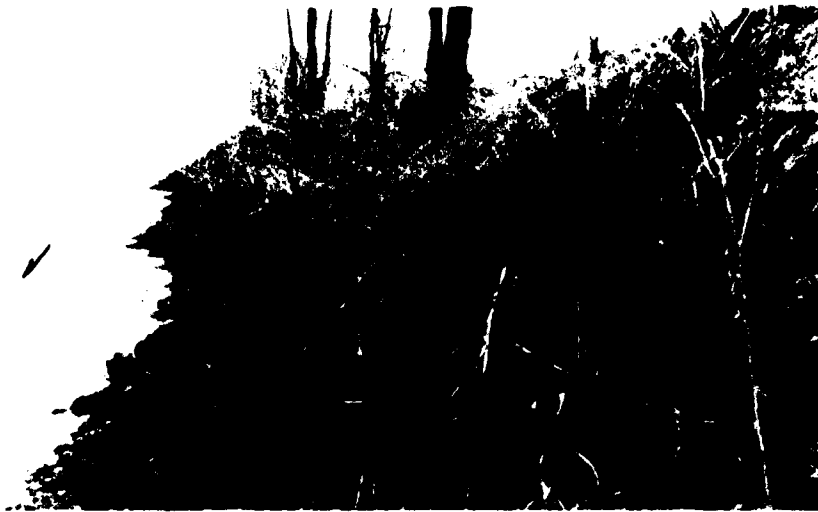
LOOKING UPSTREAM FROM STATION 27+50  
8 APRIL 1980

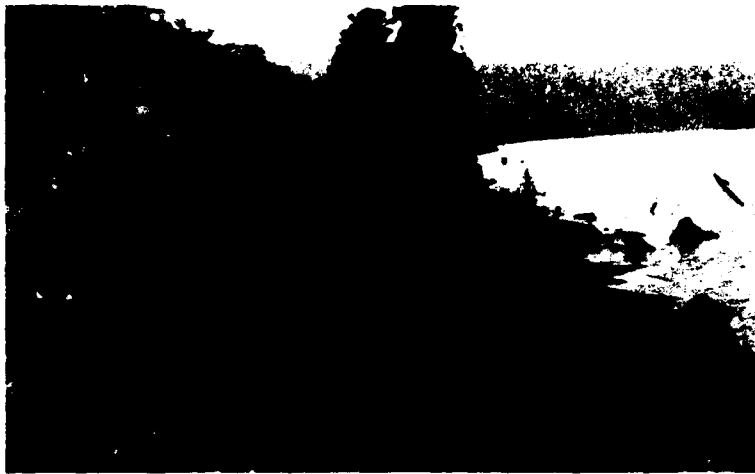
POST CONSTRUCTION  
22 JULY 1977

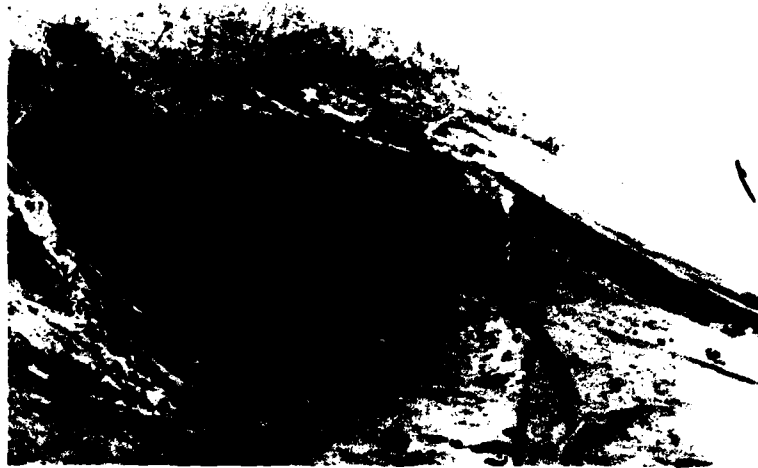
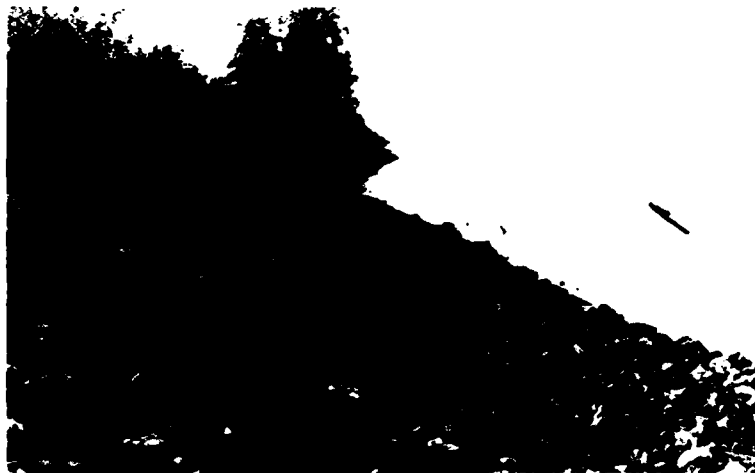
SCHEME  
REHABILITIZED  
8 AUGUST 1978

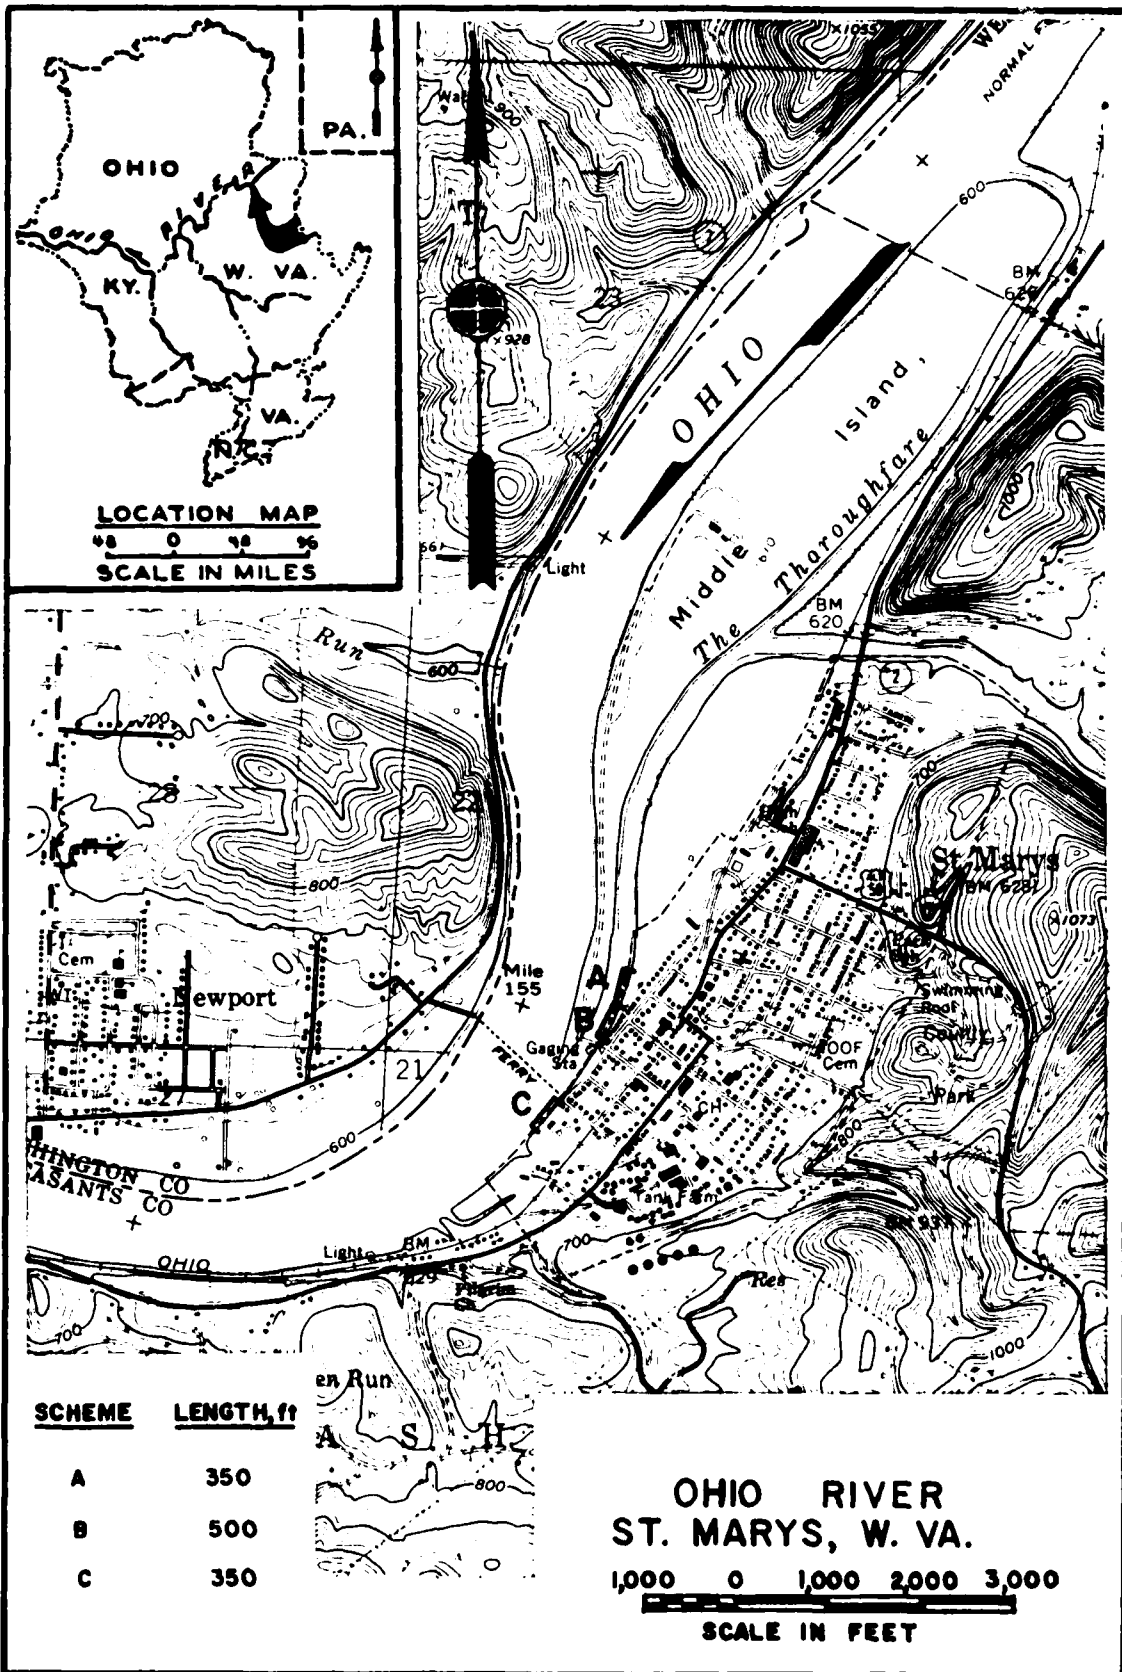
slopes within this area; however, loss of bank materials by failure erosion has most probably been reduced. The downstream adjacent treatment, Section B, consists of dikes with their effect on adjacent slope instability conditions being considered as beneficial. Section C, the most downstream treatment, consists of tire walls which have experienced some loss of fine granular backfill during storm and excessive flow events but are performing satisfactorily in effecting a reduction in bank failure and erosion.

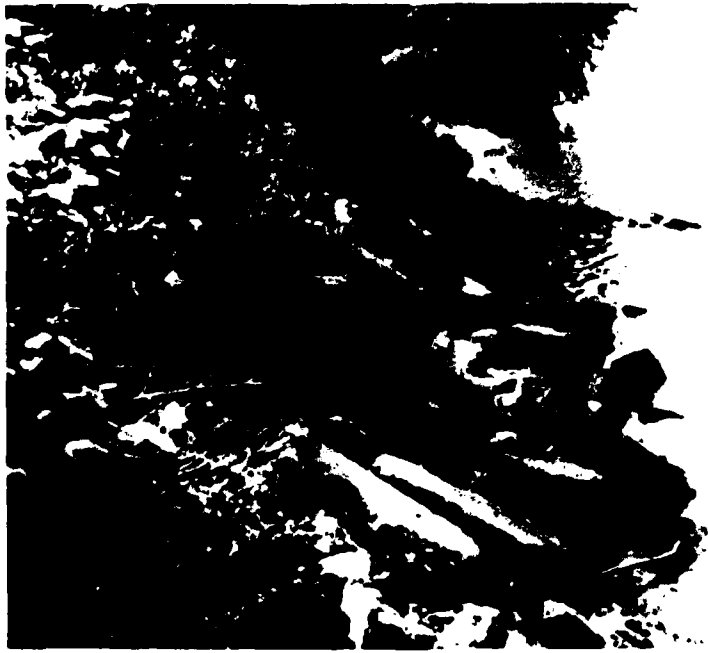
SCHEME A: LOOKING DOWNSTREAM BEFORE CONSTRUCTION

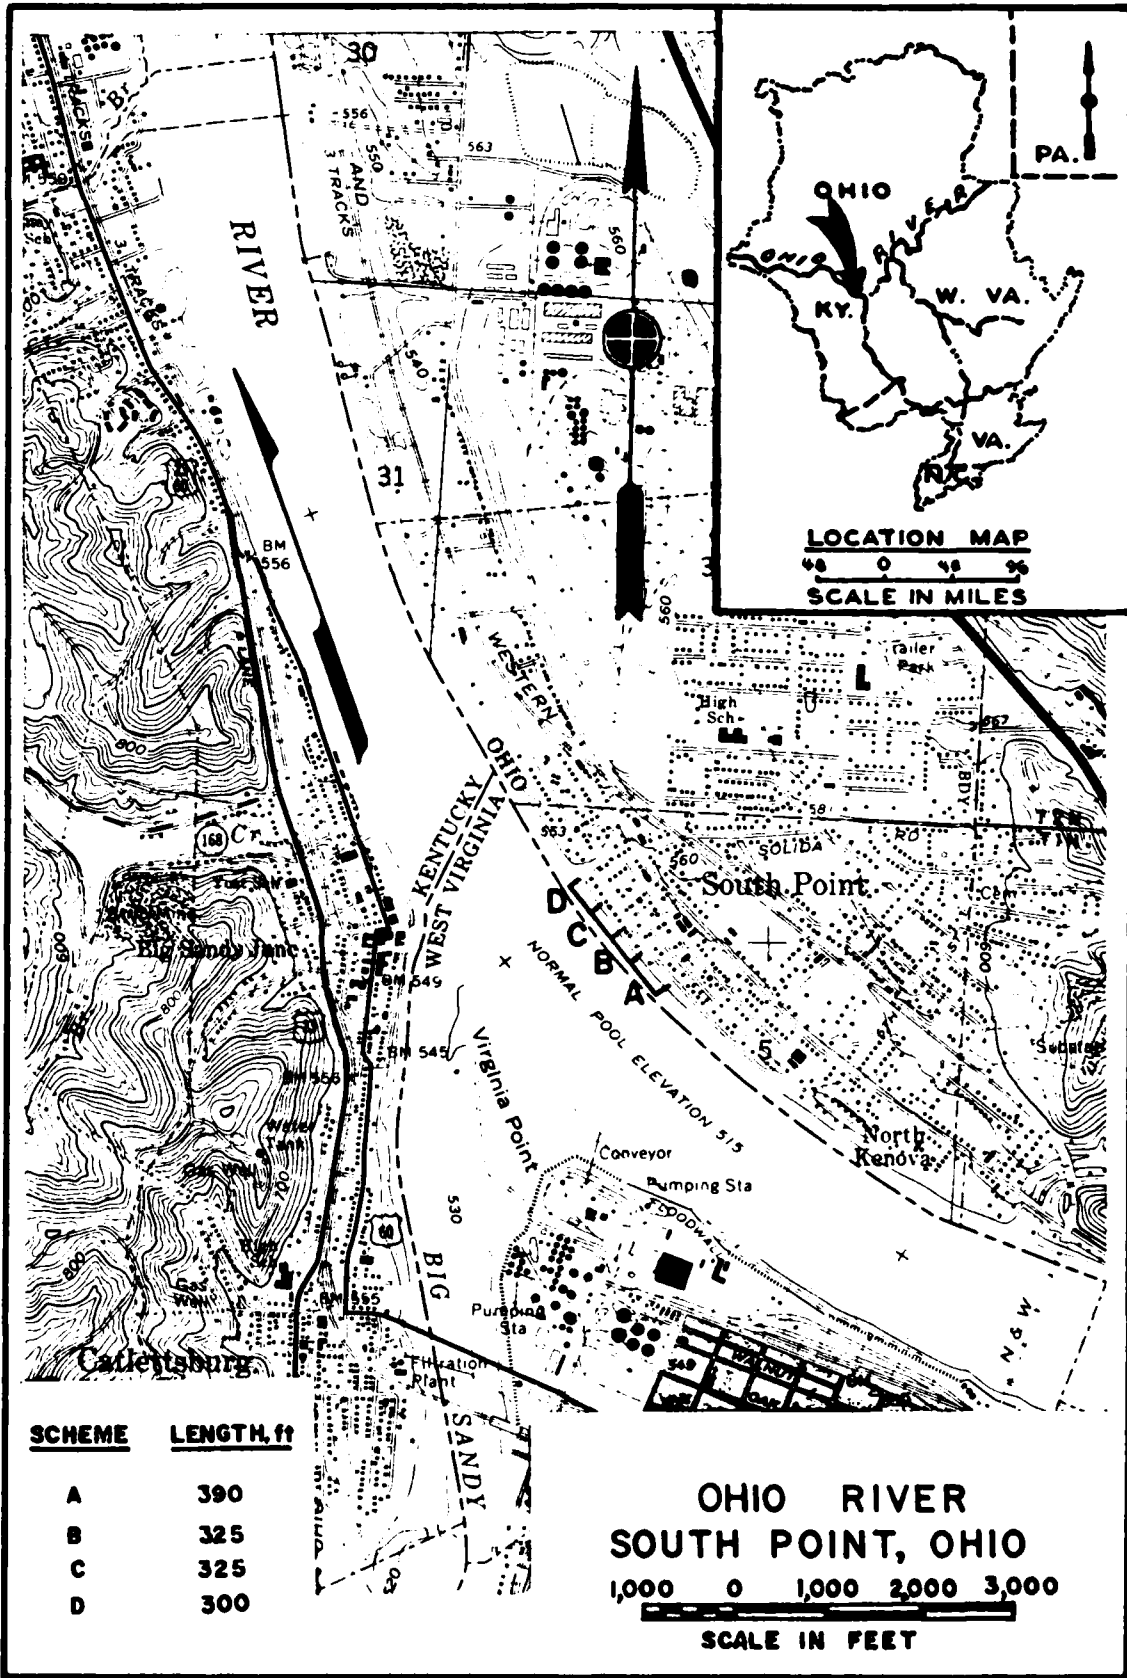
alluvium has been effected. Reconstruction of some reaches utilizing waste concrete and rock is required. Upper bank seepage and related failures have continued. Sediments have not accumulated within the mat protection. Upper bank accumulations of sandy fine silts to a depth of 1/10th inch were noted. Vegetation cover at this site has been effected; however, mowing by the City of South Point, Ohio, may be detrimental.

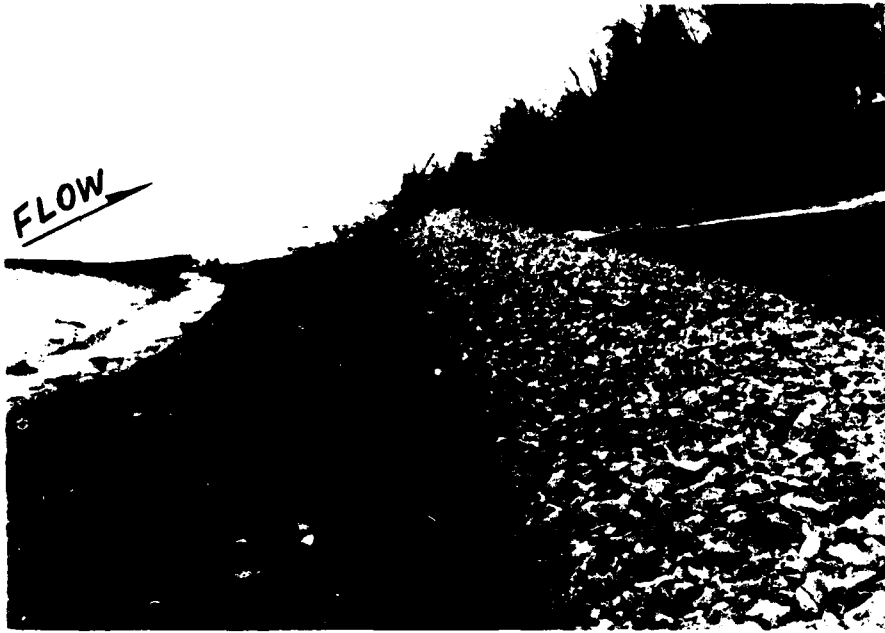
PHOTO NO. 1. 22 Jan. 81. Second Monitoring inspection. Looking downstream (Stations 20+40-27+30).

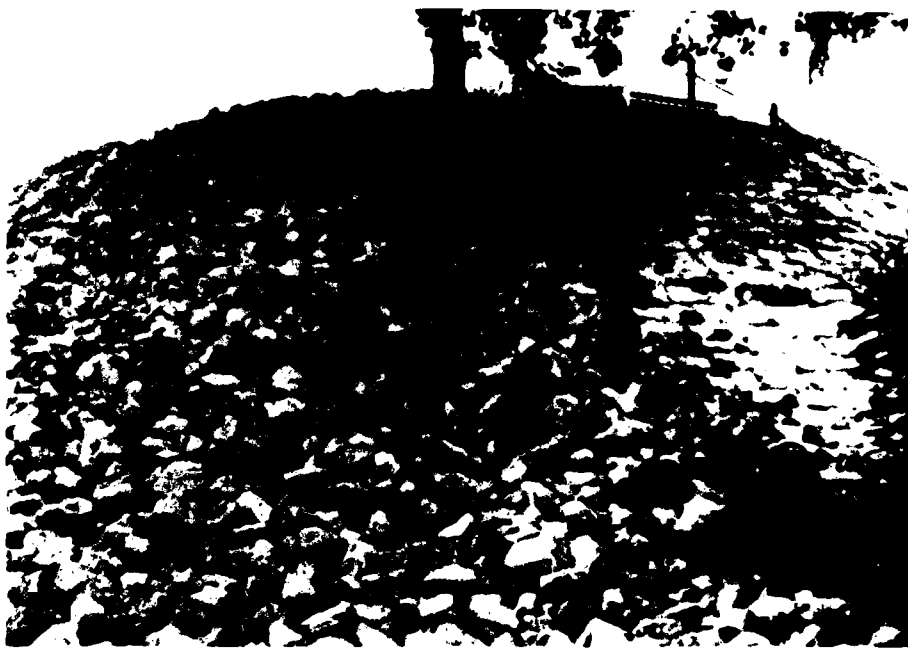
PHOTO NO. 7. Oct. 77. Remedial repair of cement bag area by rock and pipe (under rock). Plate shows details of remedial repair.

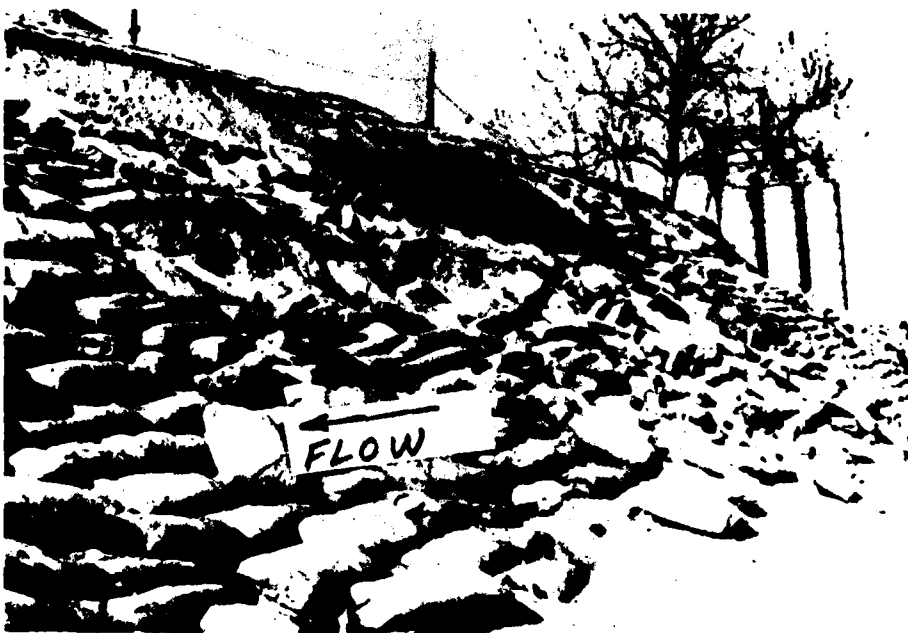
PHOTO NO. 8. May 79. Continued loss of cement bags due to loss of bedding material and sliding during high water. Rehabilitation obviously needed at that time.

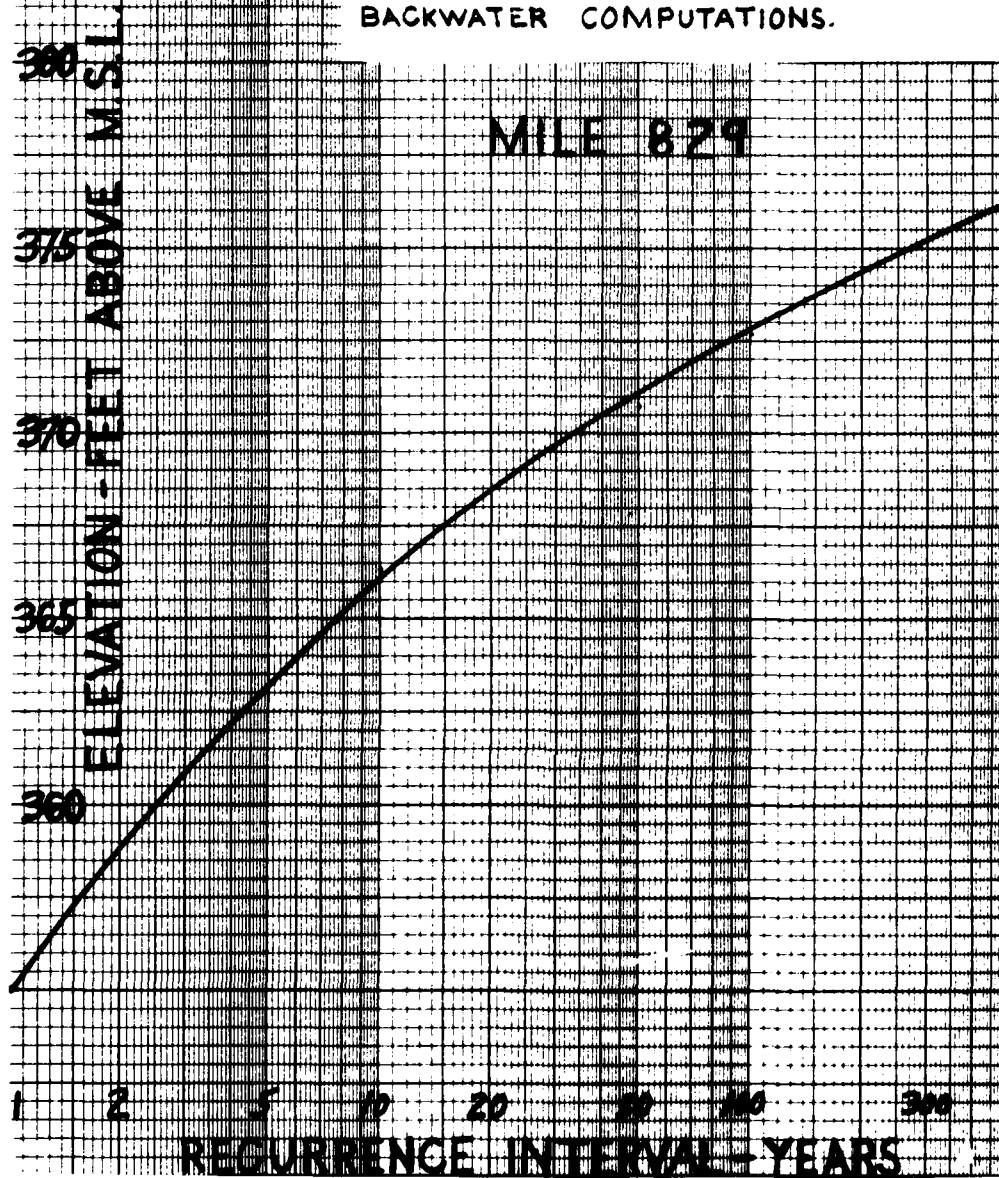
OHIO RIVER  
ELEVATION FREQUENCY
