THE STREAMBANK EROSION CONTROL  
EVALUATION AND DEMONSTRATION ACT OF 1974  
SECTION 32, PUBLIC LAW 93-251

## Appendix H - Evaluation of Existing Projects

Volume 1 of 2

# FINAL REPORT TO CONGRESS

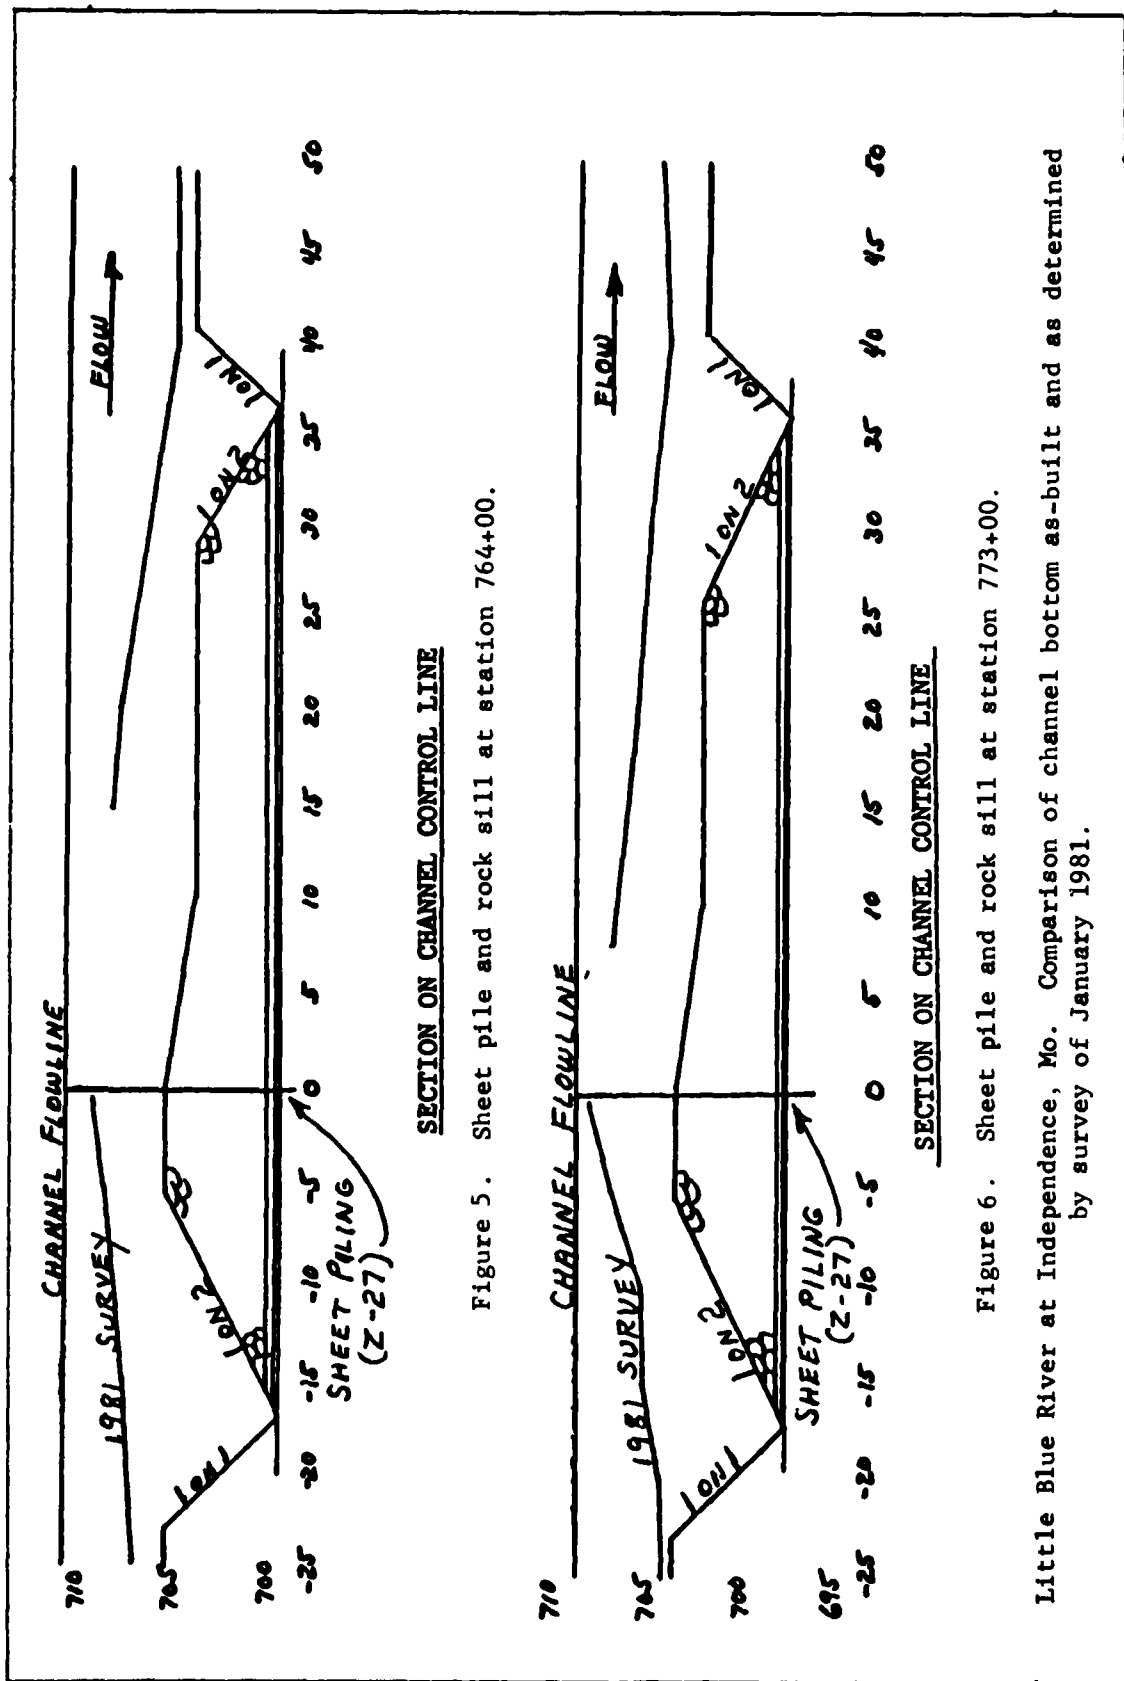
Figure 5. Sheet pile and rock sill at station 764+00.

Figure 6. Sheet pile and rock sill at station 773+00.

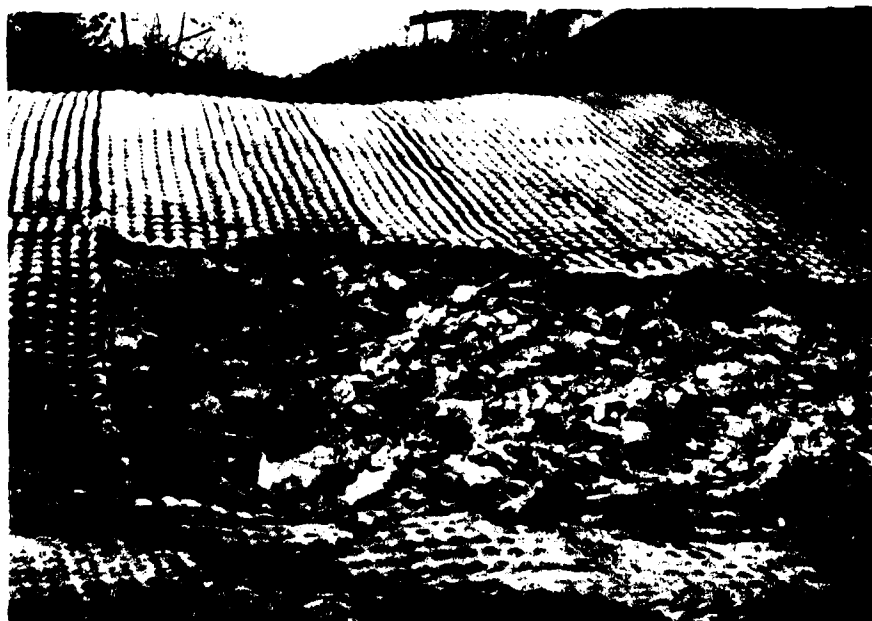
Figure 15. 102 River (East Fork) at Bedford, Iowa. View of damaged Fabriform revetment upstream of the State Street Bridge.
