**THE STREAMBANK EROSION CONTROL  
EVALUATION AND DEMONSTRATION ACT OF 1974  
SECTION 32, PUBLIC LAW 93-251**

**Appendix H - Evaluation of Existing Projects** Volume 2 of 2

Consisting of  
A BRIEF SUMMARY REPORT AND INDIVIDUAL EVALUATION  
REPORTS ON FIFTY EXISTING STREAMBANK EROSION CONTROL  
PROJECTS CONSTRUCTED PRIOR TO OR SEPARATE FROM THE  
SECTION 32 PROGRAM

U.S. ARMY CORPS OF ENGINEERS  
December 1981

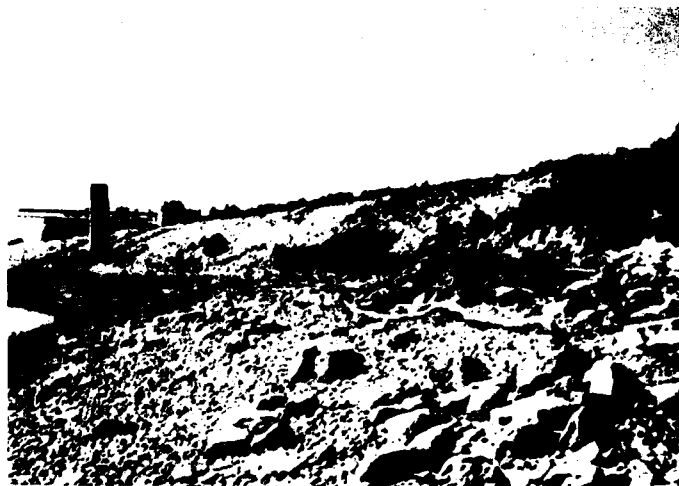
**OCT. 1980 - LOOKING DOWNSTREAM POST  
CONSTRUCTION. PHOTO SHOWS  
LEVEE SLOPE AND RIPRAP  
ARE IN GOOD CONDITION.**
