# Floating Breakwater Field Experience, West Coast

Eugene P. Richey

MISCELLANEOUS REPORT NO. 82-5

U.S. ARMY, CORPS OF ENGINEERS  
COASTAL ENGINEERING  
RESEARCH CENTER

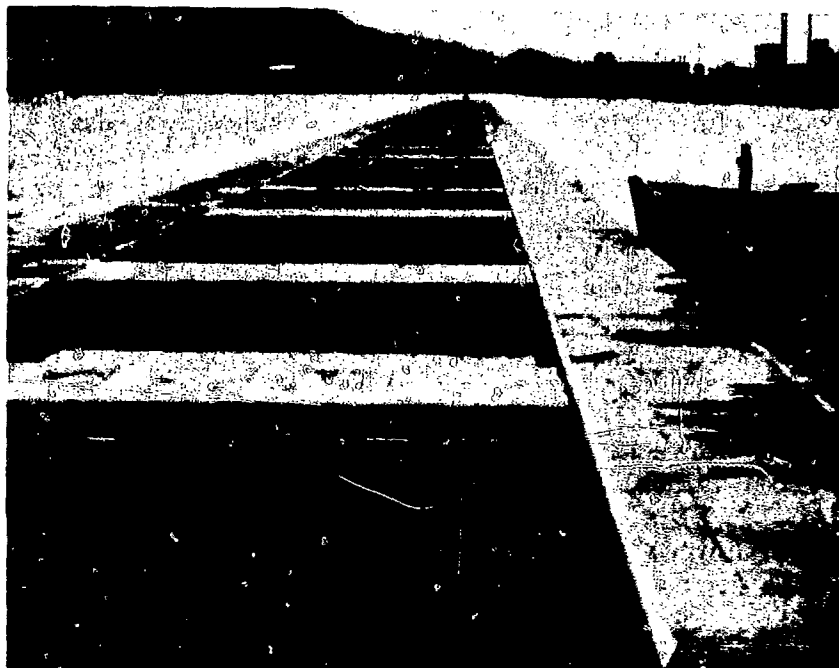
Figure 5. Photos of gaps at both north and south of harbor, Ketchikan, Alaska.

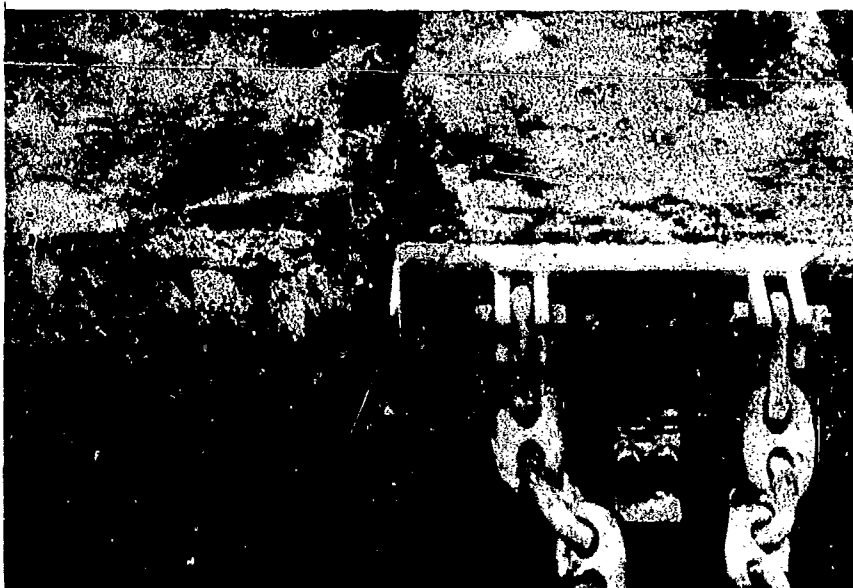
a. Floating breakwater alinement.

b. Module connection.

d. Discussion. The breakwater design is well matched to the site conditions for construction as well as to exposure and use. In 8 years, the only maintenance has been the straightening of the dog-leg alinement, a well-recognized weakness in the initial design layout. The new module connectors also promise to eliminate another weakness--the slack condition that develops as the rubber fender unit loses its resiliency.

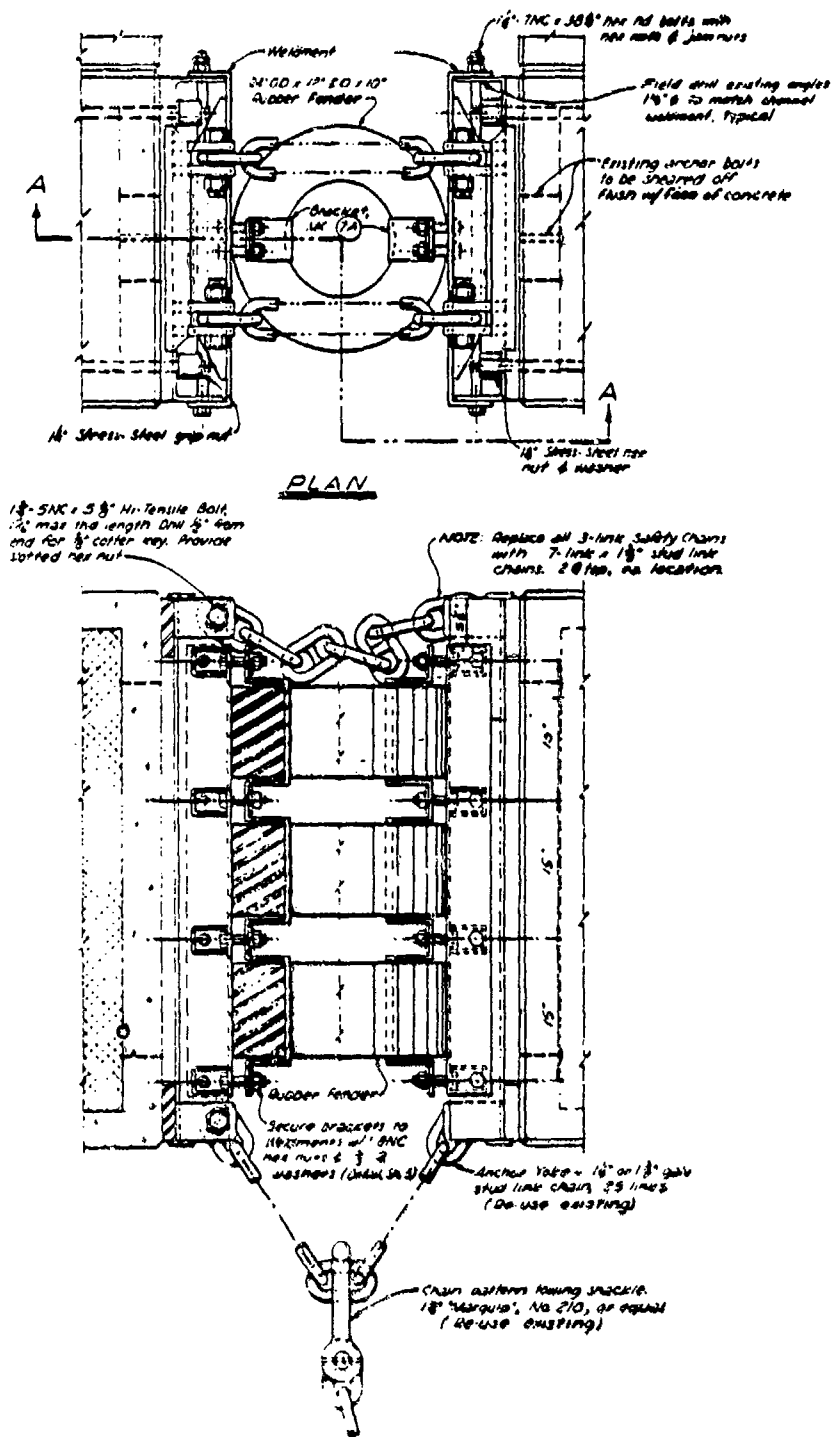
Figure 13. Replacement module connector for floating breakwater, Tenakee Springs, Alaska.

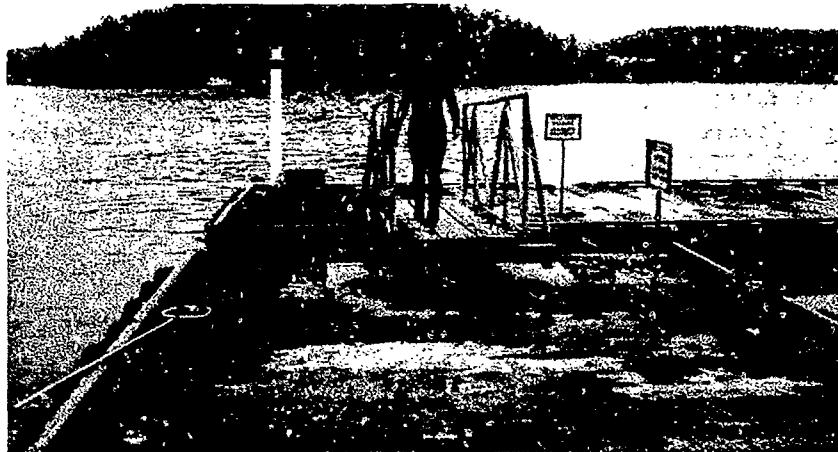
Some adjustments in the breakwater were necessary after installation. The gangways between the sections had to be redesigned to provide greater freedom of movement to avoid being overstressed. One of the sections did not

b. Gangway between sections.

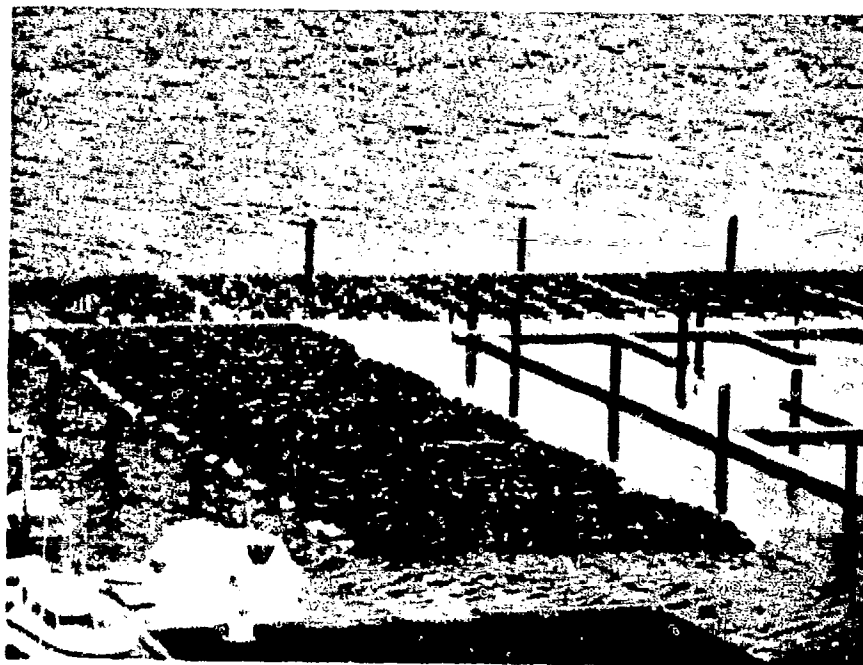
(2) Performance. The breakwater reduces the short-crested waves satisfactorily, but transmits too much energy in the lower frequencies. Connections in the boat slips were overstressed, and boats have not been permitted to use them. The slips were removed for the 1980-81 winter season. The north end of the east breakwater has been sinking, possibly due to the combination

Figure 29. Photo of floating tire breakwater, Langley, Washington.

of current drag and loss of buoyancy. Reports on other Styrofoam-filled tire breakwaters state that the foam breaks down under the continuous flexure experienced in the wind wave exposure.
