MISCELLANEOUS PAPER GL-82-17

EVALUATION OF SOD SAVER BLOCKS AND M. C. GILL PANELS FOR TACTICAL BRIDGE ACCESS/EGRESS APPLICATIONS

Geotechnical Laboratory

October 1982

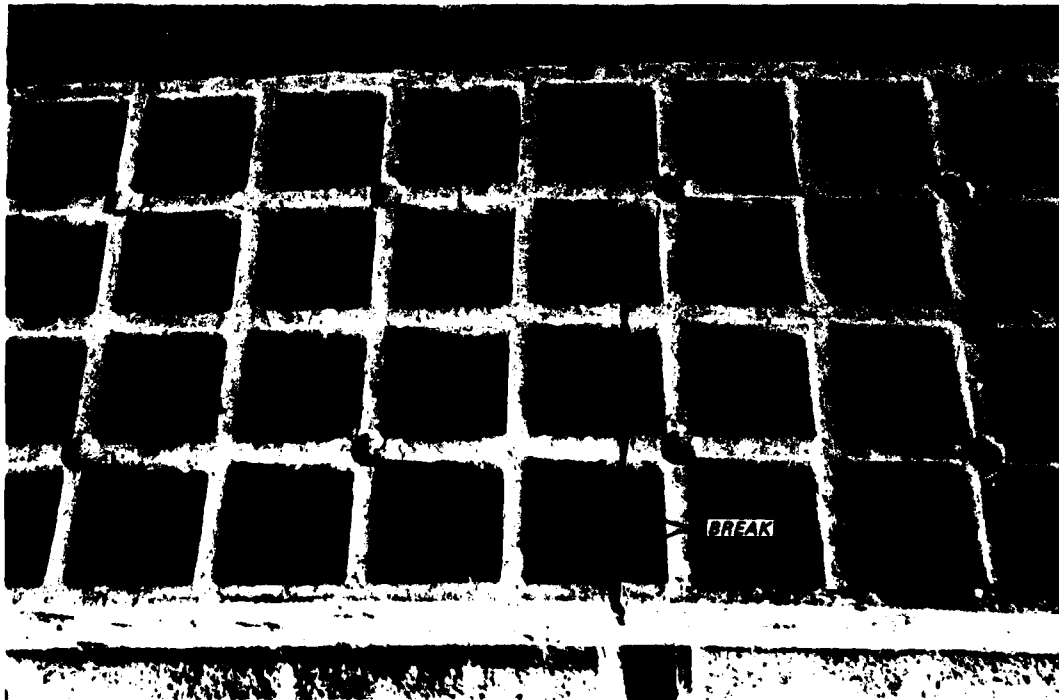
Photo 22. Close-up of break in bottom of Sod Saver Block at failure after 39 passes with 5-ton truck

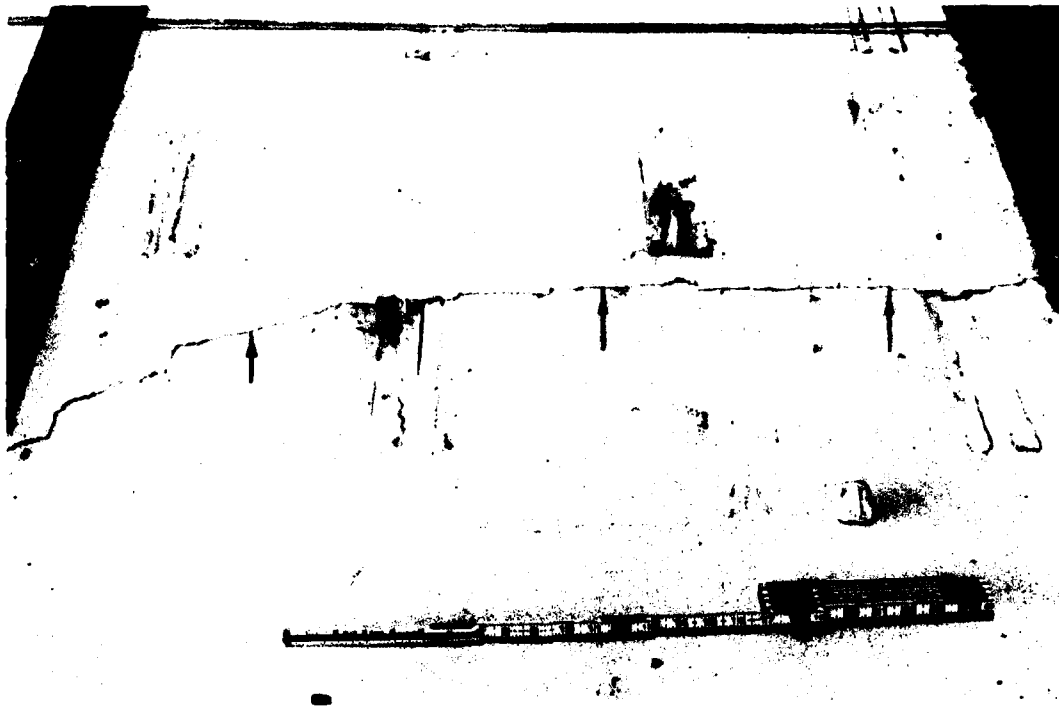
- i. 168 passes. The top skin break in panel 1 extended completely across the panel (Photo 33).
- j. 194 passes. The metal edge channel on panel 1 was completely broken, and the top skin in the broken area mentioned after 168 passes was disbanded completely across the panel.

Photo 33. Break in panel 1 after 168 passes with M48A1 tank

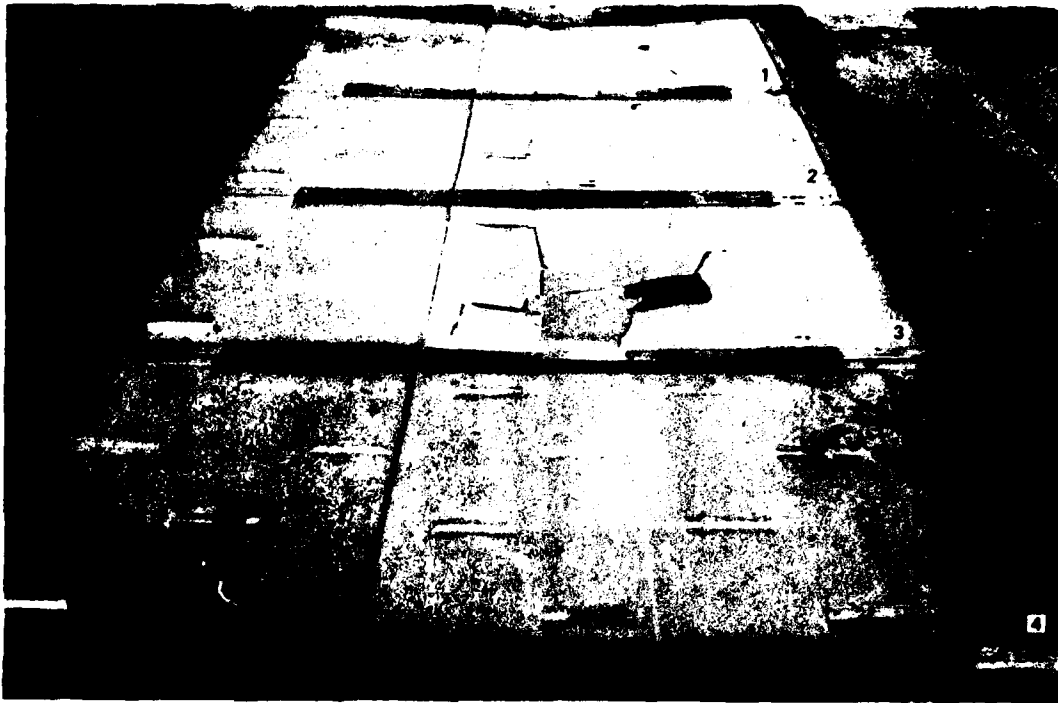
Photo 37. General view of item 2 at failure after 1920 passes (200 tank and 1720 truck passes)

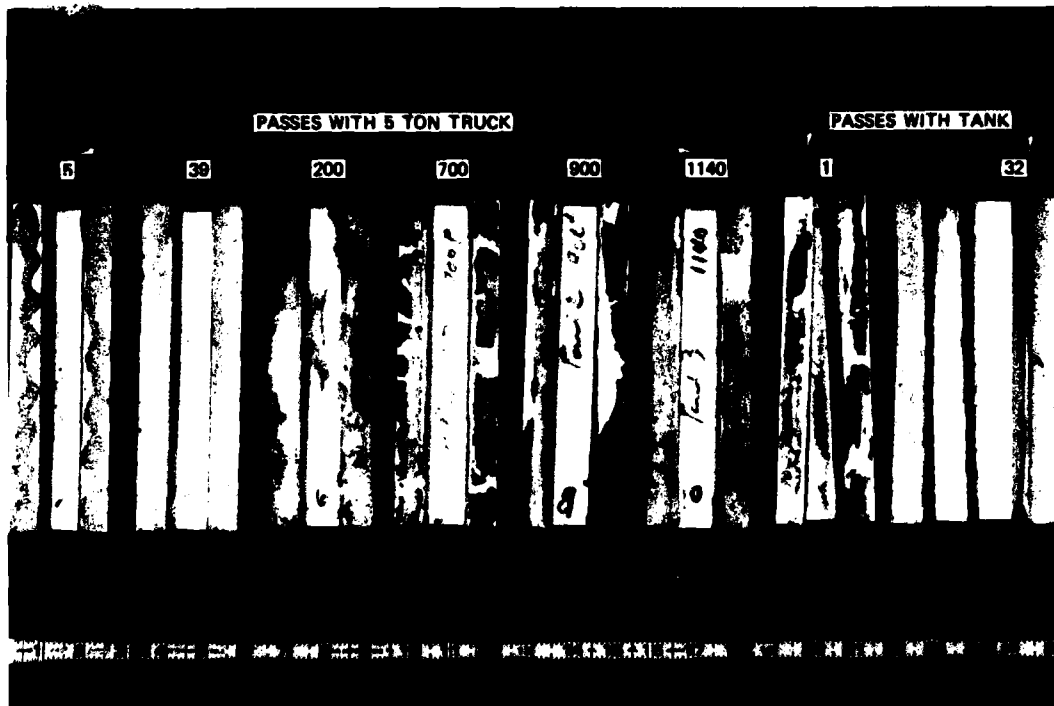
- a. Cleat 1 failed at 5 passes as a result of poor adhesive application between cleat and panel skin.
- b. Cleat 3 failed at 39 passes, due to adhesion failure (glue-metal interface).

- c. Cleat 6 failed at 200 passes due to skin failure in the area of the bond.
- d. Cleats 7, 8, and 10 failed at 700, 900, and 1140 passes, respectively, due to a combination of cohesion and adhesion failures.
- e. Cleat 14 failed at 1 pass with the M48A1 tank. This failure was caused by metal crushing under load.
- f. Cleat 26 failed at 32 passes with the M48A1 tank due to complete metal failure by breaking.

Photo 39. Cleats that failed and were torn from M. C. Gill panels; failures indicated at various phases

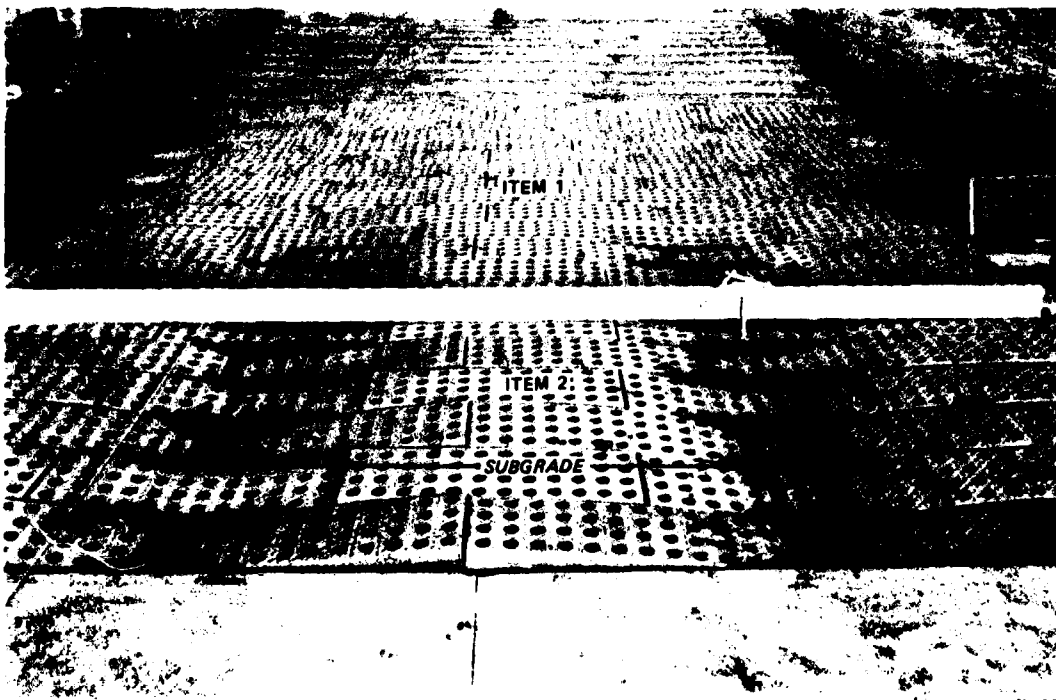
26. Fifty passes were made on the Sod Saver Blocks with the 5-ton M54 truck empty (20,000 lb gross weight). No broken blocks or rings were noted, although the blocks were deformed in the wheel paths (3.0 in. maximum in item 2), as shown in Photo 44. Fifty additional passes were made with the 5-ton truck loaded with 10,000 lb (30,000 lb total weight). After this traffic, the blocks in item 2 were deformed more, but no breaks were found in the blocks or the rings. Cross-sectional and profile data were taken (Figures 14-19) after a total of 100 passes were

Photo 44. General view of test section after 50 passes with 5-ton truck; note permanent deformation and subgrade pumping in item 2, test II

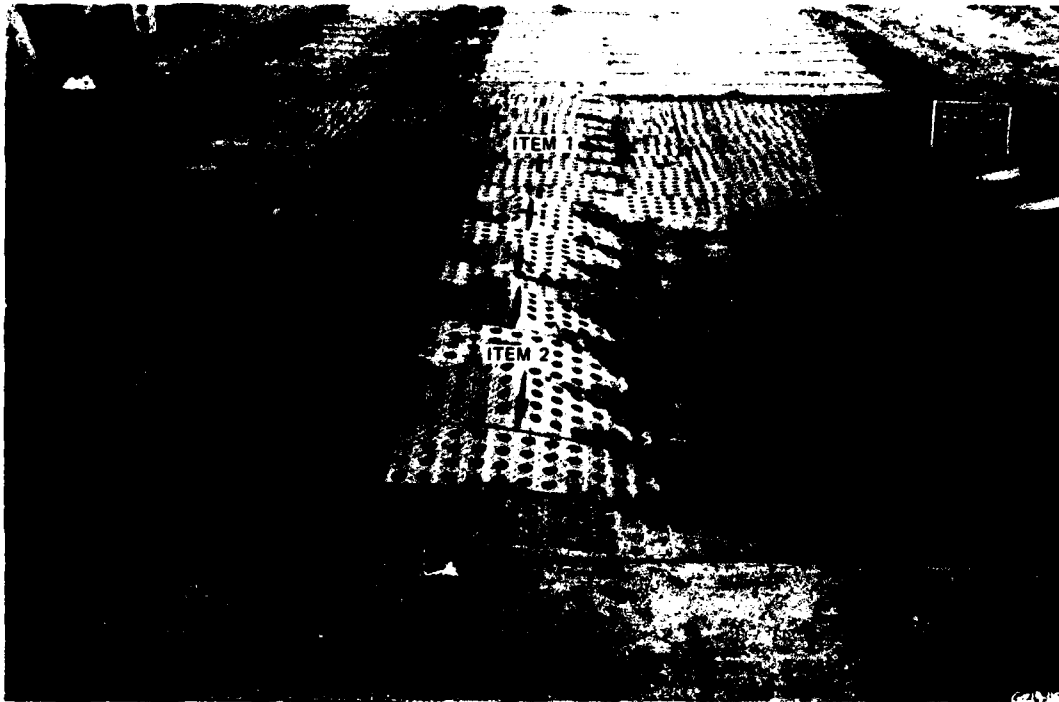
28. The 5-ton truck was loaded with 20,000 lb (40,000 lb total weight). Item 2 failed after 33 additional passes with this loading. The blocks in item 2 had become severely deformed, and several rings had pulled through the block ends. This condition caused the undercarriage of the truck to drag. A general view of the test section with item 2 failed after 133 passes with the 5-ton truck and 25 passes with the M48A1 tank as shown in Photo 45.

Photo 45. General view of test section showing item 2 failed after 158 passes (25 tank and 133 truck passes), test II

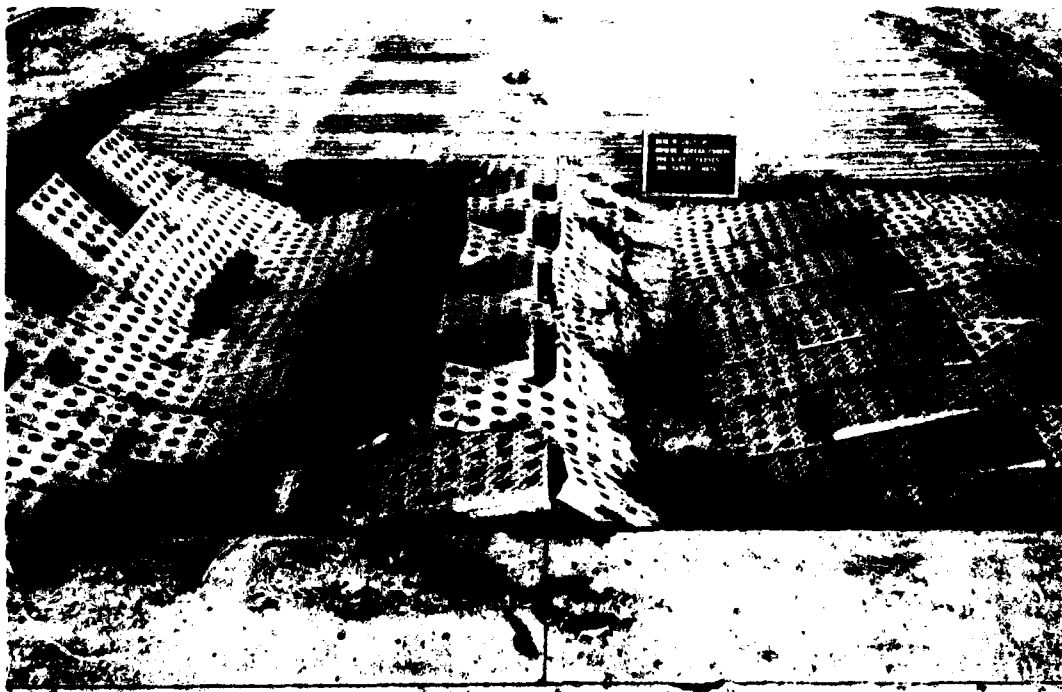
29. Traffic continued on item 1 with the 5-ton truck for a total of 300 truck and 25 tank passes. Item 1 was considered failed due to broken Sod Saver Blocks which caused deep ruts and also rings which pulled out of the block ends at the centerline, allowing the truck undercarriage to drag. The maximum rut depth was recorded at 15-5/8 in. in the west wheel path. Cross-sectional and profile data are shown in Figures 14-19. The cross-sectional data in item 1 show that the average maximum difference in elevation between 0 passes and 100 passes was 1.7 and 2.0 in. in the west and east wheel paths, respectively. The same data taken after 300 passes at the same locations showed average maximum elevation differences of 6.8 and 7.0 in. in the west and east wheel paths, respectively. The average maximum difference in elevation when measured on the block surface was 11.1 in. (measured from bottom of rut to highest point at center of traffic lane), as shown in Figures 16-17. The permanent deformation profiles show that for each additional 100 passes applied, the average maximum deformation increased 2.02 in. at

2-1/2 ft east of the center line and 2.47 in. at 3-1/2 ft east of the center line. These data also indicate how the subgrade was displaced, as discussed earlier. A general view of this failed item is shown in Photo 46. A close-up of the failed blocks is shown in Photo 47. Broken blocks and rings pulled loose from panel ends are shown in this photograph. A close-up of a typical break in a Sod Saver Block is shown in Photo 48.

Photo 46. Item 1 (with runners) failed after 325 passes (25 tank and 300 truck passes), test II

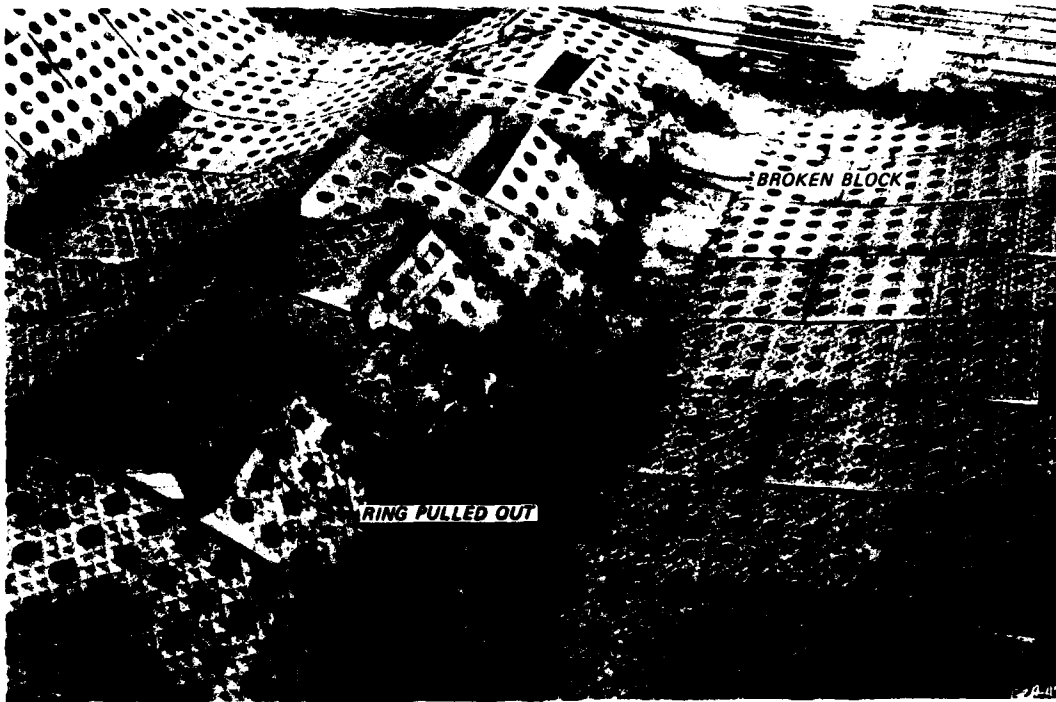
Photo 47. Close-up view of item 1 (with runners) failed after 325 passes (25 tank and 300 truck passes), test II

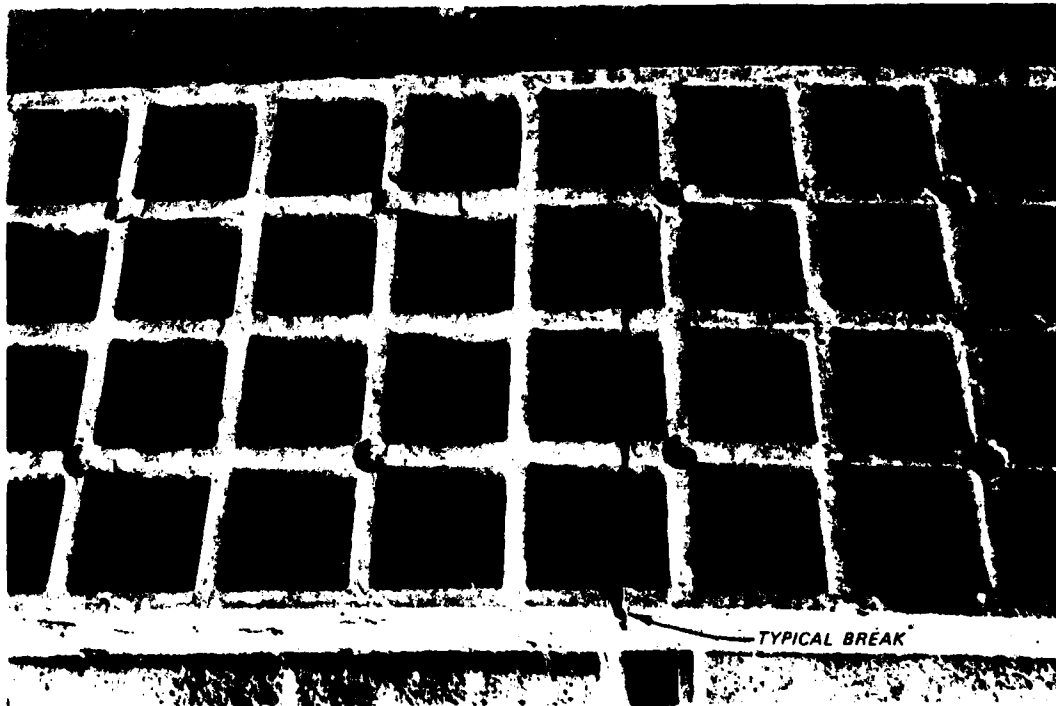
Photo 48. Close-up of a typical break in the bottom of a Sod Saver Block at failure
