## STRUCTURAL EVALUATION OF AN ADVANCED COMPOSITE HYDROFOIL FOIL COMPONENT

TEST AND EVALUATION REPORT

DTNDRDC-82/082

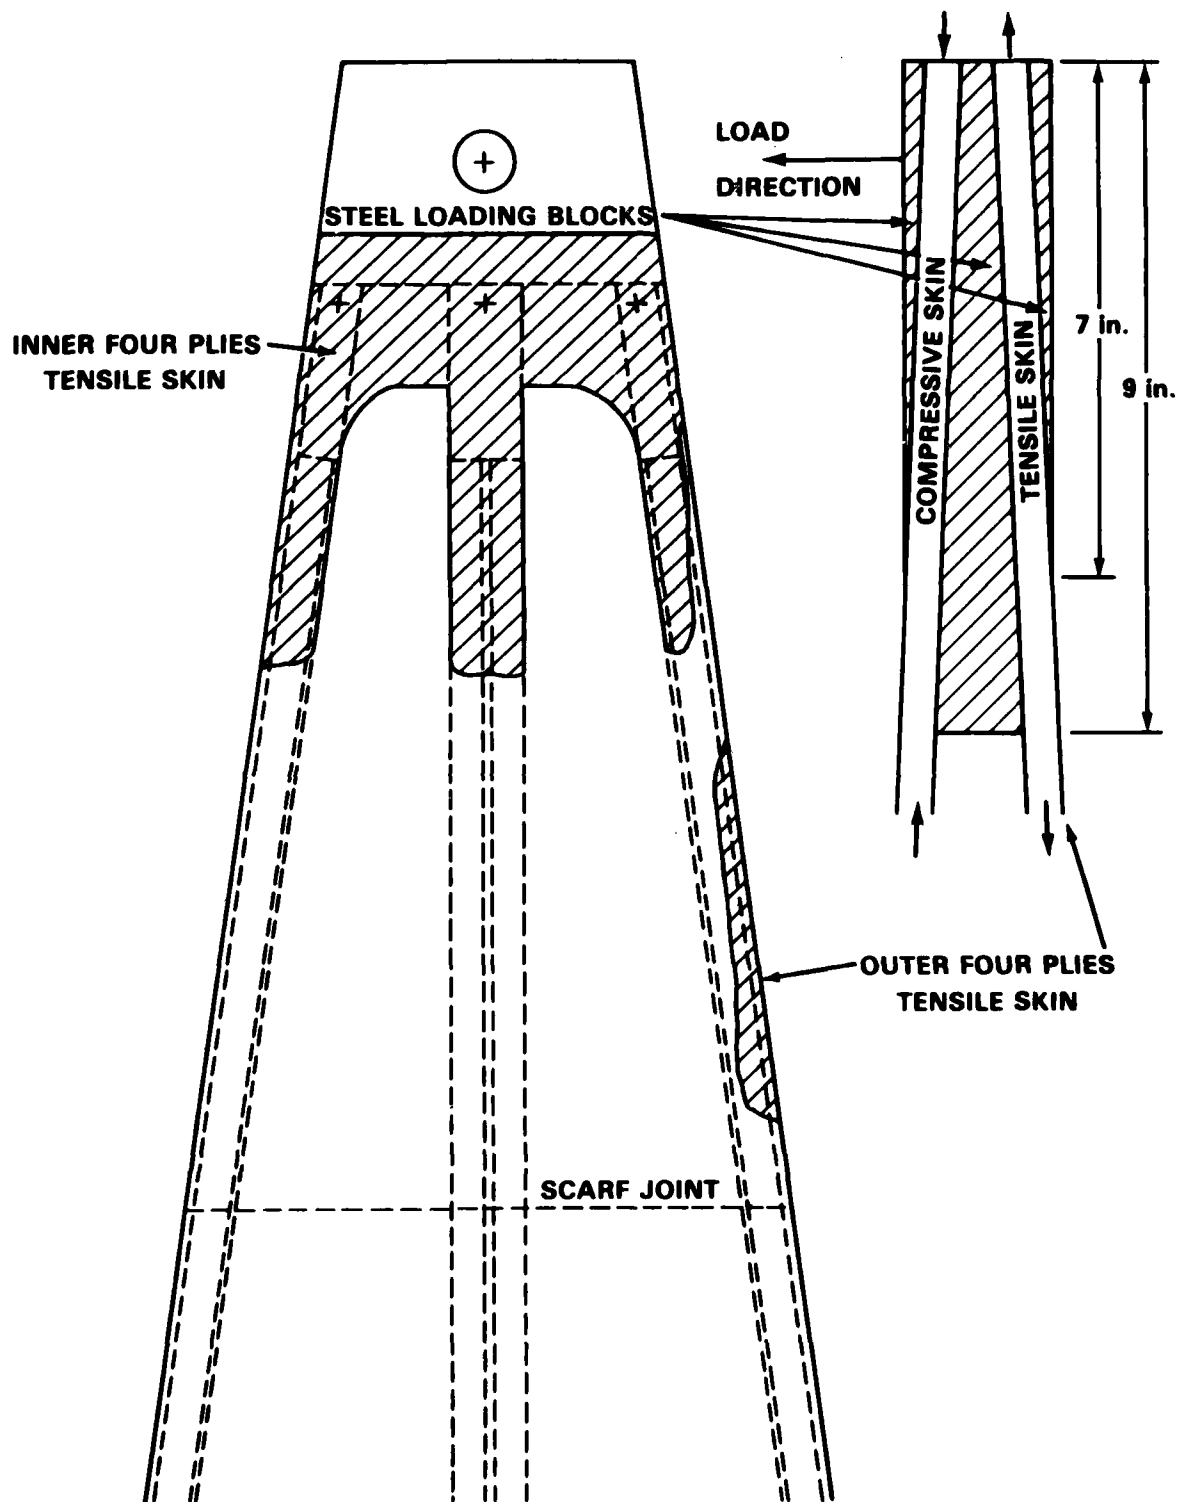
Figure 6 - Sketch of Delaminations Found by UT Following Test 1

The box beam incurred delaminations to the inner surface of the tensile skin in the load application area at 48 kips (80 percent of the maximum operating load of 60 kips) during the second run of the first test. Figure 6 is a sketch showing the delaminated area as determined by NRL ultrasonic inspection (UT). The box beam was then shipped back to the manufacturer to be repaired. The repair consisted of: (1) bonding the outer four plies back to the tensile skin, (2) attempting to infiltrate resin into the delamination on the inner surface of the tensile skin, (3) bolting

and bonding 0.5-in. thick steel doubler plates to the load application area, and (4) bonding a layer of glass-reinforced plastic to the edges of both skins. Figure 7 shows the location of the doubler plates as well as the results of the NRL UT following the attempted repair. (The internal aluminum blocks were used to minimize the volume of resin used during infiltration so as to prolong the pot life.) The initial interpretation of the NRL UT results indicated that the delamination still existed; i.e., the attempt to infiltrate the internal delaminations may have been unsuccessful. However, further studies related to the effect of thick bonds showed that the ultrasonic signal could have been caused by a delamination or a thick layer of resin. Thus, the adequacy of the repair could not be determined.

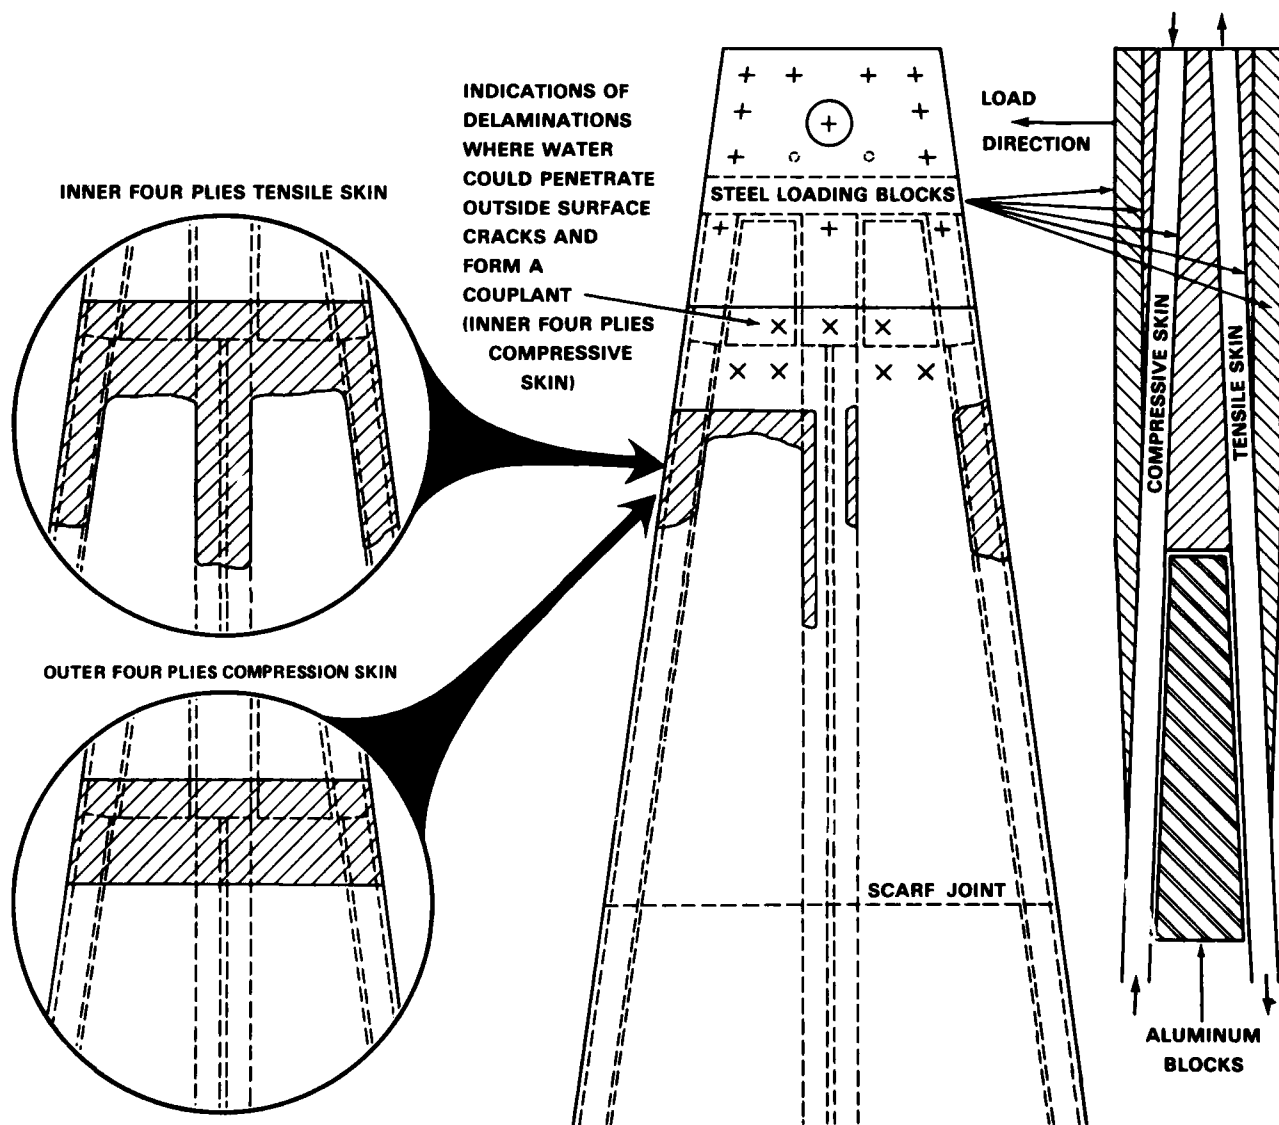
Figure 8 - Sketches of Delaminations found by UT Following Test 2

A second static test was conducted, and again the box beam delaminated in the load application area at 48 kips during the second run as shown in Figure 8; this time the delaminations were much more extensive. The box beam was then tested to 30 kips to determine what effect the delamination had on the overall stiffness; it was sent back to the manufacturer for repairs. This time the repairs included removing the doubler plates and outer delaminated plies from both skins, replacing them with a built-up area, as shown in Figure 9, and bolting (only) the outermost 0.5-in. thick steel doubler plates back in place. Following the second repair, the

box beam was inspected by NRL using a hand scan UT technique and by the Sea Water Component Integrity Measuring Instrument<sup>5</sup> (SCIMI) developed for the Navy by the Electric Boat Division of General Dynamics. The results of this inspection indicated that there were still delaminations on the inside surface of both skins along the spars, and potential midskin delaminations just above the scarf joint in both skins. There was also an indication of delaminations on the outside surface of the built-up areas on both skins in the load application area.

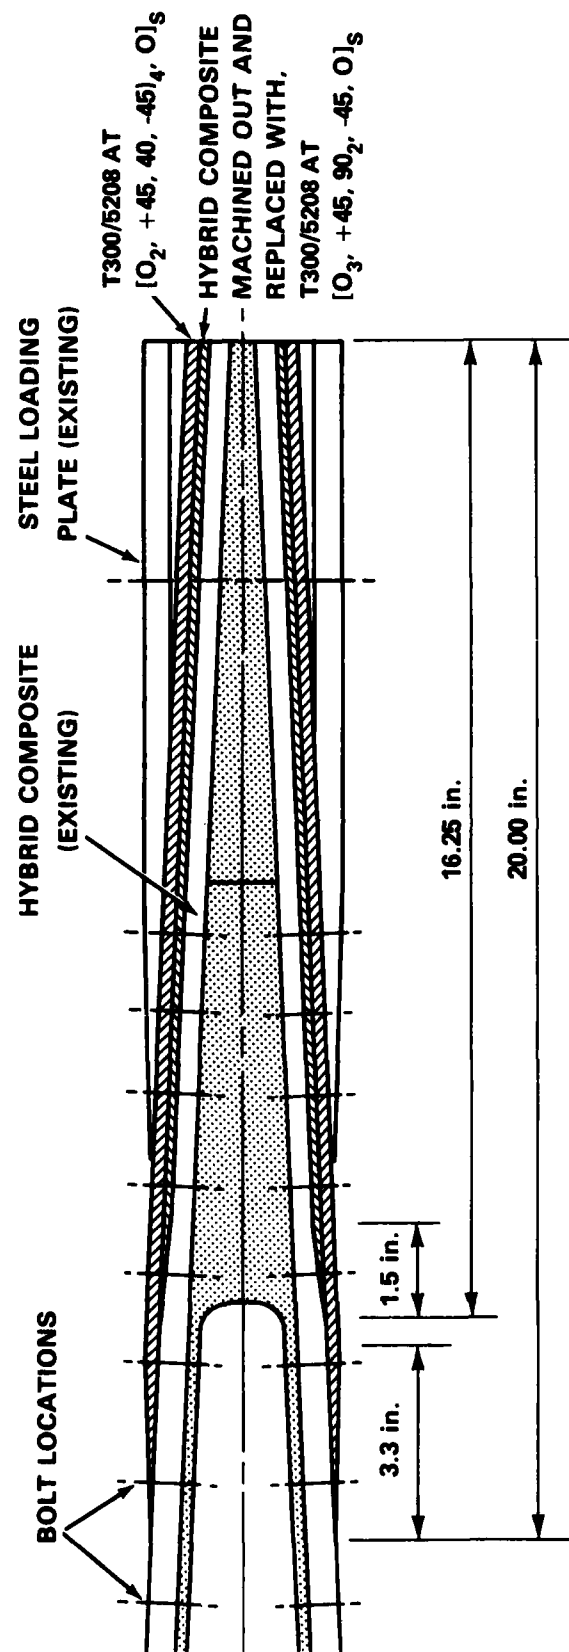
Figure 9 - Box Beam Loading Area Showing Results of Repair 2

Following the second repair, the box beam was again tested statically; this time to the maximum planned operating load of 60 kips. The box beam sustained 60 kips for 5 min. Several surface delaminations occurred during this test run. The strain data were analyzed and an exact maximum load of 57 kips was selected for the cyclic tests. At 57 kips, the maximum stress in the box beam was 43 ksi. This leads to a design safety factor of 1.58 with an ultimate strength allowable of 68 ksi. The box beam was then loaded to a maximum load of 57 kips prior to the initiation of the cyclic tests. Extensive delamination occurred during the fourth test in the outer layers of both skins. This limited the effectiveness of the UT inspection, and made the SCIMI inspection unproductive. The NRL hand scan UT inspections did find evidence of internal delaminations in the built-up section of the load application area, but no growth of previously noted flaws could be detected.

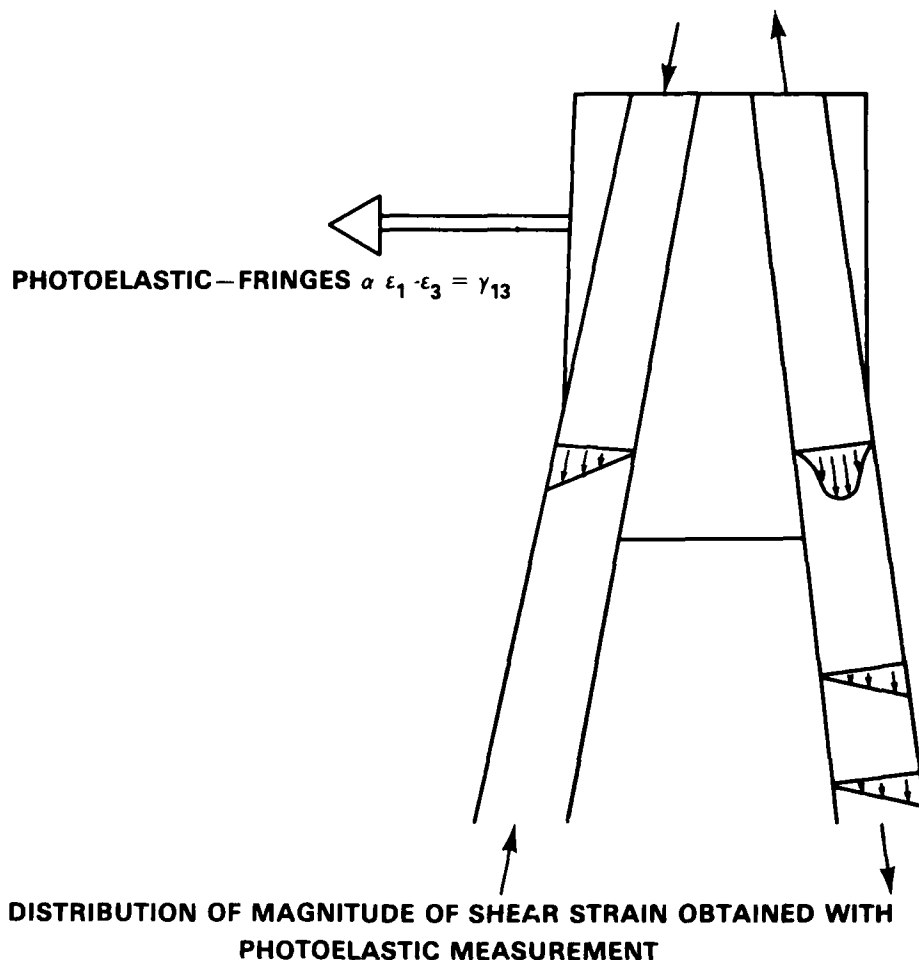
Figure 13 - Qualitative Distribution of Shear Stress Magnitude  
for Box Beam 2 from Photoelastic Measurements

NOTE PARABOLIC DISTRIBUTION ON TENSION SIDE IN  
LOADING REGION
