DESIGN, FABRICATION, AND STRUCTURAL EVALUATION OF AN ADVANCED COMPOSITE HYDROFOIL CONTROL FLAP

by
William P. Couch

STRUCTURES DEPARTMENT
TEST AND EVALUATION REPORT

November 1982

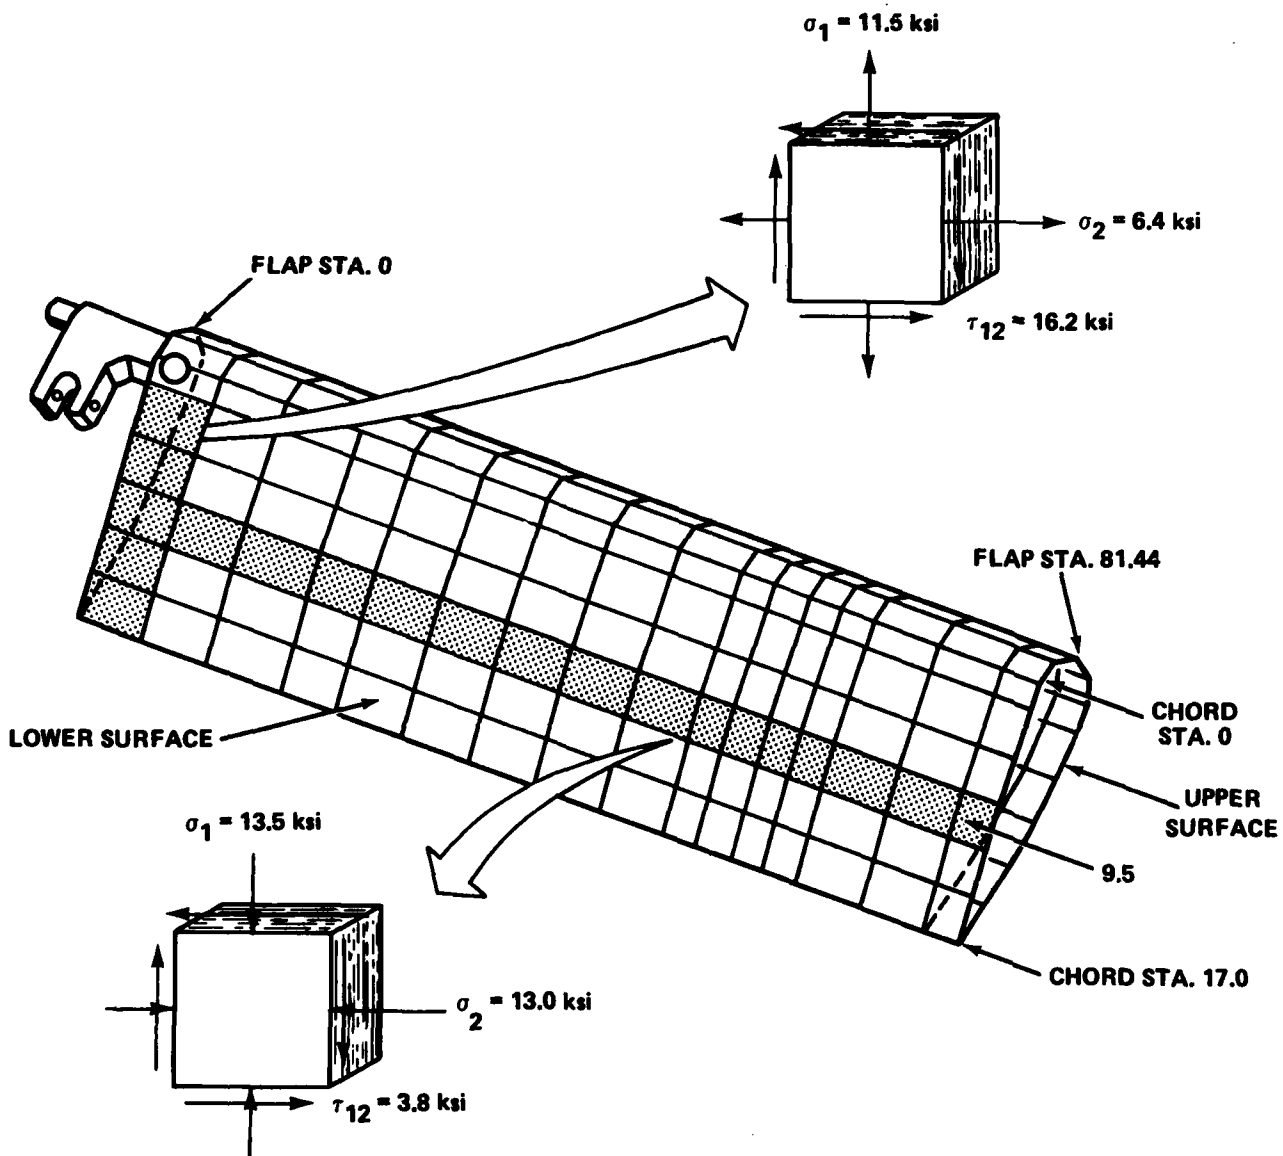
Figure 2 - Boeing NASTRAN FEA Model and Critical Stress Areas of the Composite Flap

crank-spar assembly. A NASTRAN computer code finite element analysis (FEA) performed by the Center indicated that the skin panel and maximum tip deflections would be excessive under the critical pressure loading of 6300 lb/ft². Subsequently, Boeing redesigned the upper and lower surface skins to a constant thickness of approximately 0.5 in. using its own NASTRAN FEA. Figure 2 shows the Boeing analysis and the critical stress areas of the redesigned composite flap. This thickness was made up of 36 plies of T 300/934 graphite epoxy fabric oriented at $\pm 45^\circ$ and 10 mils of 6Al-4V titanium bonded to the exterior surfaces of each skin. The cladding was incorporated as a barrier to water absorption by the graphite epoxy skins, to prevent cavitation erosion of the epoxy matrix, and to add a measure of protection against small object impact. The skins were bolted and bonded to a crank-spar assembly made of ELI grade 6Al-4V titanium. It incorporated five sets of integral hinge lugs and a load crank machined to the same geometry as the existing steel design; see Figure 2 for details.

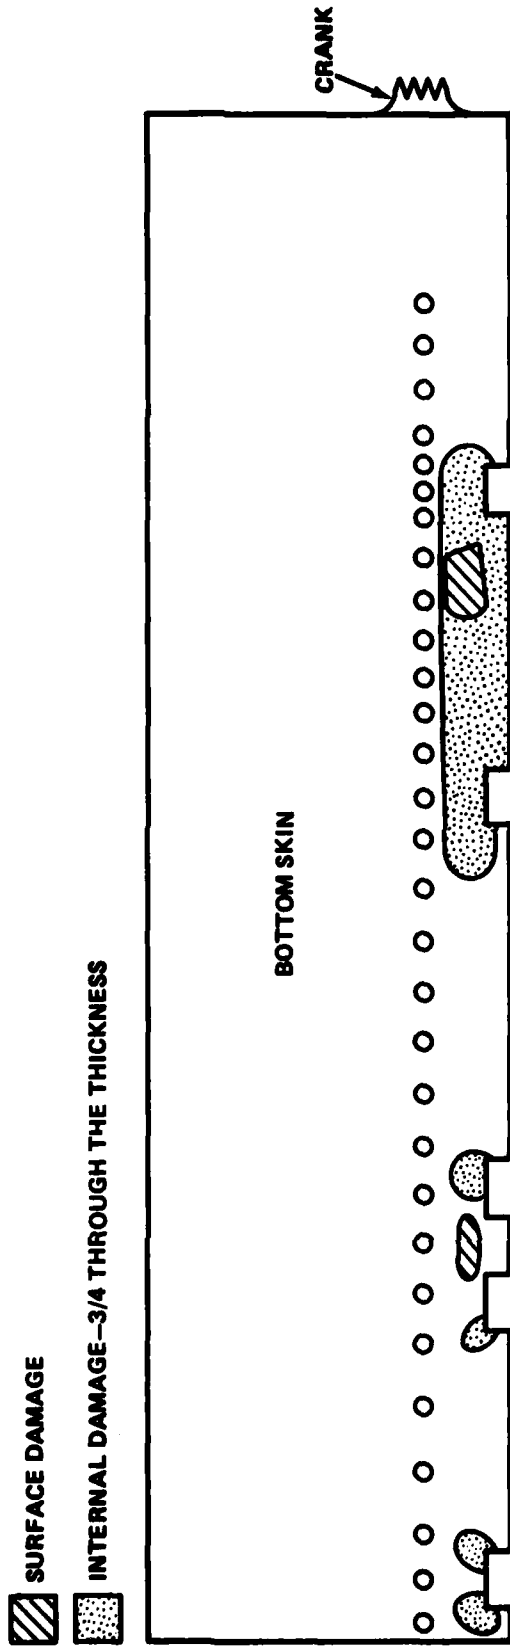
Figure 13 - Ultrasonic Inspection of Composite Flap after Static Overload

1. IN GENERAL, DAMAGE GREATEST IN HALF CLOSEST TO CRANK.
2. TOP SURFACE UNDETECTED.
3. UNABLE, WITH AVAILABLE TRANSDUCERS, TO EXAMINE CURVED LEADING EDGE.
4. DAMAGE CONFINED TO AREA BETWEEN CURVED LEADING EDGE AND FIRST ROW OF BOLTS ON BOTTOM SURFACE.
5. TWO HINGES FARTHEST FROM CRANK-DAMAGE AT CORNERS ONLY.
6. SLIGHT SURFACE DAMAGE AROUND BOLTS BETWEEN FOURTH AND FIFTH HINGES.
7. DAMAGE BETWEEN THIRD AND FOURTH HINGES - SURFACE AND POSSIBLY INTERNAL DAMAGE EXTENDS ONE-HALF WAY FROM HINGES TO BOLTS.
8. CLOSER TO CRANK END, DAMAGE EXTENDS ALL THE WAY TO THE ROW OF BOLTS.
