CAESAR CREEK LAKE  
LITTLE MIAMI RIVER BASIN  
OHIO

EMBANKMENT CRITERIA AND  
PERFORMANCE REPORT

PREPARED BY  
U.S. ARMY ENGINEER DISTRICT, LOUISVILLE  
CORPS OF ENGINEERS

SEPTEMBER 1982

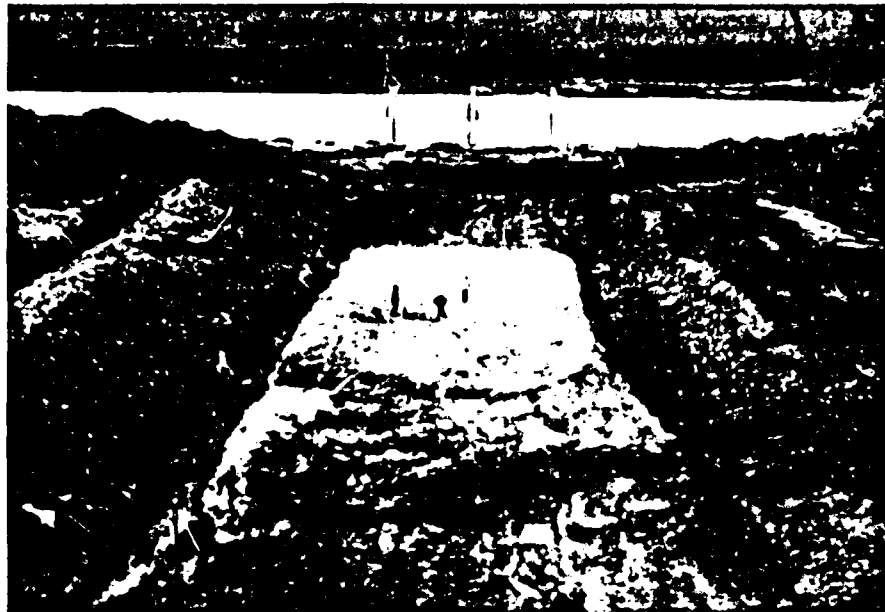
(5) View showing shale foundation of valley cutoff trench from left abutment Dec 1973.

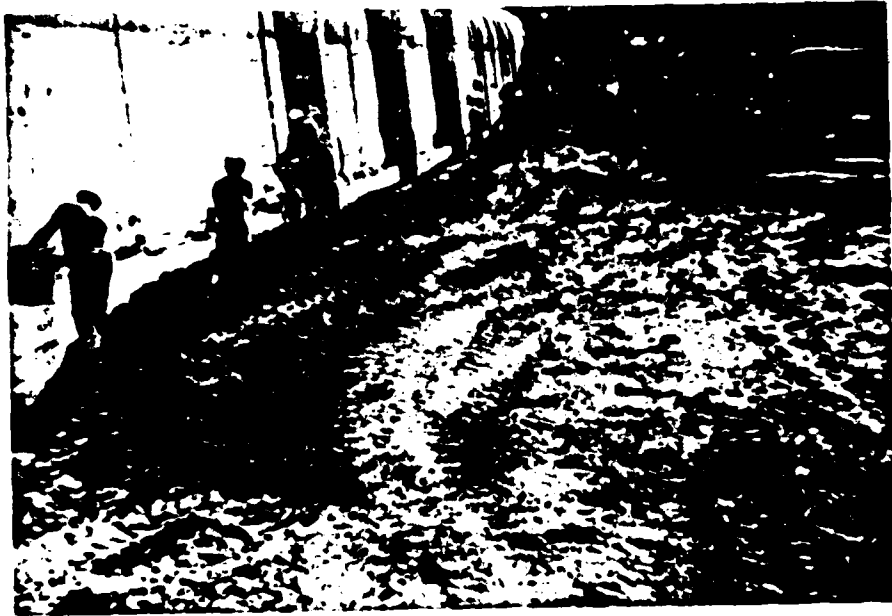
(7) Impervious embankment being placed along left side of conduit, and right abutment toe of dam 17 Sep 1974.

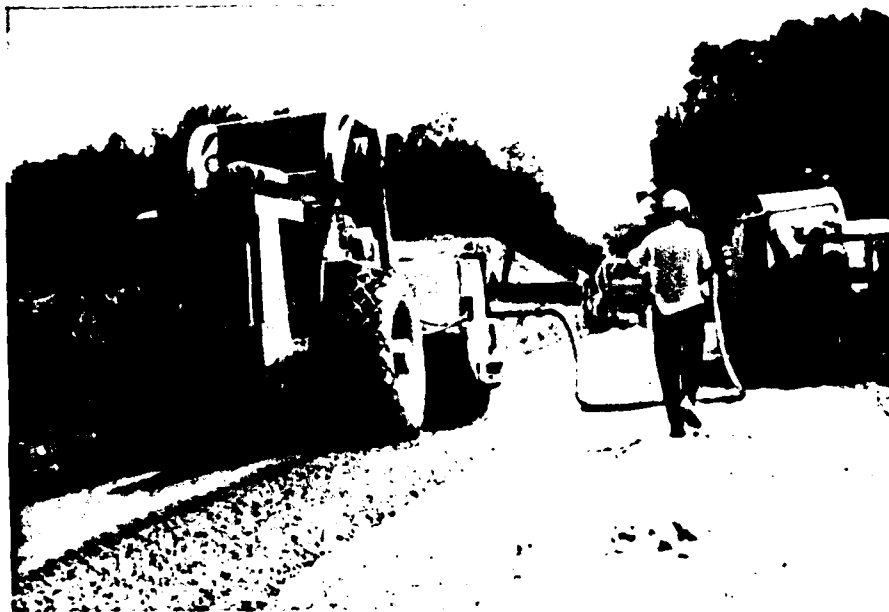
(13) Spray bar and water supply wagon used to add moisture to transition material. June 1975.

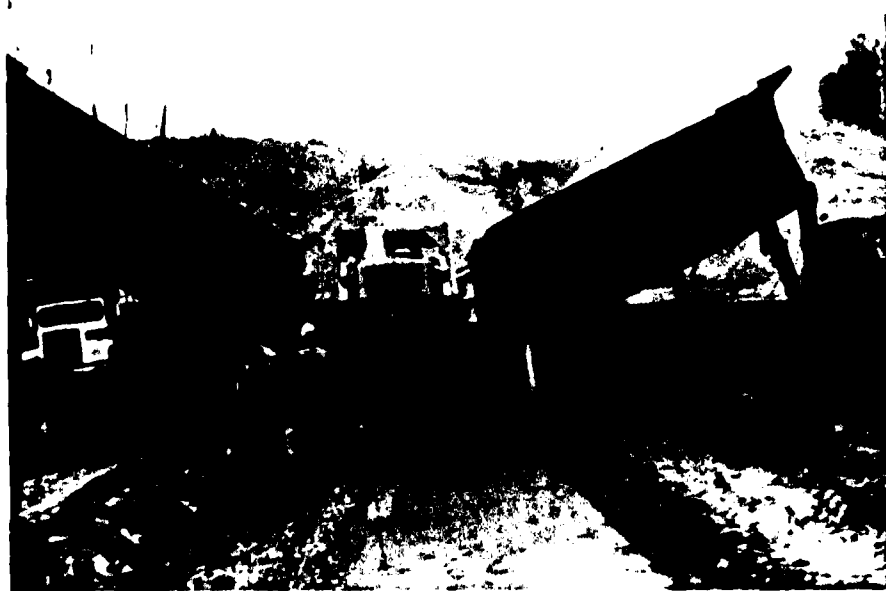
(14) Transition and inclined drain materials being dumped into spreader box. April 1975.

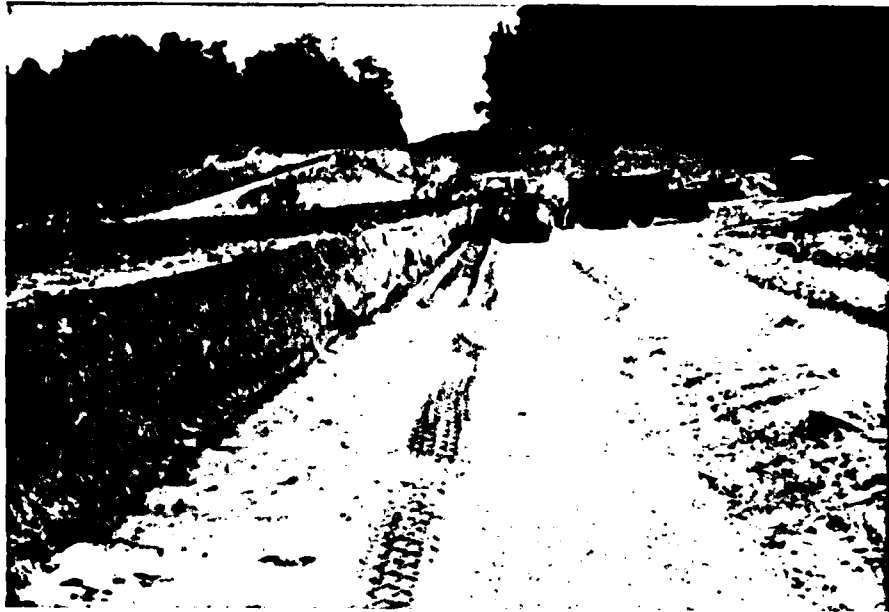
(15) View showing overbuilt width of core zone after being cut back to designed edge of zone by a grader. June 1975.

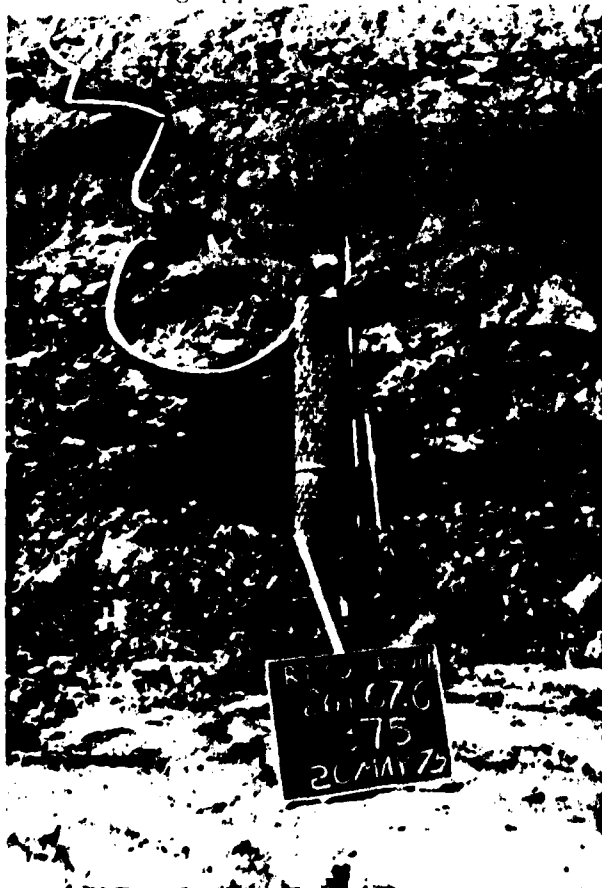
(18) Close view of over-burden collection dewatering casing and pump used to keep core area dry. May 1975.

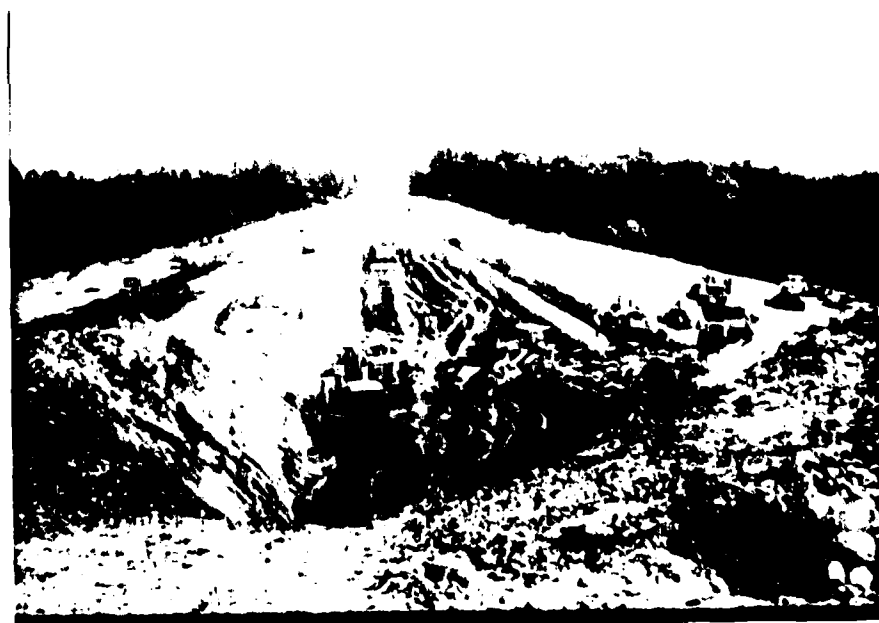
(24) General view of construction operations looking from right abutment. June 1975.

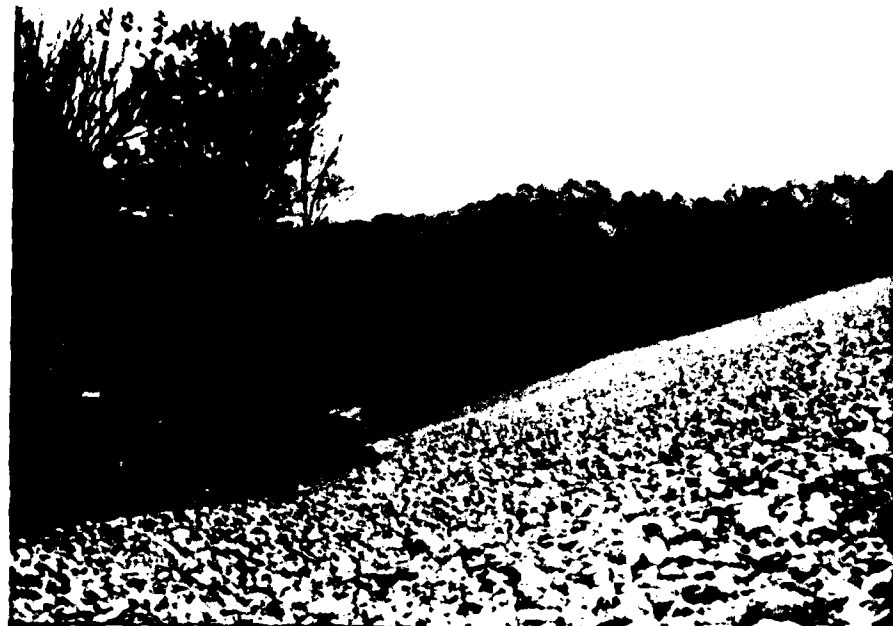
(25) View from right abutment to left abutment across upstream face of dam showing placed riprap. 4 Oct 1975.
