STRUCTURES REPORT 389

BRITTLE FRACTURE OF CRASH HELMETS

S. R. SARRAILHE AND G. PAUL

FEBRUARY, 1982

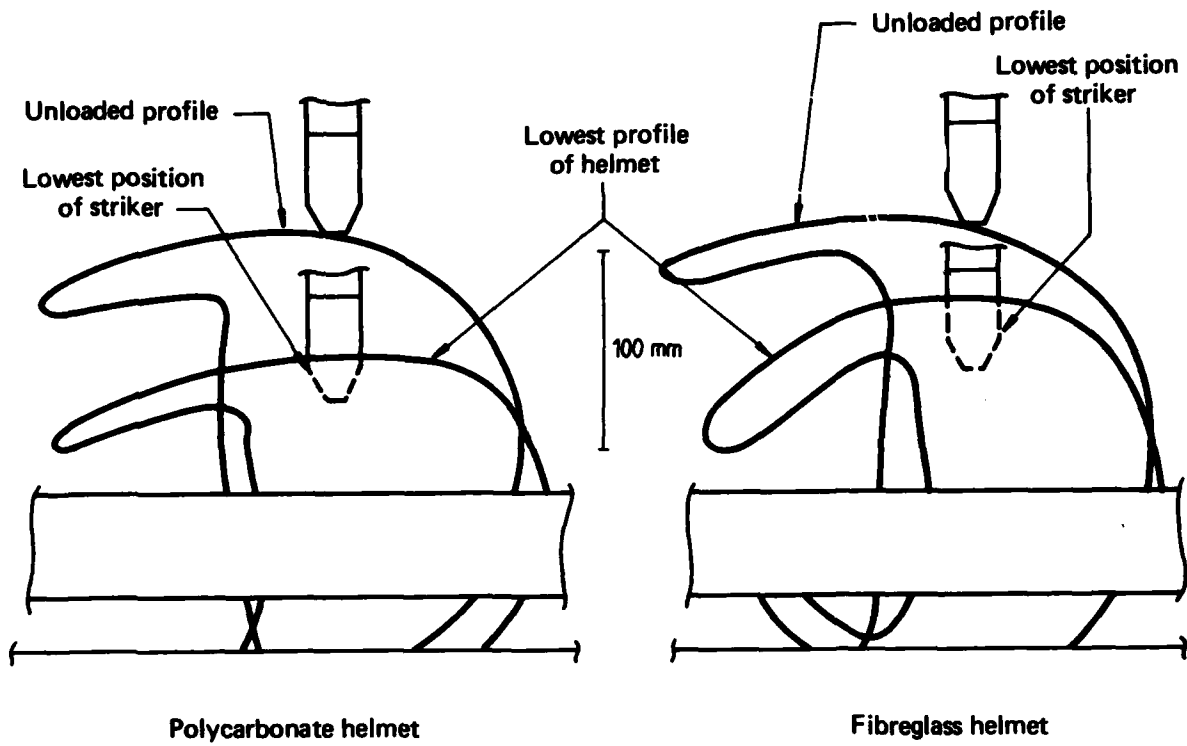
With the new impact test on empty helmets the deflection was extreme, as shown in Figure 4. Several new polycarbonate helmets withstood repeated impacts without fracture, one polycarbonate helmet cracked at a maximum sideways compression of 86 mm at the striker. The crack ran along pre-existing scratches as shown in Figure 5. In another test, an old, used helmet broke on the side away from the striker. The only fibreglass helmet in this group tested was penetrated by the striker to a depth of 83 mm below the original surface. This is shown in Figure 4, the position of the striker within the helmet was deduced from the part of the striker which was visible.

FIG. 4 PROFILE OF SHELL DURING HIGH SPEED IMPACT TEST ON AN EMPTY HELMET (from high speed film) Velocity: 16 m/s Helmet tested as received.

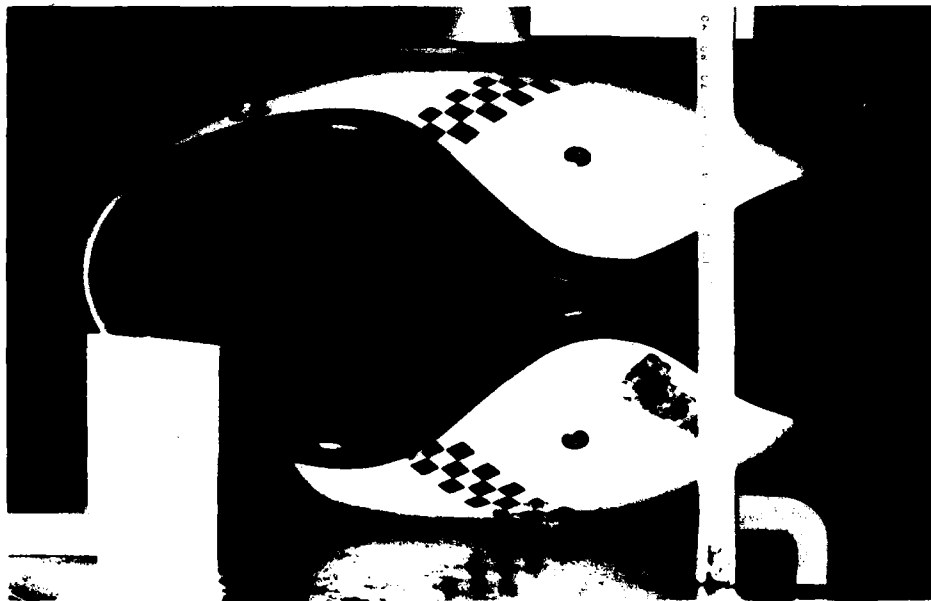
FIG. 8(b) POLYCARBONATE HELMET
LOAD = 4 kN

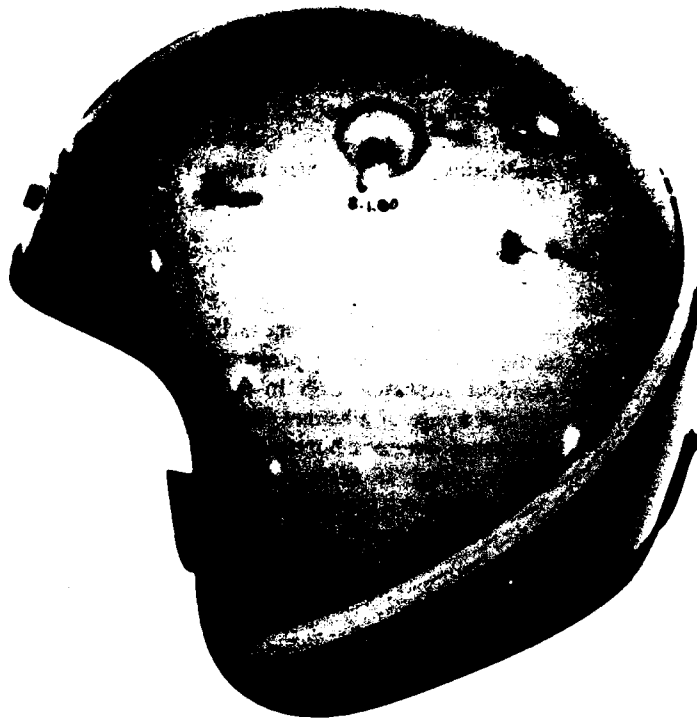
Three specimens of seven models of helmets, including three with polycarbonate shells, were exposed on a north facing roof at ARL. Two of each model were tested at intervals and after 12 months no deterioration was detected (as indicated by the standard penetration test of ASI698). After eighteen months one helmet cracked around an impact point with the crack running through a previous impact site, as shown in Figure 12. It is considered that this shows deterioration as a result of weathering, but the other exposed helmets must be tested before conclusions can be drawn.

**FIG. 12 POLYCARBONATE HELMET AFTER 18 MONTHS EXPOSURE TO WEATHER.
DAMAGE CAUSED BY PENETRATION. EXPOSURE COMMENCED ON 13.6.79.
DATE OF TEST SHOWN ADJACENT TO IMPACT.**
