ARTIFICIAL AND NATURAL ICING TEST OF THE YCH-47D(U)  
ARMY AVIATION ENGINEERING FLIGHT ACTIVITY EDWARDS AFB  
CA C F ADAM ET AL. JUL 81 USAAEFA-79-07

USAAEFA PROJECT NO. 79-07

# ARTIFICIAL AND NATURAL ICING TEST OF THE YCH-47D

FINAL REPORT

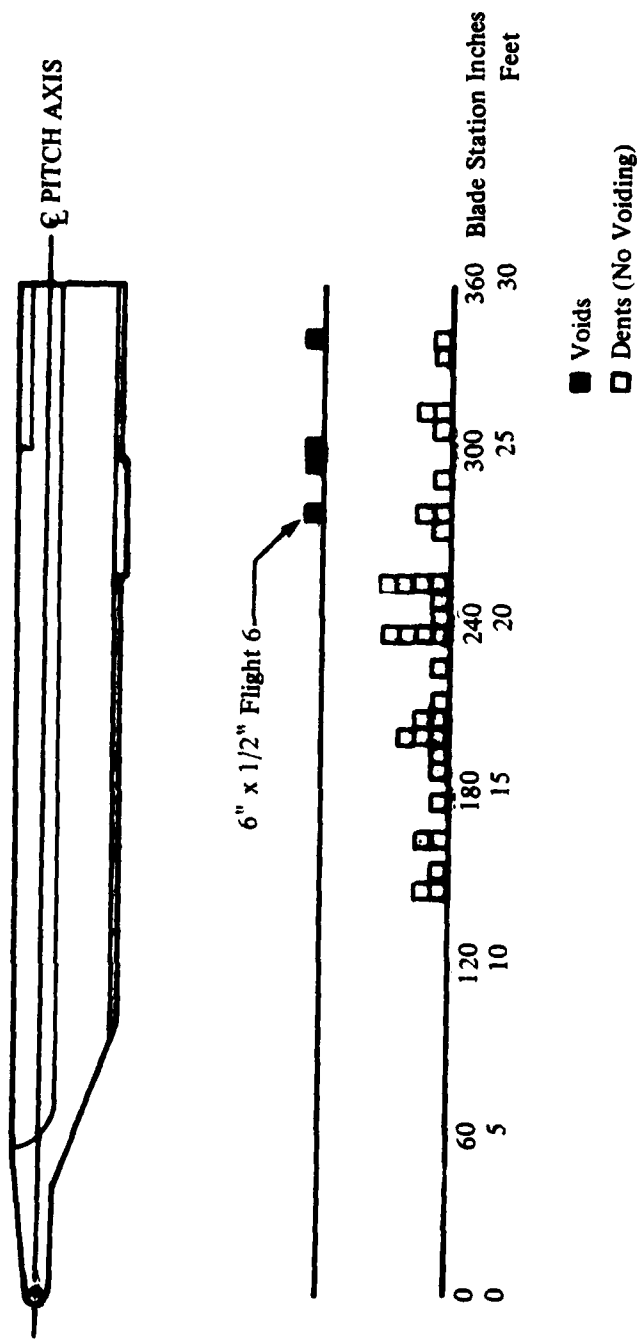
Figure 2. Ice Damage to the Bottom of the Fwd Rotor Blades

25. Small dents and voids were detected during postflight inspection on the underside of the forward and aft rotor blades. Figures 2 and 3 show the location of all blade damage encountered during the icing tests. The majority of the dents were incurred during the natural icing flights conducted at  $V_{mcp}$  airspeeds (flights 14, 17, 18, and 20). The largest blade void occurred during flight 9, behind the HISS, at a flow calibrated LWC of 1.2 gm/m<sup>3</sup> and -10° C (photo 7, app E). The voids marked with an arrow in figures 2 and 3 reflect blade damage that required repair (para 27). Annotations show the size of the damage and flight number. The YCH-47D, with unheated blades, can operate continuously at temperatures down to -5° C with up to 0.5 gm/m<sup>3</sup> LWC without incurring significant blade damage or asymmetric shedding. An ice detector is necessary to give the pilot an indication of the icing conditions, so he can keep the aircraft within established limits.

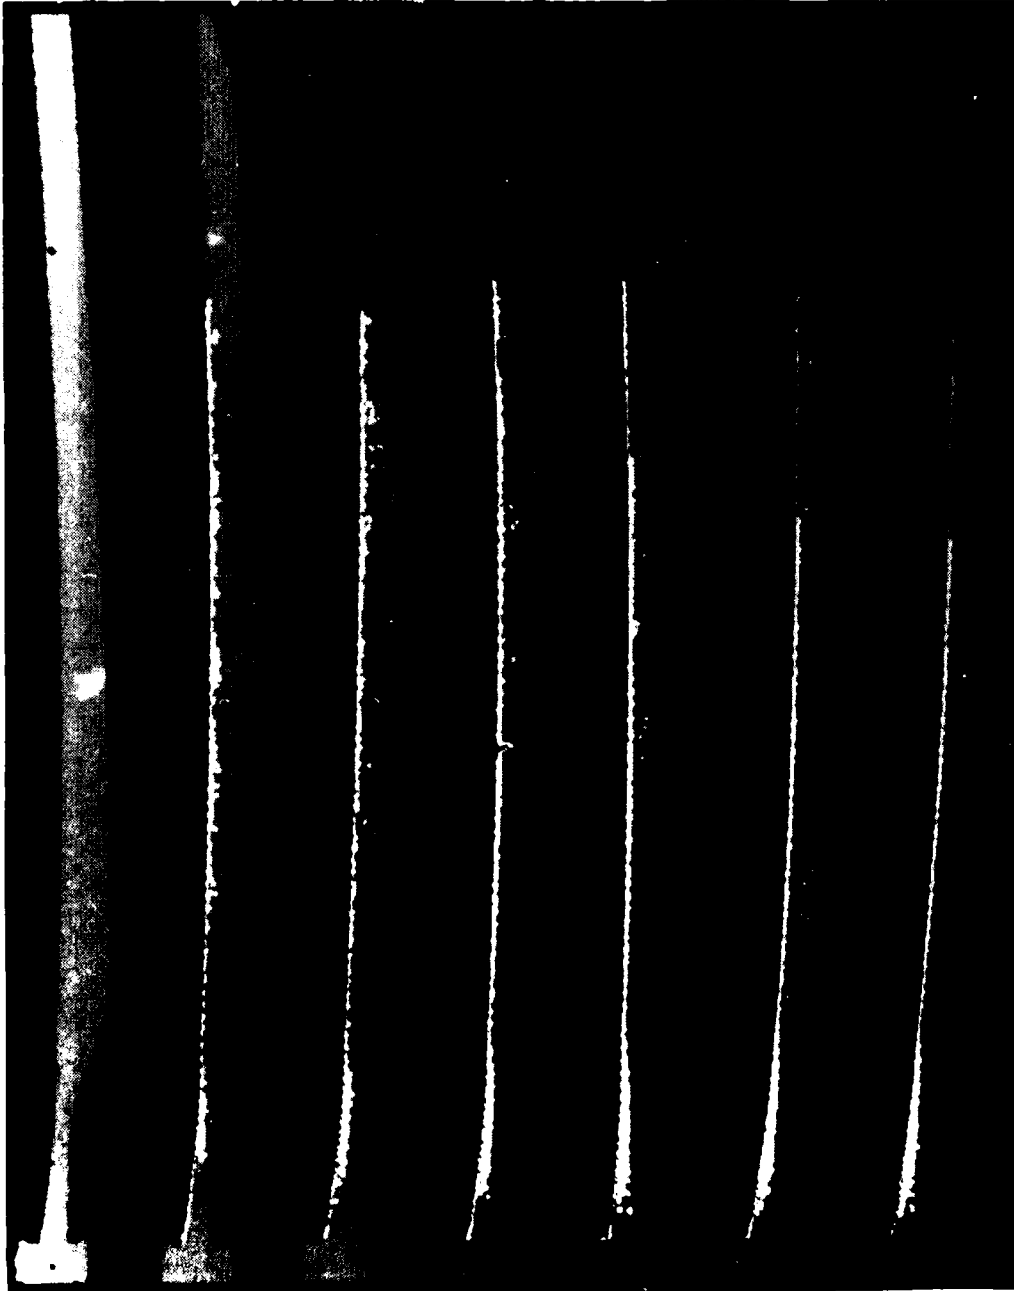
22. Ice accretion along the full span of the blade was documented on still and high speed motion photography. A camera mounted on the top of the cabin was synchronized with a single aft rotor blade. Pictures taken of flight 4, at 2-1/2 minute intervals, show the intermittent self shedding characteristics of the unheated FRB in natural icing conditions (photos 1-3, app E). The ice, depicted on the computer enhanced photographs, ends abruptly at 3/4 span of the blade and was not presented because of out of focus negatives. A computer analysis of the ice present on each blade is presented in figure 1. On flights 4 and 10, pieces of ice approximately 1 to 2 feet in length shed about blade station 180. Ice sheds were also noted in the vicinity of blade station 275. Thicker ice, as indicated by contrasting shades, was

found inboard of station 180 and only a thin ice buildup occurred outboard of station 275. Pieces of ice were taken from blade station 120 after flight 4 which were 3/4 inch in thickness (photo 4).

Photo 1 of 3. Natural Ice on Aft Rotor Blade at 2½-Minute Intervals - Flight 4
