RICHARD BENZINGER JR., Capt, USAF
AIR FORCE CIVIL ENGINEERING CENTER

ENGINEERING REPORT
AFCEC ER 74-3
JULY 1974

INVESTIGATION AND ANALYSIS - GROUND SUBSIDENCE,
SHEMYA AIR FORCE STATION, ALASKA

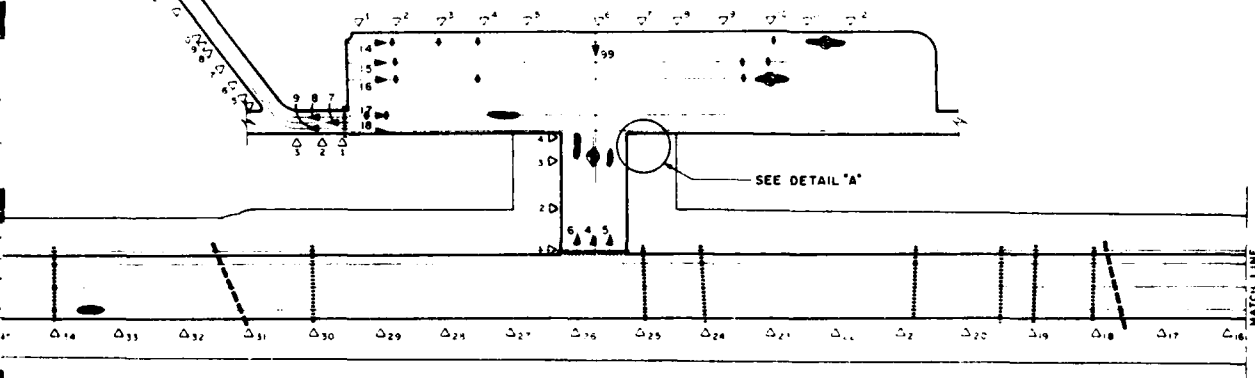
B. At Shemya, the subsidence studies appears local in nature. Since the materials all around the subsidence have continuous interface with each other, the anomaly and resulting hole was probably due to the original construction techniques. It appears that a coarse rock fill with fines was placed over the native rock and that water may now have carried the fines into the underlying rock matrix.

A. Drilling be accomplished at Shemya according to the drilling plan provided in Section A.
