# EMBANKMENT CRITERIA AND PERFORMANCE REPORT

SALT CREEK AND TRIBUTARIES, NEBRASKA

SITE 10

YANKEE HILL DAM AND LAKE

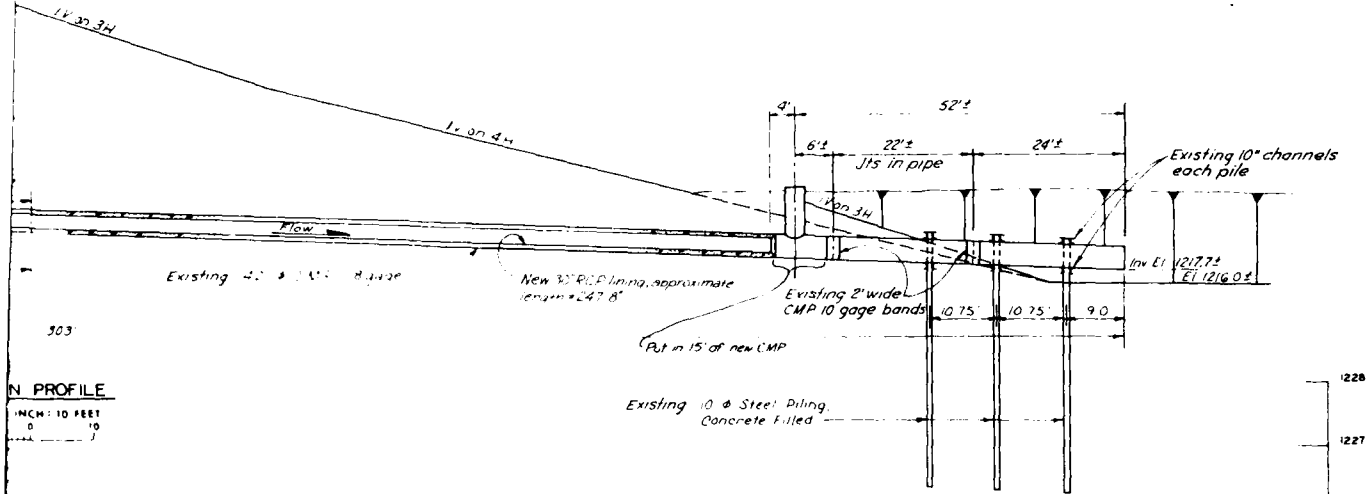
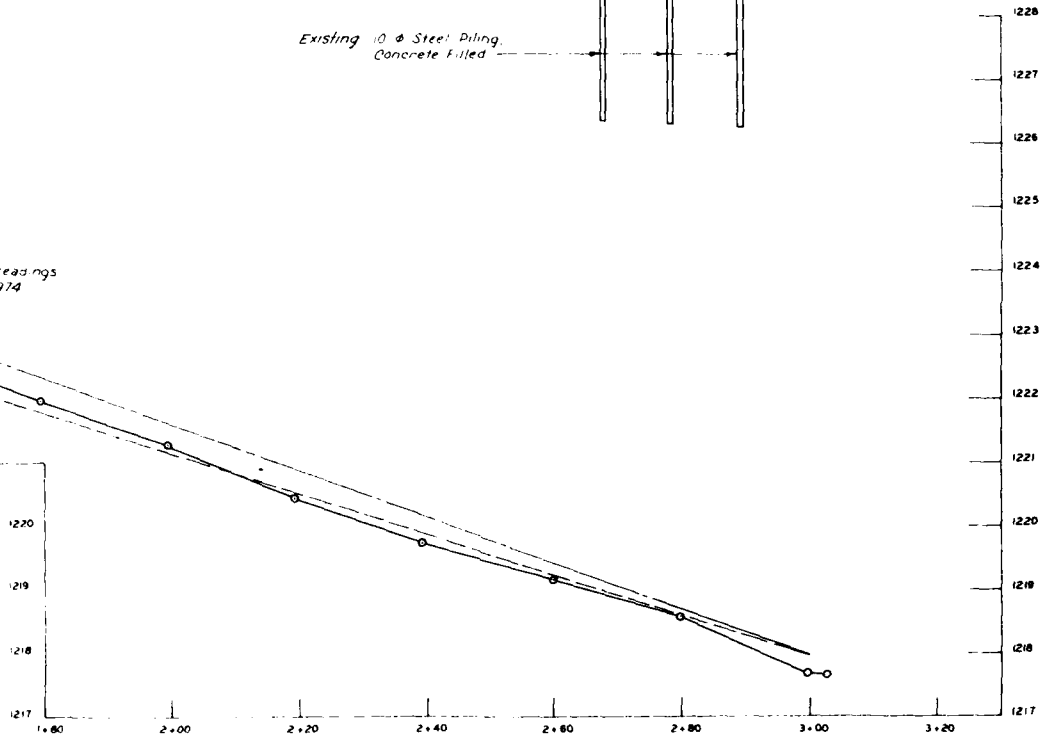
## SETTLEMENT PROFILE (INVERT ELEVATION READINGS)

**9.4.2. Repair of Outlet Works.** During the first periodic inspection of the project in April 1974, small amounts of seepage were found in about 30 percent of the field joints of the conduit. The areas of leakage were located on one or both sides of the pipe and generally from about the area of springline down through the invert area. Subsequently, during the fall of 1977 to the spring of 1978, grouting of the CMP discharge conduit, reshaping the plunge pool, and downstream channel cleanout was performed under Phase I of a comprehensive "Outlet Works Rehabilitation" project scheduled for the Salt Creek Dams.

Elevation readings  
24 April 1974

Additional rehabilitative measures were accomplished on the outlet conduit in 1980. Because of a general deterioration of the asphalt lining, leaking joints, and corrosion at this project and similar projects; a contract was let on 26 February 1980 to install a precast concrete pipe lining inside the existing corrugated metal pipes. This was completed under Phase IV - Outlet Works Rehabilitation, Salt Creek Dams and Lakes. The contract was awarded to Dobson Brothers Construction Company, Lincoln, Nebraska under contract No. 80-C-0151.

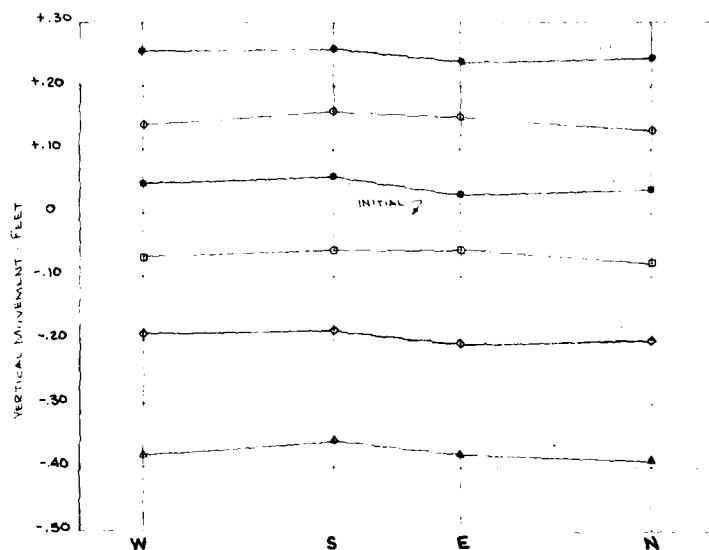
VERTICAL MOVEMENT -  
INTAKE STRUCTURE

**8.3. Outlet Works.** Four movement inserts markers are located in the top of the concrete intake structure as shown on Plate A19. Vertical movement surveys of the intake structure have been conducted three times since the February 1974 surveys and the 1974 Periodic Inspection. They were in December 1974, December 1976 and October 1979. As seen on the movement vs. time plots on Plate A19, large amounts of rebound and settlement were recorded which do not seem very reasonable. It is suspicioned that the reference benchmarks may have been damaged by frost action, maintenance operations, or vandalism.

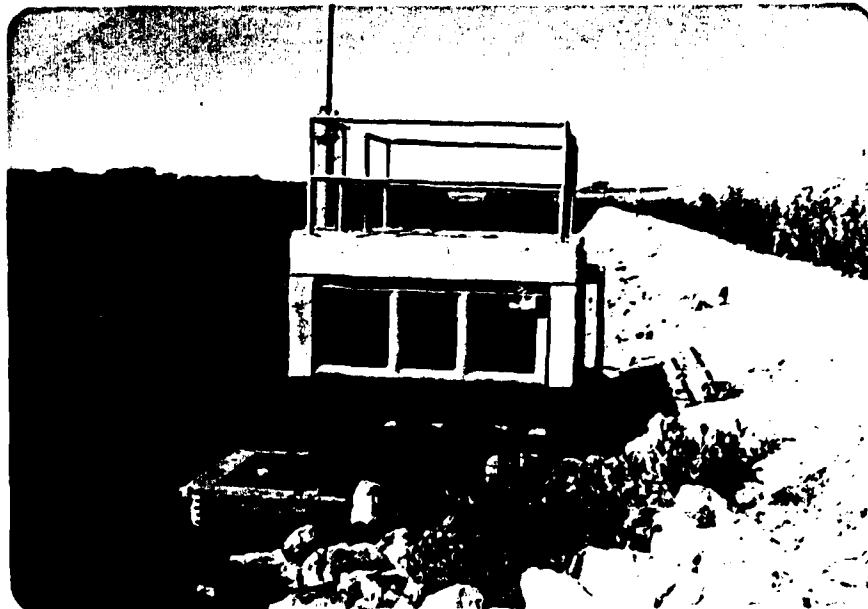
9.4.1. Riprap. In the Periodic Inspection Report No. 1, April 1974, it was recommended that a service or access berm be constructed on Salt Creek Dams just above the riprapped area. This would provide for more efficient and less costly maintenance, and for more efficient inspection of the riprap slope protection. In 1975-1977 a rock berm, surfaced with crushed rock was constructed at Yankee Hill Dam by Ft. Crook Area Forces along the upstream embankment slope at the top of the riprap. See Photos No. 8 and 13. Also, in 1978 a 250 ton stockpile of riprap was placed at the right abutment to provide for an on-site source of riprap for emergency repairs.

Photo No. 8 - View of intake tower structure and surrounding riprap during normal pool conditions. Note crushed rock service road along the top of the riprap.
