TN NO: N-1647

TITLE: MICROBIOLOGICAL DEFACEMENT OF NAVY BUILDINGS

DATE: October 1982

NAVAL CIVIL ENGINEERING LABORATORY  
PORT HUENEME, CALIFORNIA 93043

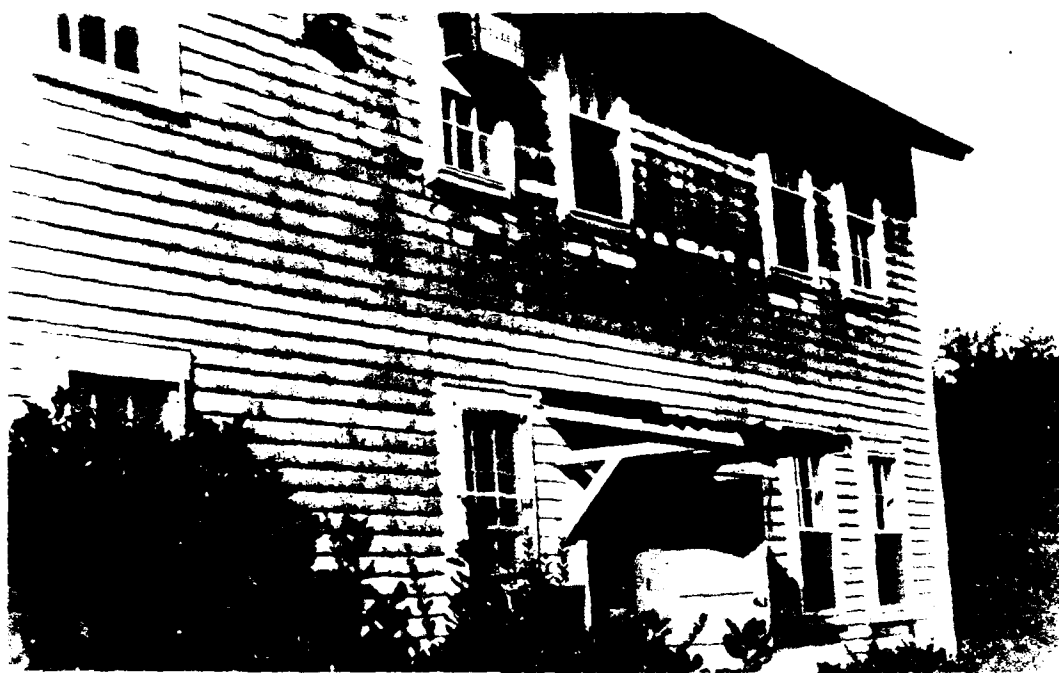
Microbial defacement and deterioration of organic coatings occur at Naval installations around the world. Although destructive microbes deface buildings at most locations (e.g., Naval Weapons Station Yorktown, VA, Figure 1), they are especially prevalent at tropical and subtropical locations. Economic effects to the Navy have never been determined, but losses caused by microbiological attack on paints and paint films in the United States have been conservatively estimated to exceed \$1 million annually (Ref 1). These cost figures do not include damage to substrates such as communications equipment, utilities, etc., which would greatly increase this estimate. Thus, the total annual damage probably exceeds several million dollars. Also of importance is the increasing awareness of the relationship of mildew to serious, chronic health problems (Ref 2). Many individuals are hypersensitive to airborne fungal parts (e.g., hyphae and spores) which, upon inhalation, act as allergens producing hypersensitivity pneumonitis. Of the fungal genera cited in this report, Aspergillus, Aureobasidium, Cladosporium, and Alternaria have been identified as allergens. Aspergillus is also associated with aspergilloma (fungus balls consisting of fungal parts in bloody sputum). Fusarium, also identified in this study, can, upon contamination of the eye, cause blindness.

Figure 1. Mildew defacement of building at Naval Weapons Station Yorktown, VA.

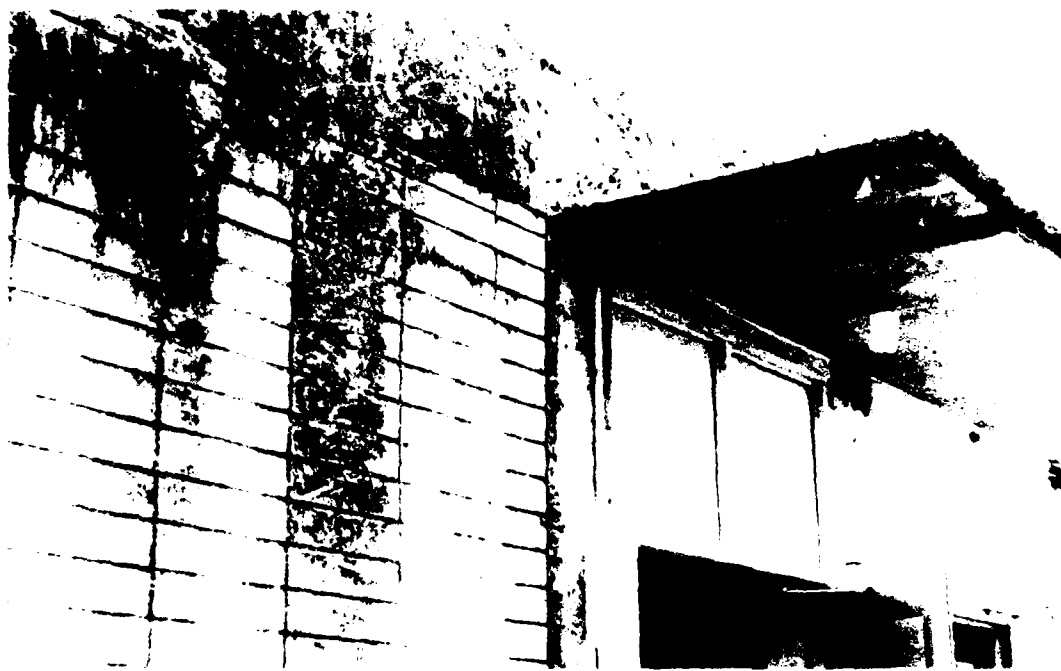
At each of the four geographical locations listed in Table 1, the types of mildew defacement appeared visually to be of three basic types but of different intensities. The first type, a heavy black growth believed to be algal (blue-green algae), was found on the facia of painted and unpainted concrete buildings and other exterior areas (especially shady areas) where water drained across the surface (Figure 2). It was also found on dry, aged concrete buildings and pavements. Many facia of buildings at Guam were painted black to obscure the subsequent black defacement. The second type was a black fungal growth believed to be caused by Aureobasidium pullulans that was found on interior (Figure 3) and shaded exterior painted surfaces in more discrete colonies. The third type (Figure 4) believed to be red and green algal growths was found much less frequently on painted surfaces. The red growth turned yellowish when streaked with a wet finger (dark "+" in Figure 5).

Figure 2. Black algal defacement accelerated by water running down side of building at Guam.

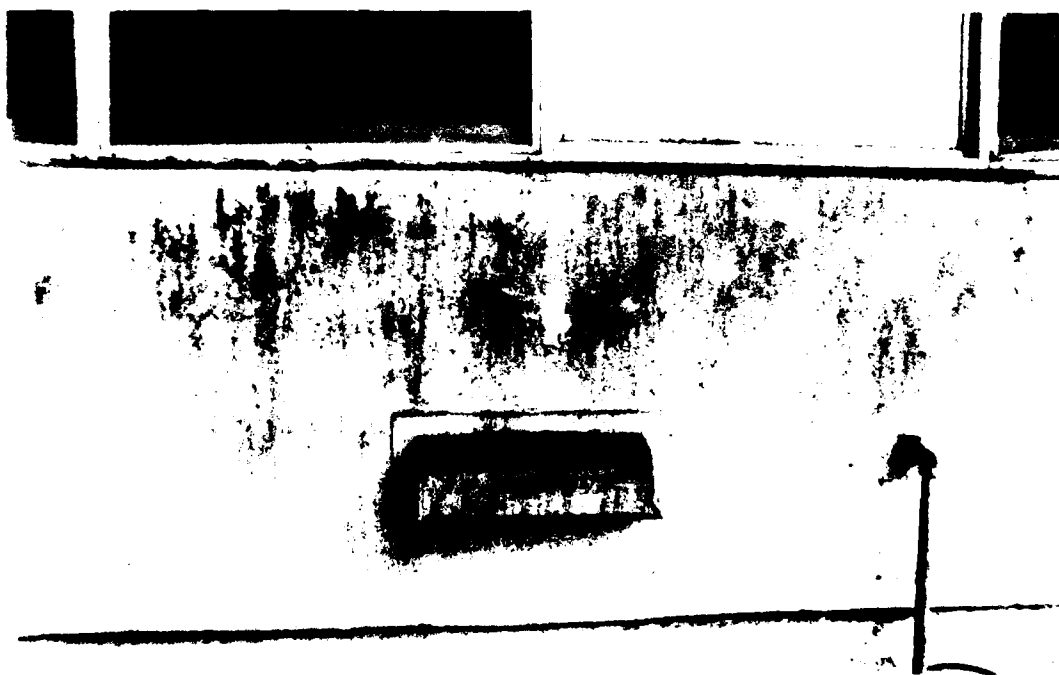
Figure 4. Green and red algal defacement of building exterior at Cubi Point.
