USAAEFA PROJECT NO. 81-21

# MITED ARTIFICIAL AND NATURAL ICING TEST OF THE OV-1D (RE-EVALUATION)

FINAL REPORT

JUNE 1982

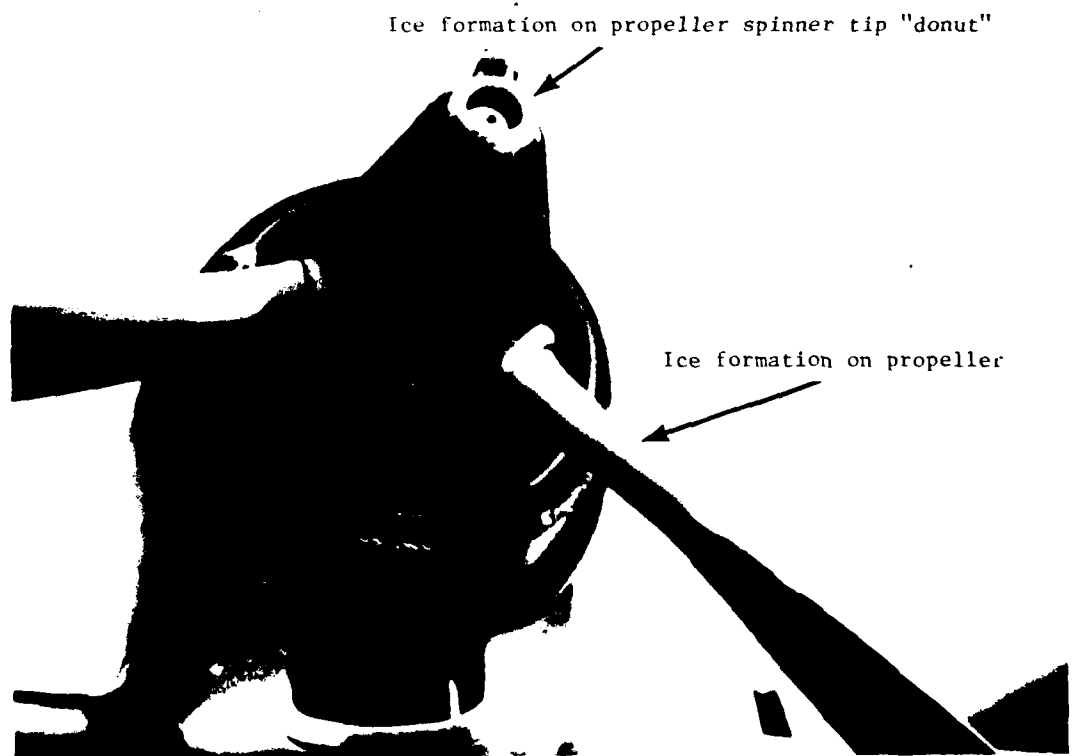
Photo 10. Artificial Icing, Phase II,  $-20^{\circ}\text{C}$ ,  $0.59 \text{ gm/m}^3$

14. The propeller spinner ice accretion characteristics were evaluated at the conditions listed in table 2. Documentation is presented in photos 3, 9 and 10, appendix F. Some small slivers of ice formed on the sides of the spinner at temperatures colder than  $-12.5^{\circ}\text{C}$  (photos 3 and 9). At all test conditions, ice formed on the forward end of the spinner. This ice was 1 to 2 inches thick and formed in the shape of a donut conforming to the shape of the spinner tip (photos 9 and 10). This ice departed the spinner when the outside air temperature was above freezing. Over a given period of time, the higher LWC's produced a larger ice donut on the tip of the prop spinner as compared to lower LWC's. However, no concrete correlation can be made to the thickness of the ice and LWC since particle size and frequency of ice sheds also influence the size of the donut. It is possible that this ice might be ingested through the engine inlet; however, this was never observed. On two occasions, the observer saw the ice depart. Flight conditions were 1500 feet per minute descent, low power, 1400 RPM propeller speed, and 150 knots indicated airspeed (KIAS). Both times, the ice donut departed over the cowl, well clear of the engine inlet. On one occasion it passed through the plane of the propeller intact. On the last flight, the duty cycle of the propeller spinner heating elements was reduced to allow more heating of the propeller butt boot. The final flight was at  $-20^{\circ}\text{C}$  and evidence of changes in spinner ice accretion characteristics was inconclusive. The formation of ice on the propeller spinner tip is a shortcoming.

15. The ice accretion characteristics of the propeller blades were evaluated at the conditions in table 2. Photographic documentation is presented in photos 10 through 12, appendix F. Ice formed on the propeller, butt boots, and blades at all conditions tested. At  $-20^{\circ}\text{C}$  ice accreted on the blade to about
