**BROOKVILLE LAKE  
GREATER MIAMI RIVER BASIN  
INDIANA**

**EMBANKMENT CRITERIA AND  
PERFORMANCE REPORT**

**PREPARED BY  
U.S. ARMY ENGINEER DISTRICT, LOUISVILLE  
CORPS OF ENGINEERS**

**SEPTEMBER 1982**

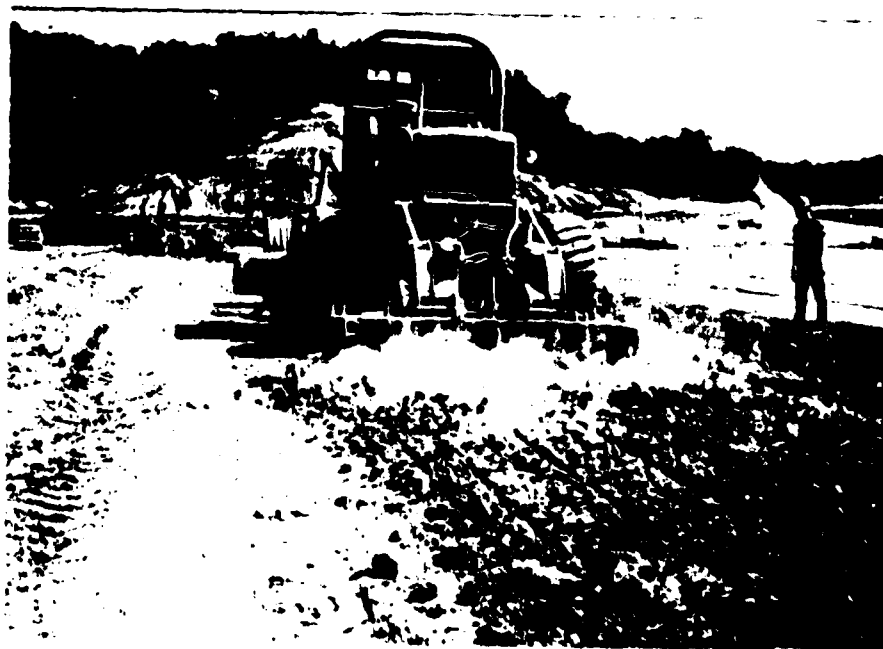
8. Disking dry impervious fill material (9/1/70).

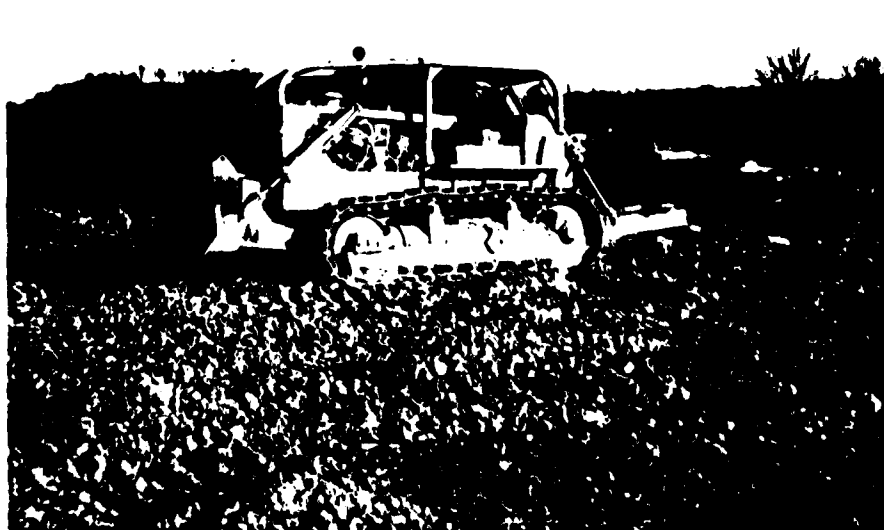
14. Ripping random shale material in spillway excavation (12/2/71).
