F-4C/D LIFE EXTENSION PROGRAM

Robert L. Schneider
Structures Test Branch
Structures and Dynamics Division

October 1982

Final Report for Period October 1974 - May 1981

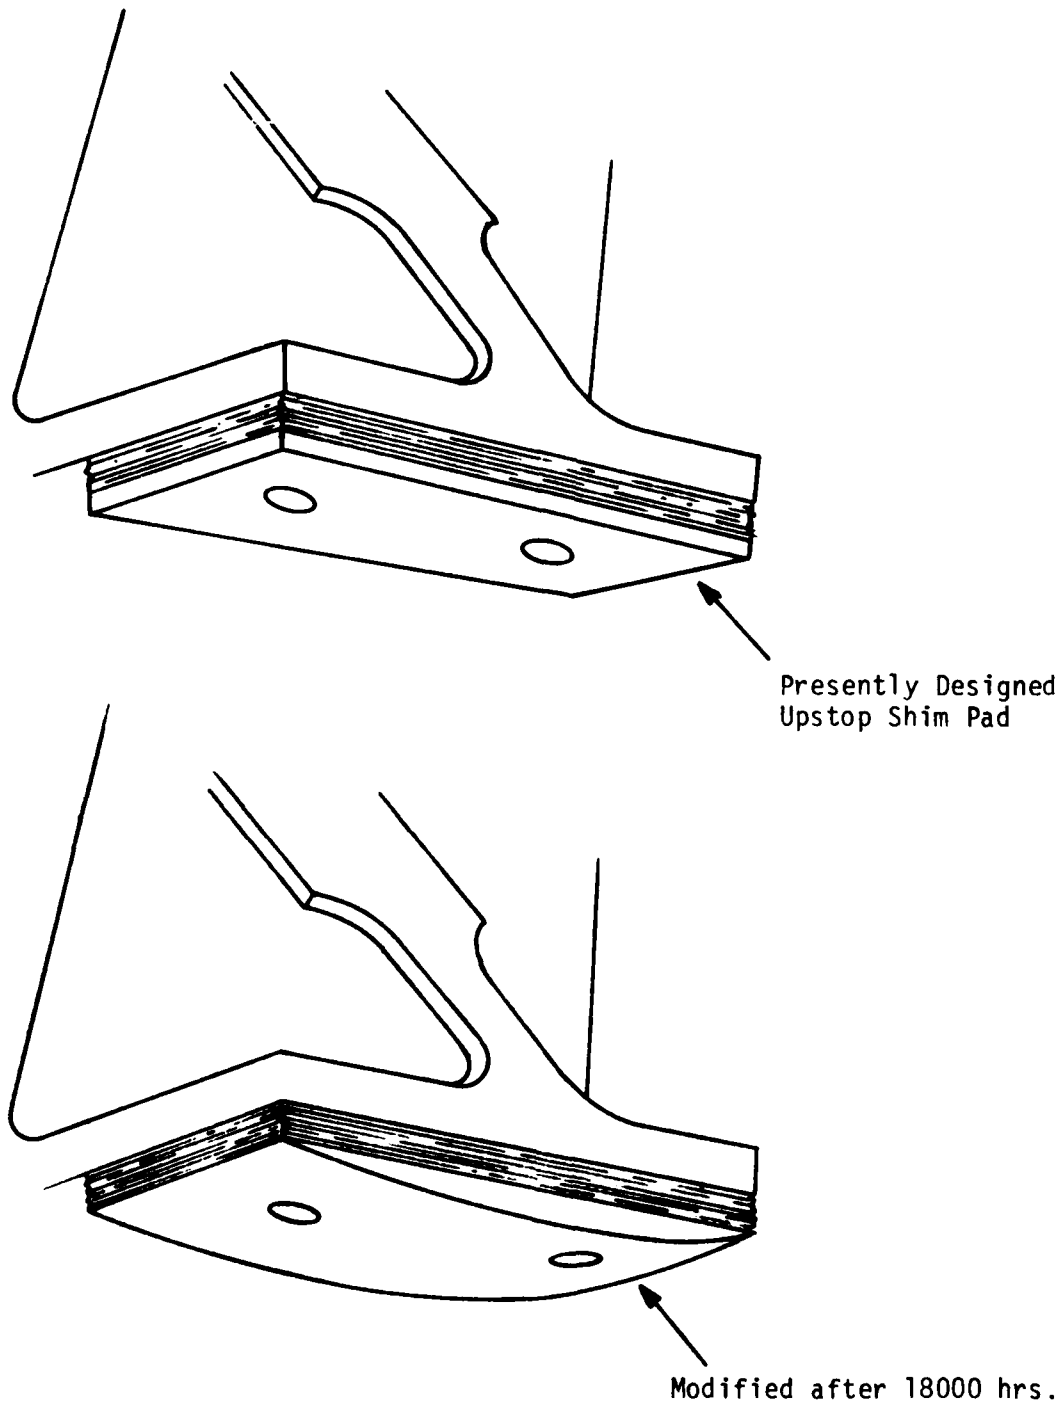
Figure 27. Upstop Modification

The flap upstop failed repeatedly and was replaced every 2000 hours. This failure constituted no major problem to the aircraft but remains a considerable nuisance in the maintenance of the aircraft. After 18,000 hours of testing, the flap upstop shims were modified and installed in the test aircraft (Figure 27). No further failures of the upstop occurred.

The rounded fore and aft edges assure that the upstop load is applied close to the middle of the pad and therefore reduces the bending associated with off center loads.

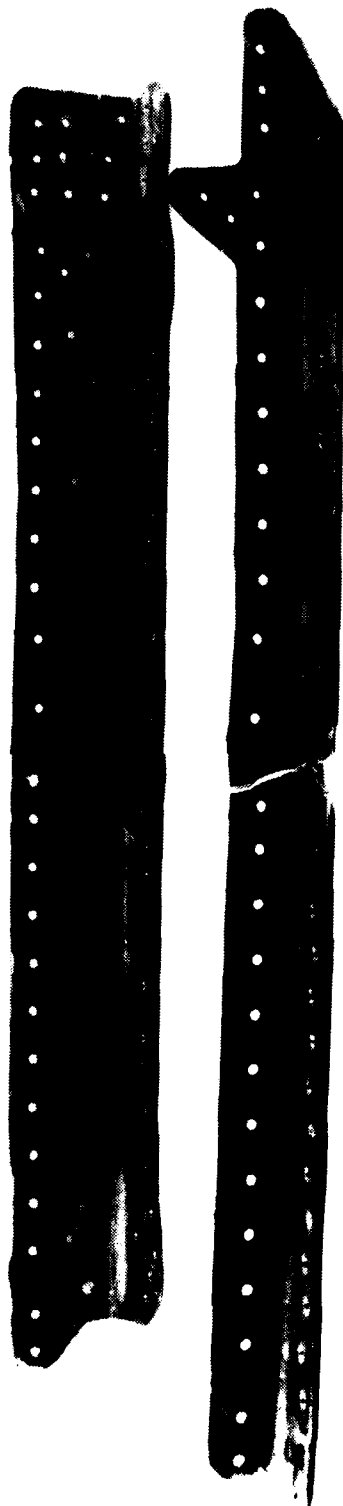
Figure 28. Speed Brake Failure

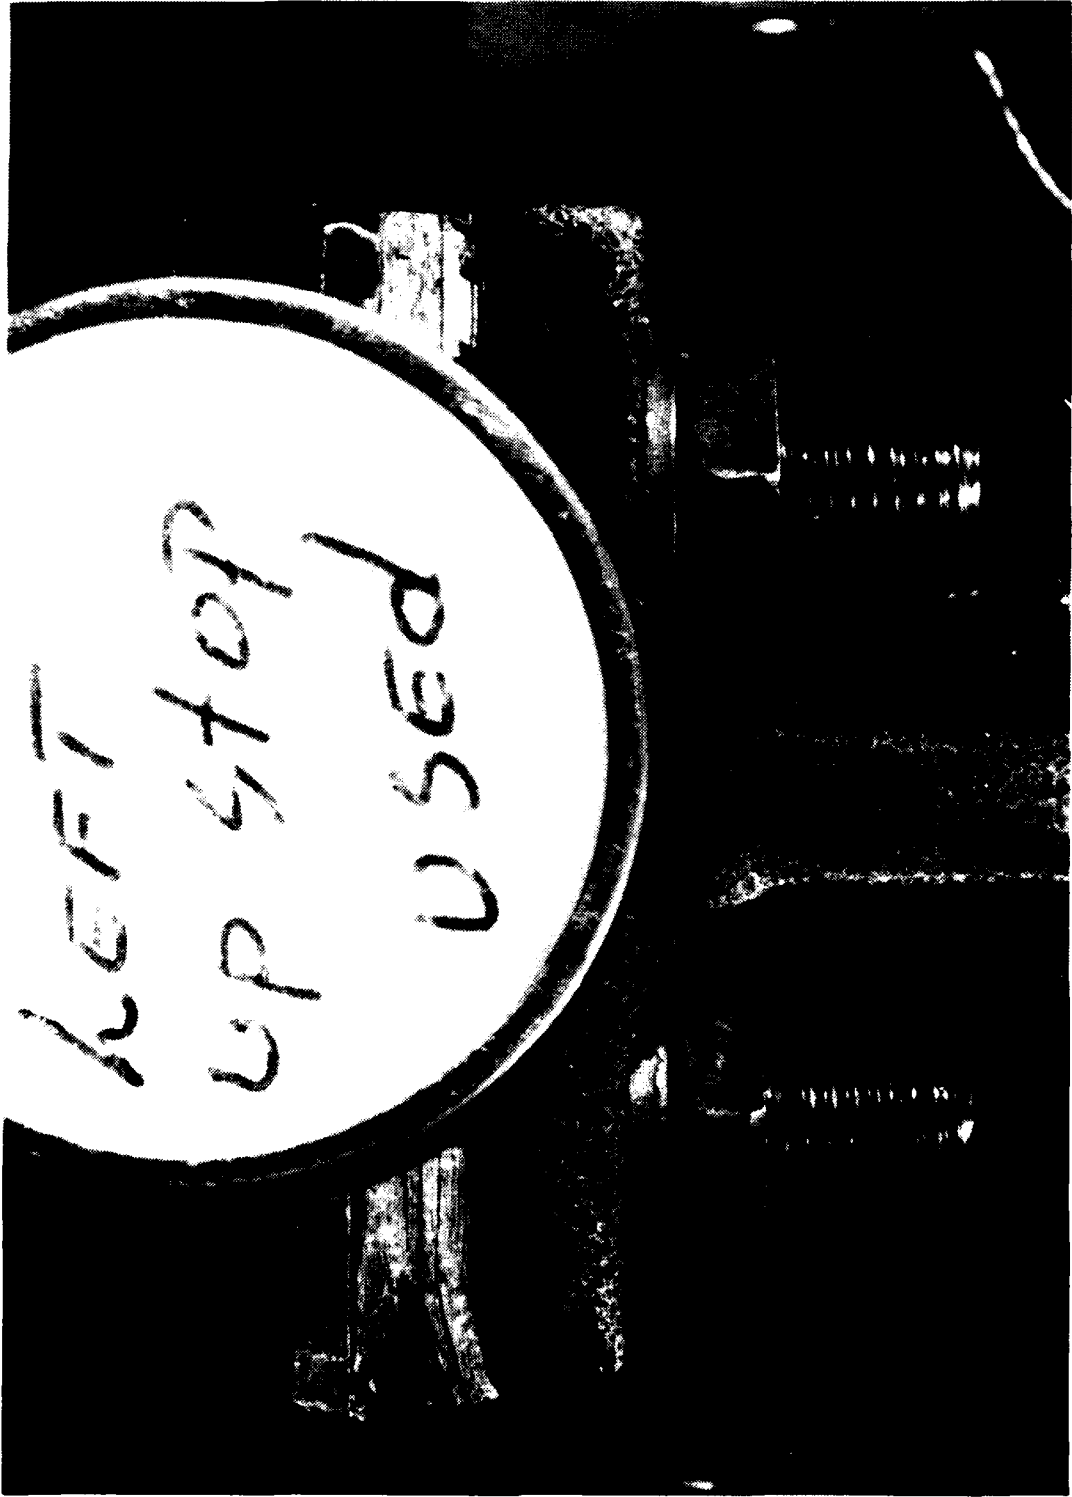
* 1875	<u>Trailing Edge Flap Up-Stop Fitting</u> (32-32506) Left Side Only (Figure 29).	Replaced with Beefed-Up Part (ECP 1014).
2750	<u>Cracked Wing Accessor Door, L/H</u> (32-11030-101)	Replaced Door.

Figure 29. Upstop Failure

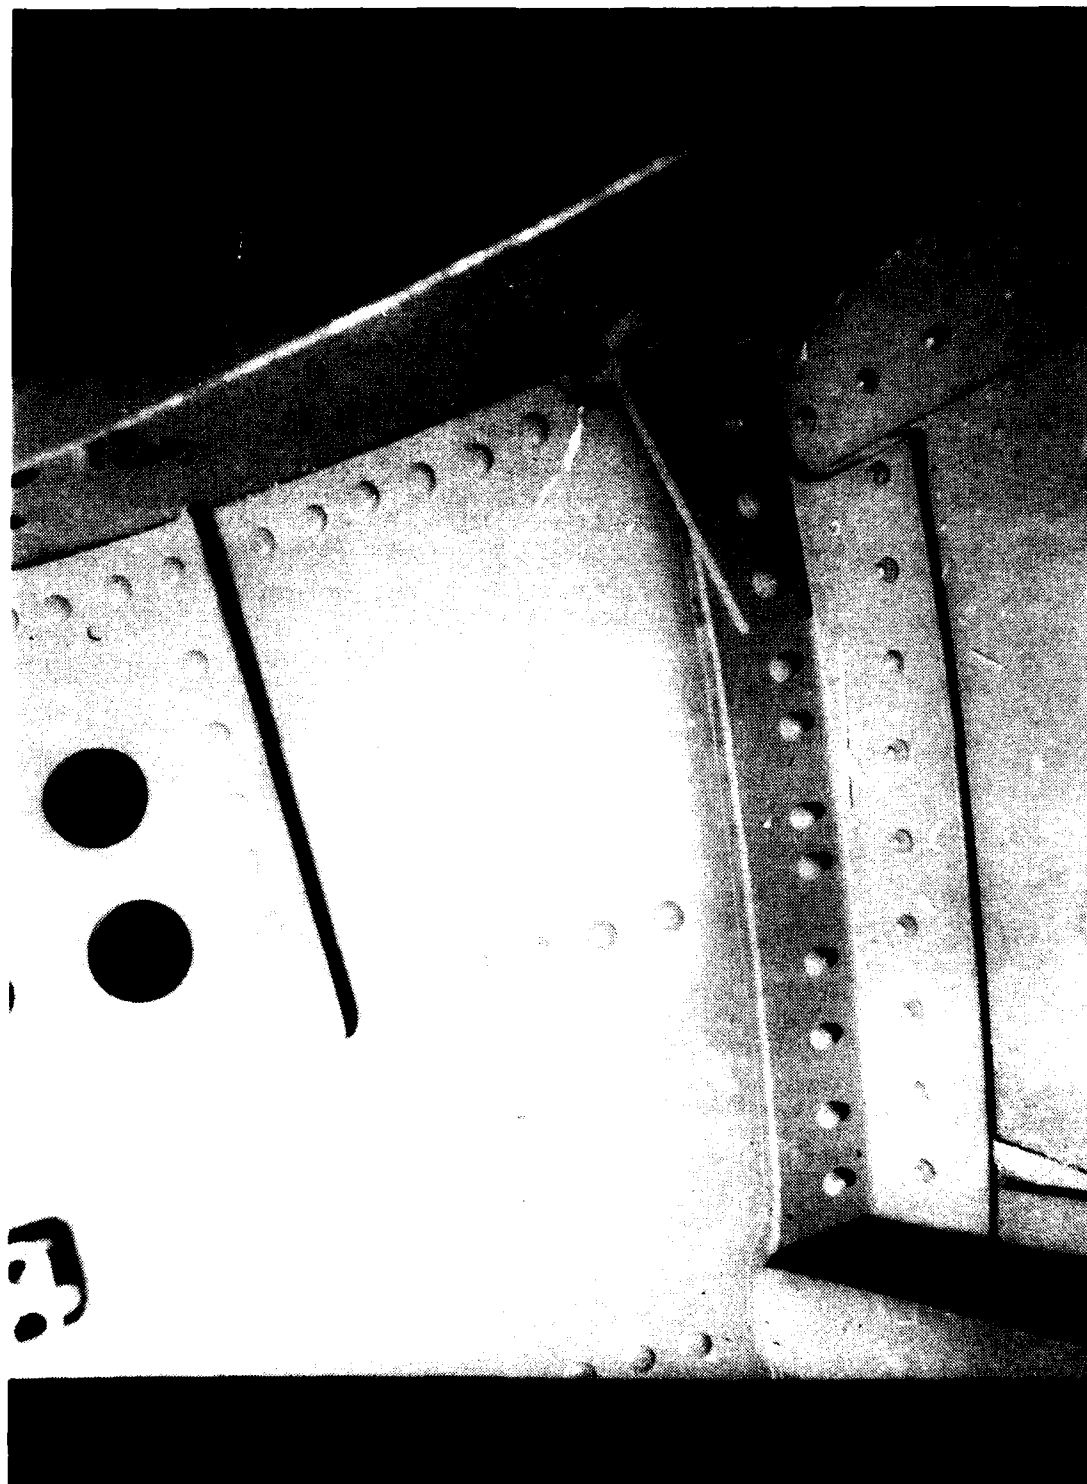
Figure 30. Crack in Engine Shroud

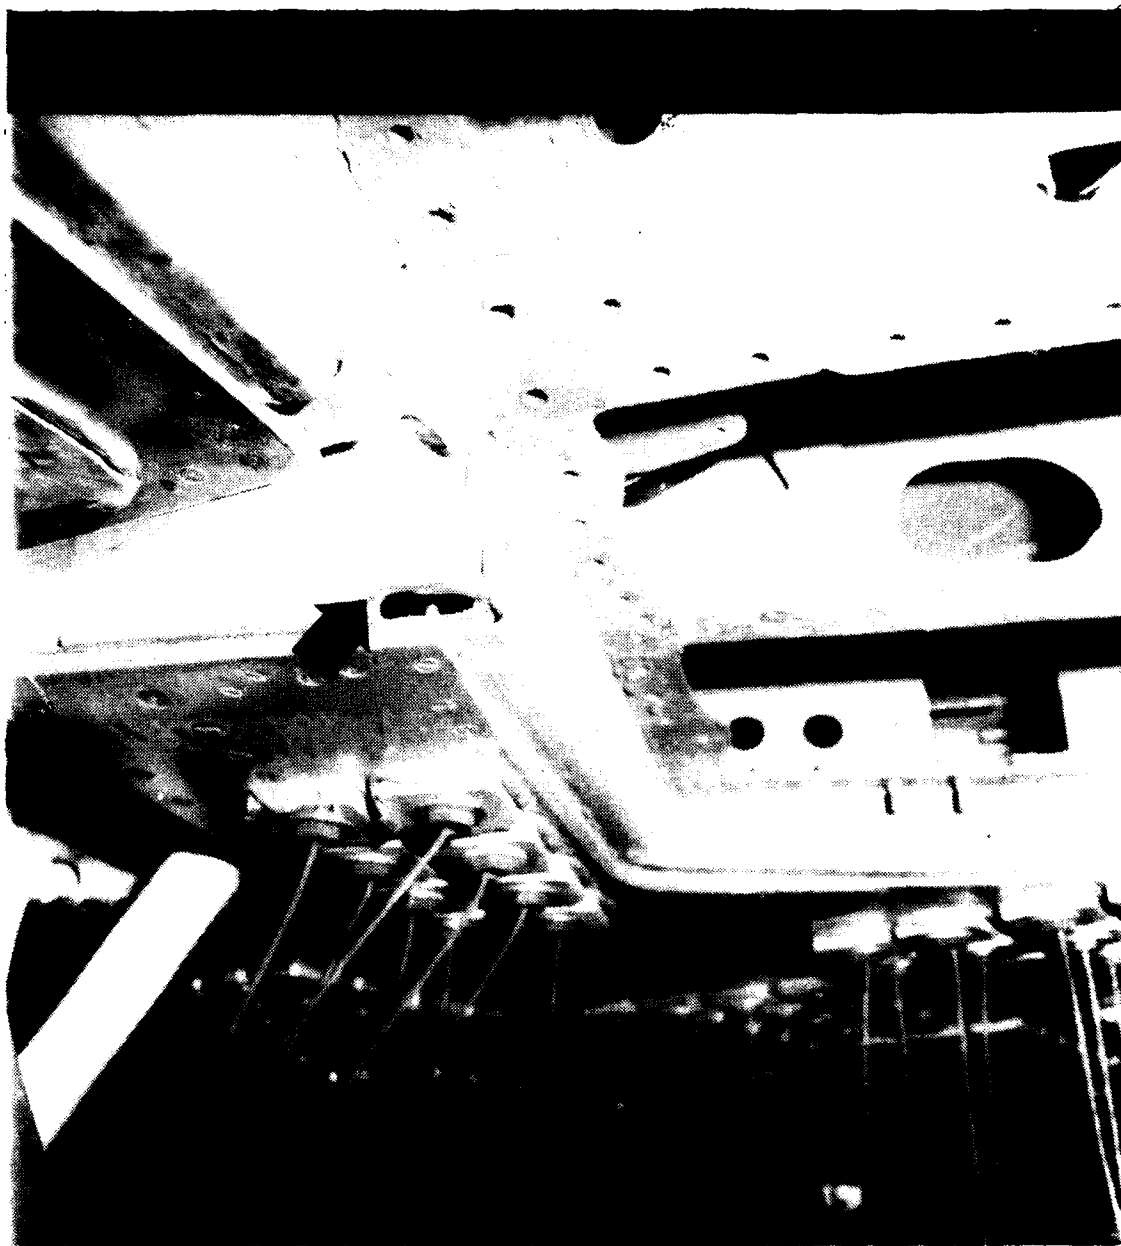
Figure 31. Cracks in Speed Brake Tunnels

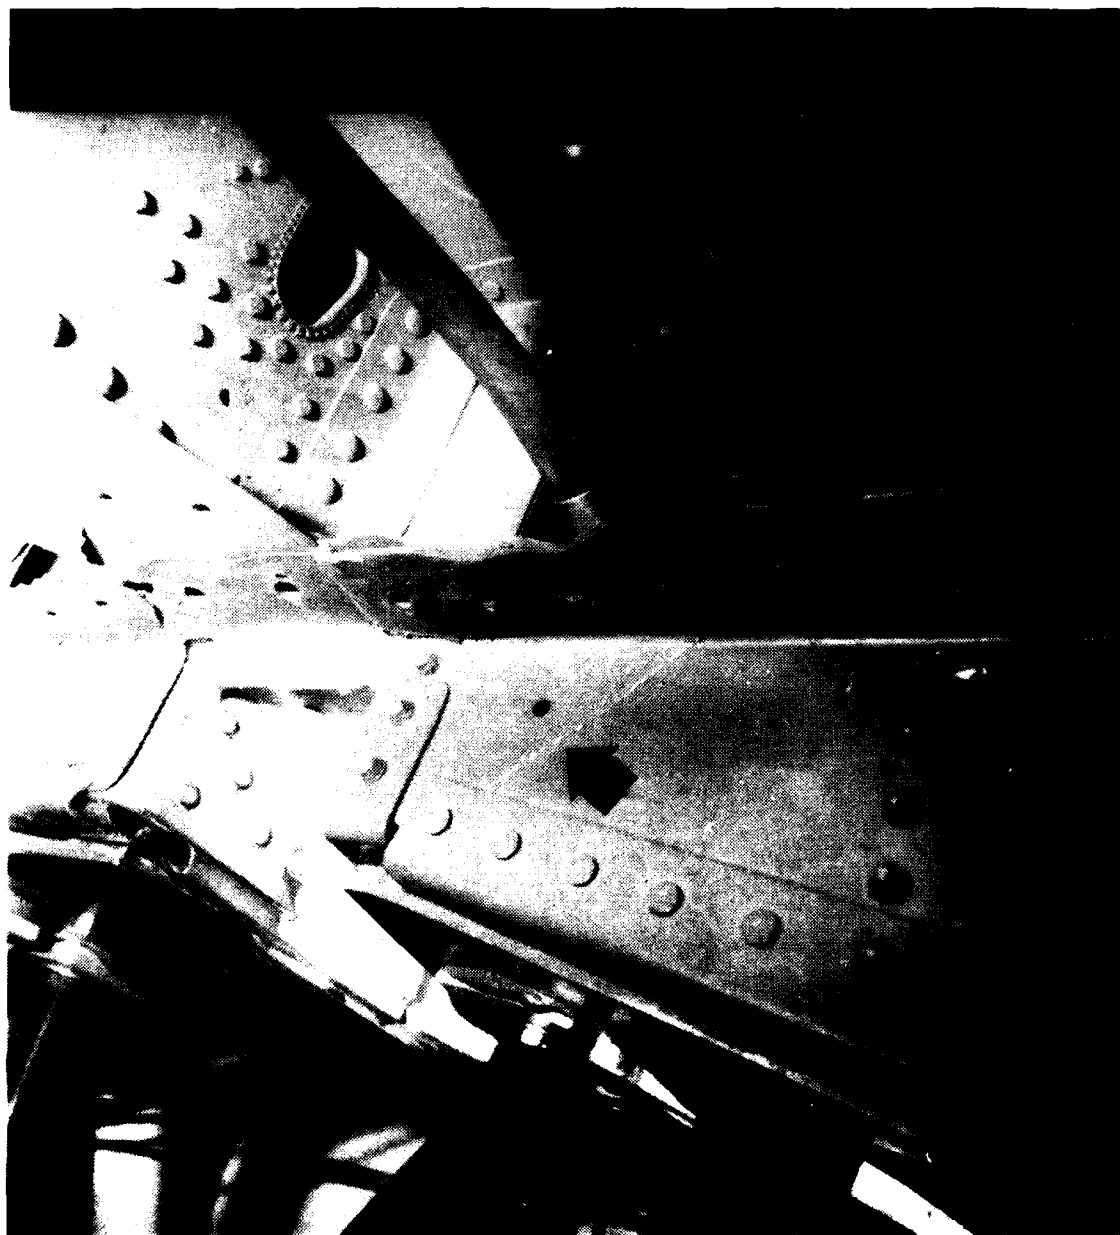
Figure 32. Failure of Speed Brake Enclosure

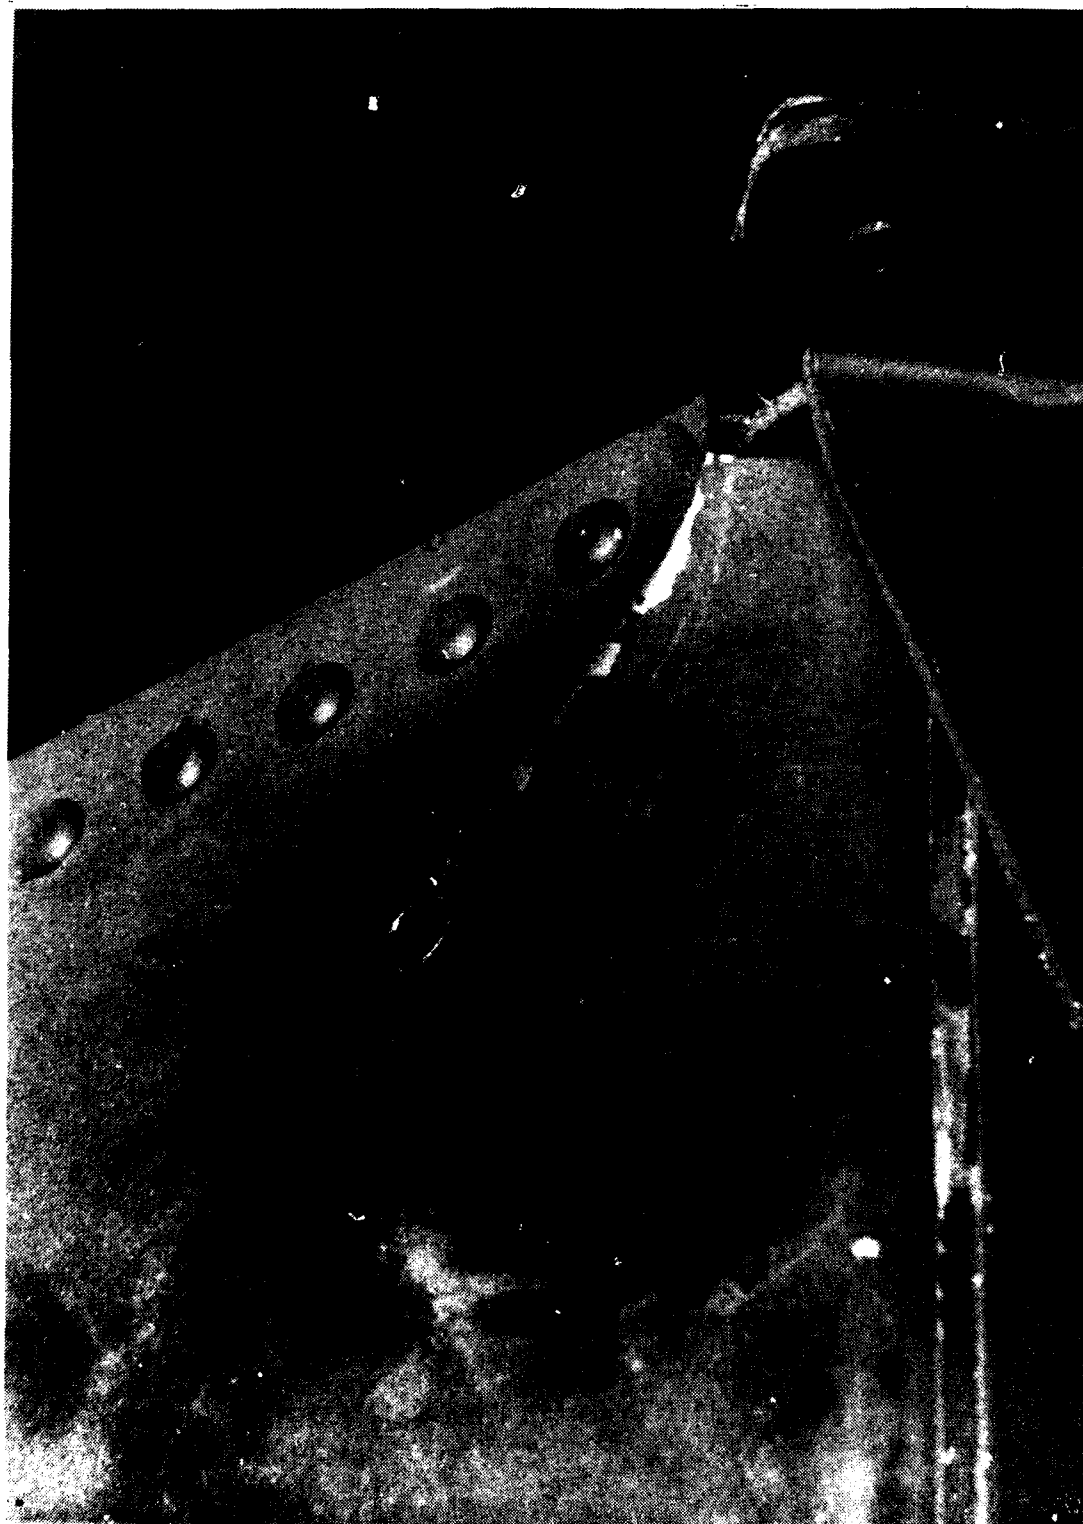
Figure 33. Crack in Shroud FS-332

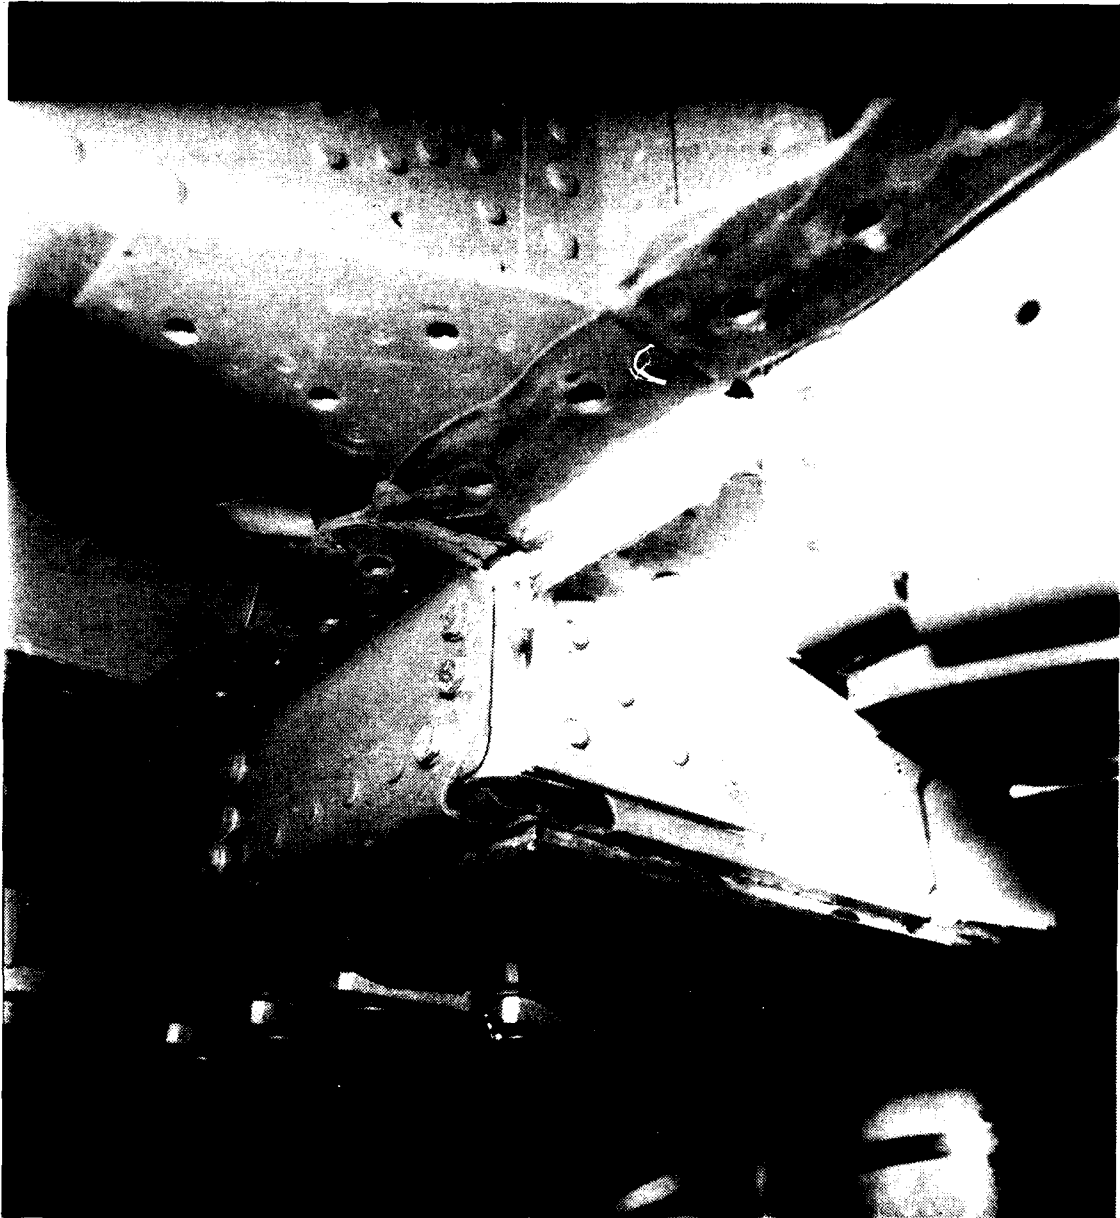
* 8000	<u>Crack in Both Left and Right-Hand Inboard Trailing Edge Flap Up-Stop Fittings (32-32506-301 & - 302)</u>	Replaced Fittings.
8000	<u>Crack in Outboard Speed Brake Tunnels Left and Right Wing (32-11215-15 & 16). Crack first found at 6000 hours did not lengthen (Figure 35).</u>	No Action Taken.

Figure 35. Crack in Speed Brake Tunnels

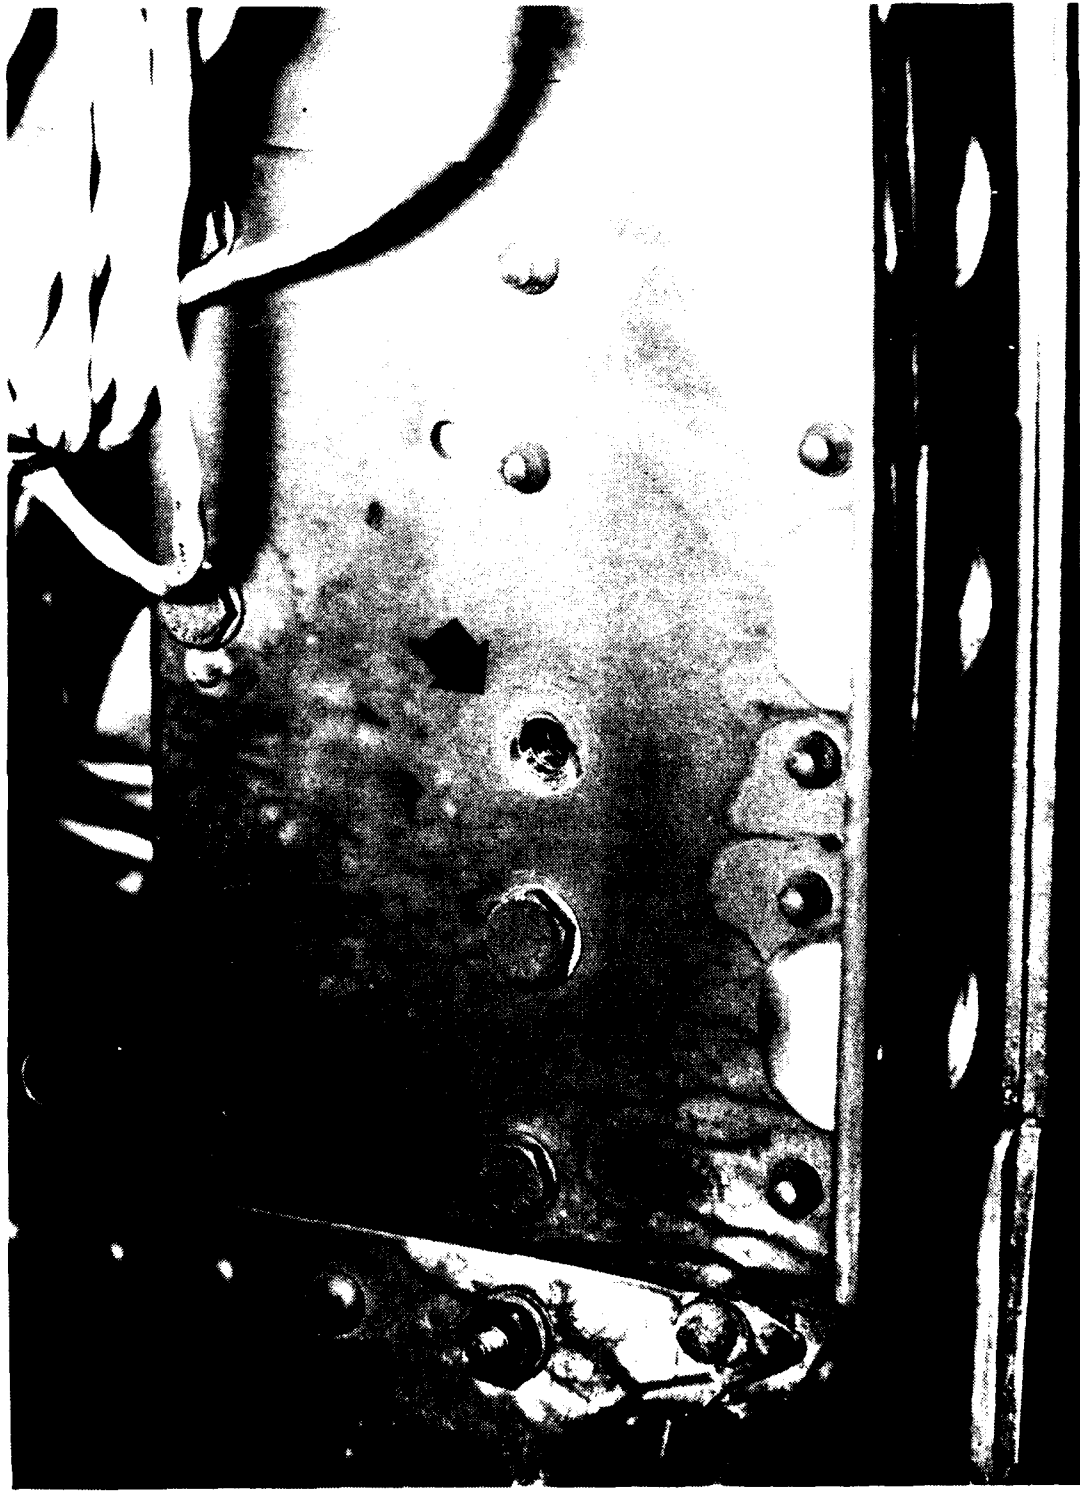
Figure 36. Failure of Fastener Tying Dogbone to Fuselage Vertical Wall

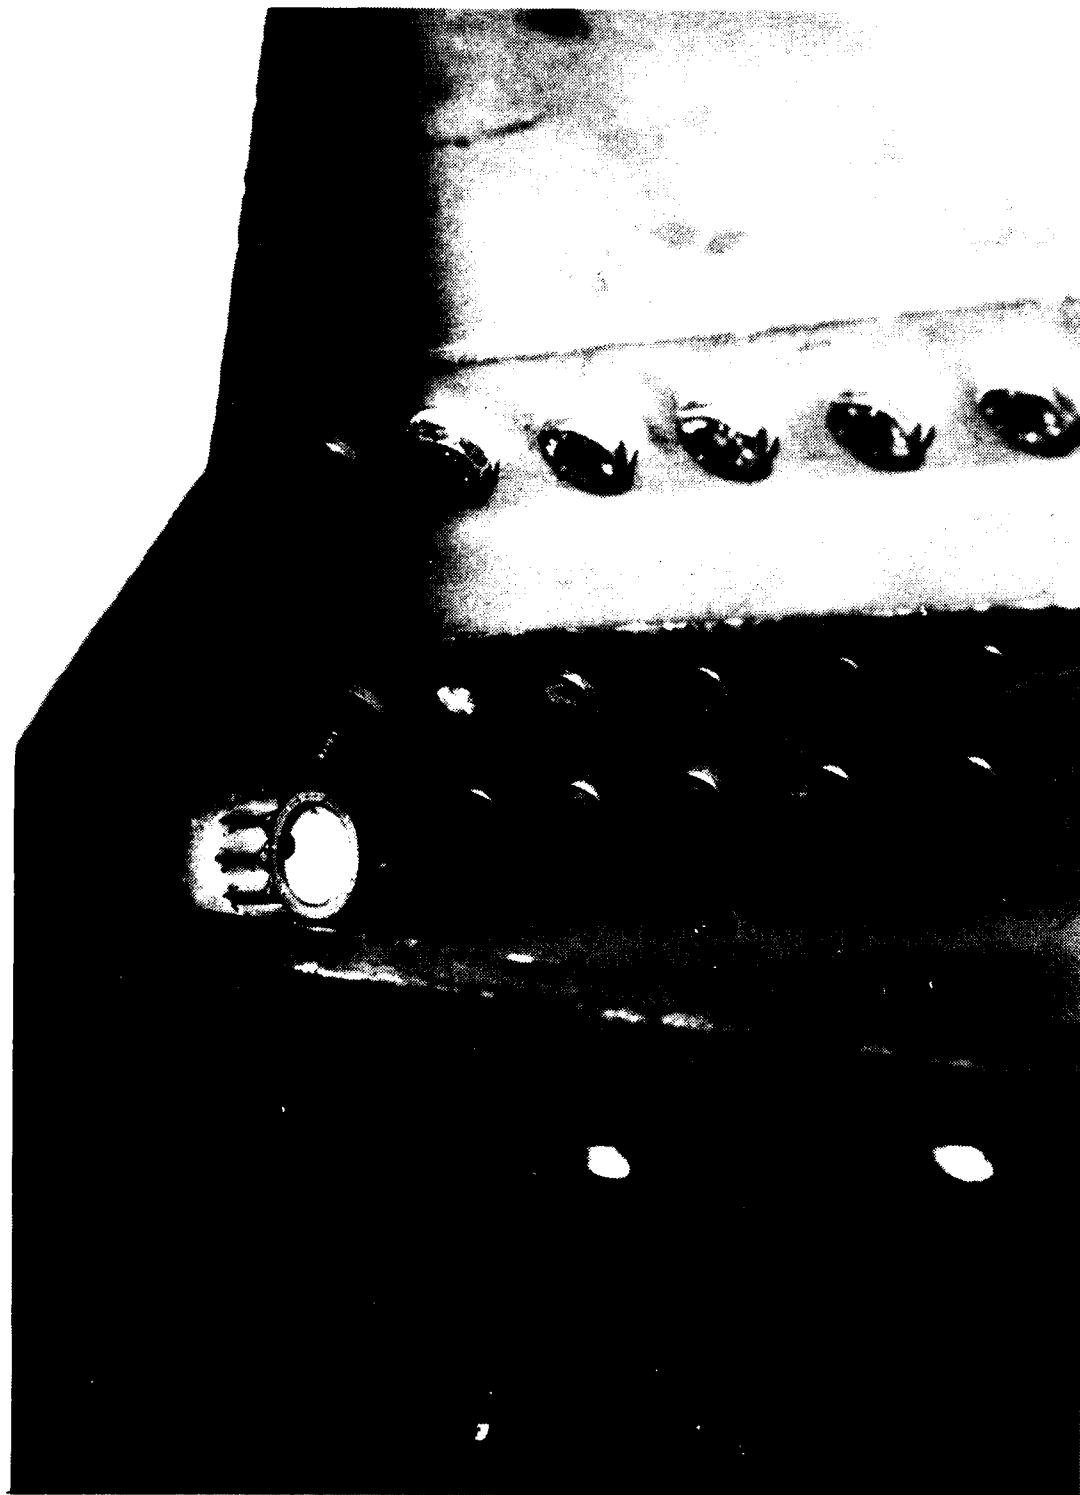
Figure 37. FS-249 Fastener Missing

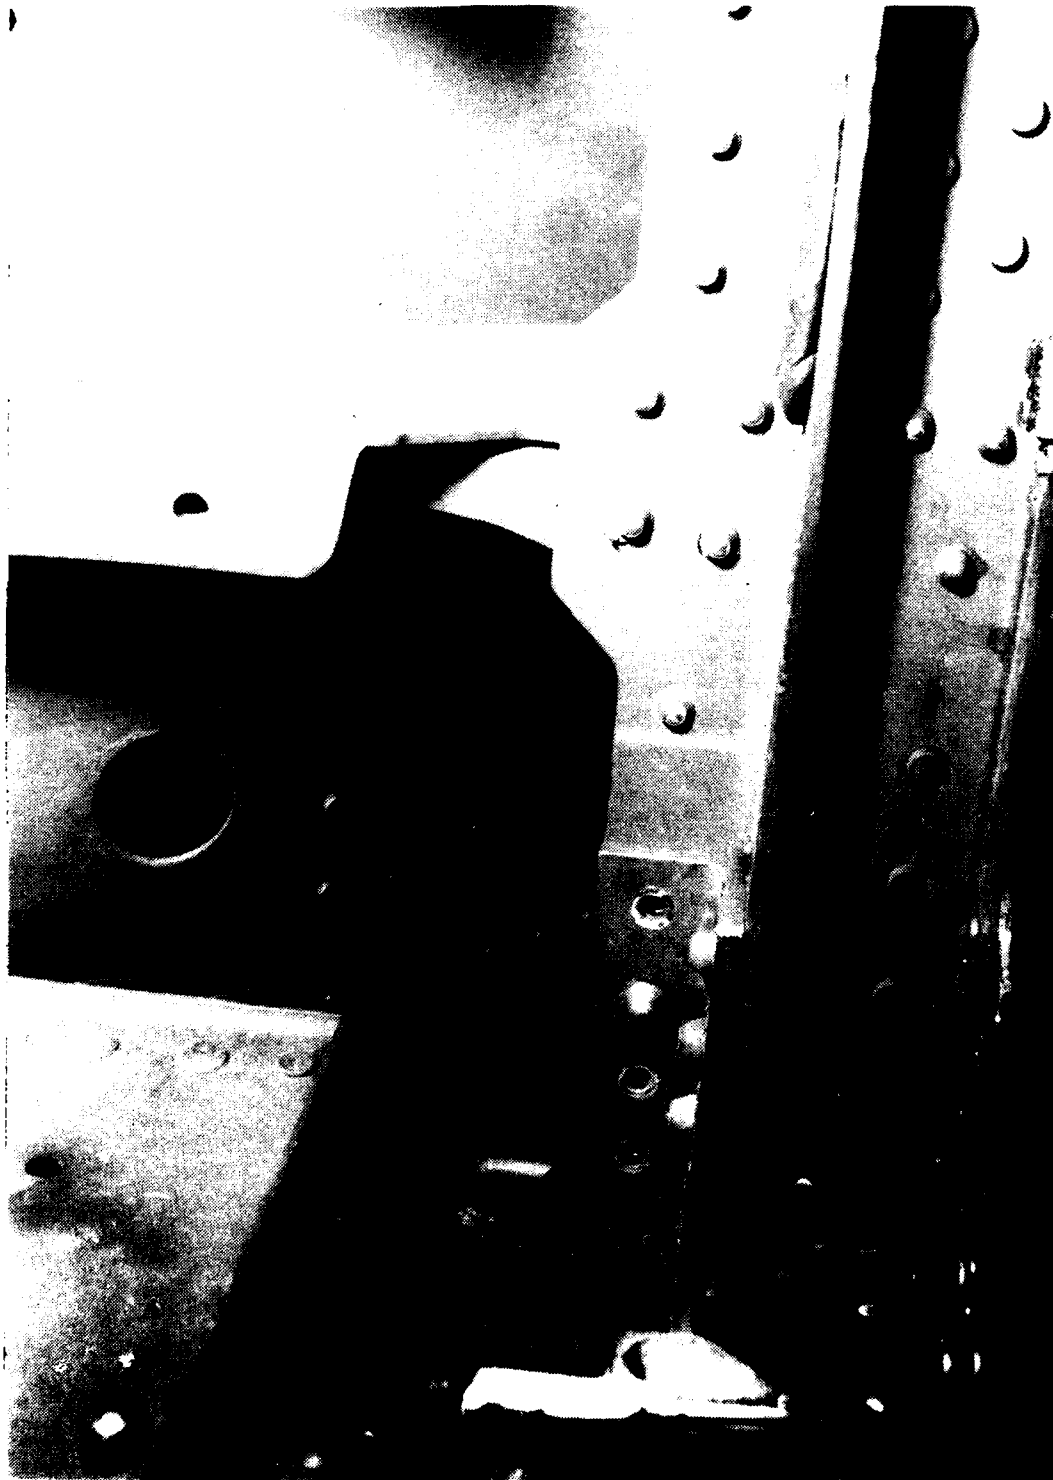
Figure 39. Rivets Missing from Splice Angle

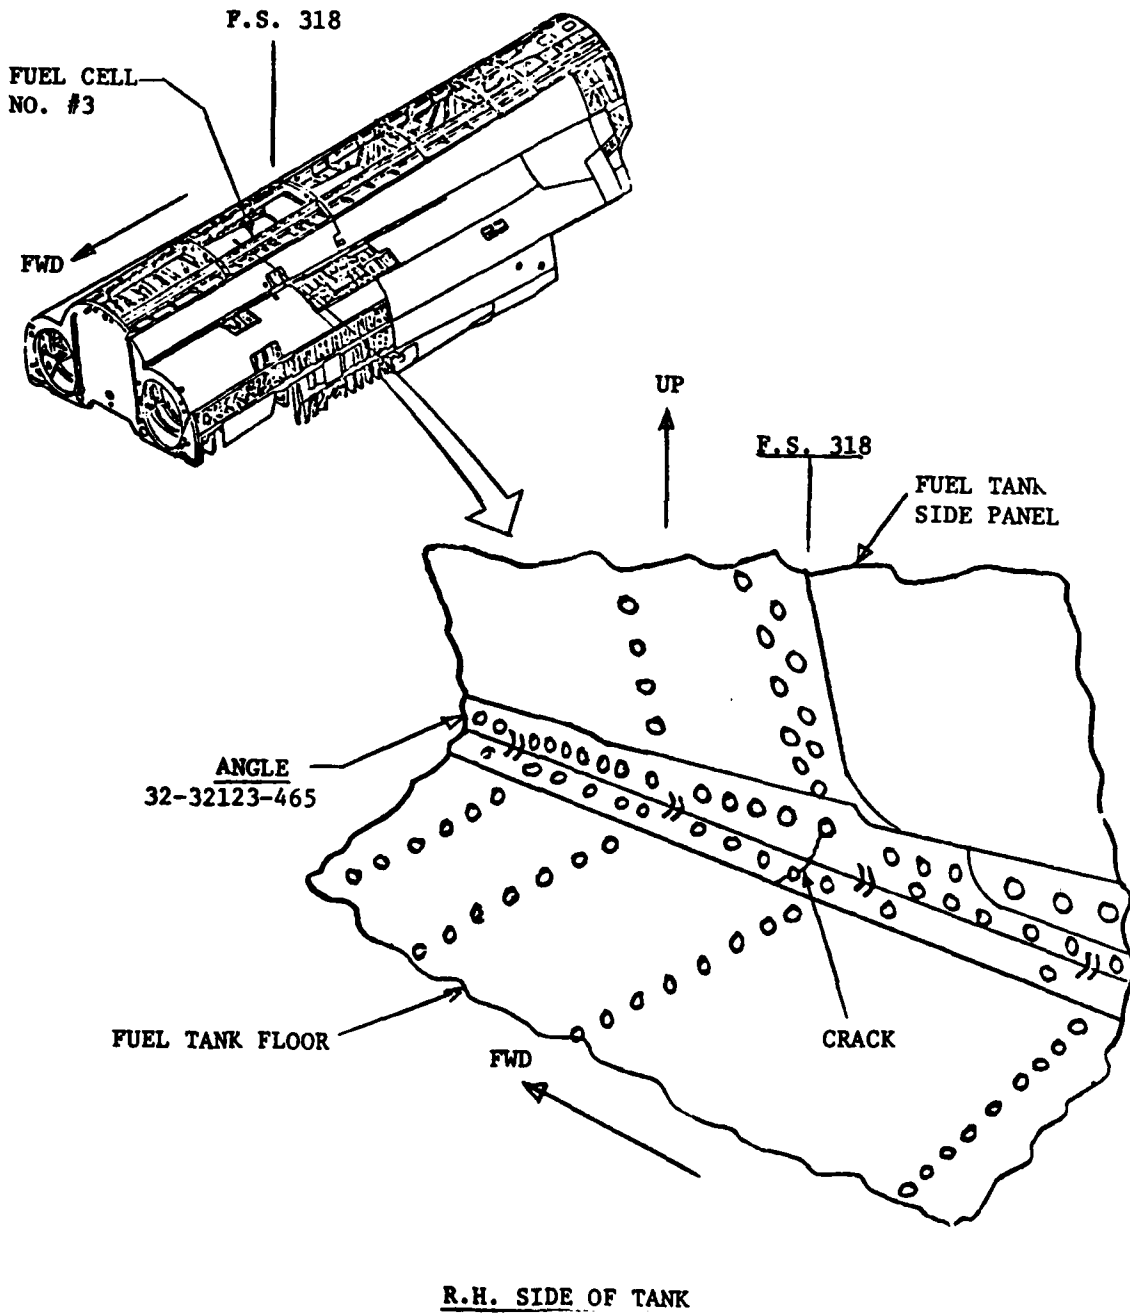
#3 FUEL TANK ASSEMBLY
32-32123-321

* 13,818	Crack Propagating from Fastener Hole in 32-32123-465 Angle Mating R/H Side Panel and Floor of # 3 Fuel Tank. (Figure 41).	Replaced Angle.
13,818	Crack in -143 Former that is Part of 32-32006-137 L/H Frame Assembly.	No Action Taken.

Figure 41. #3 Fuel Tank Cracked

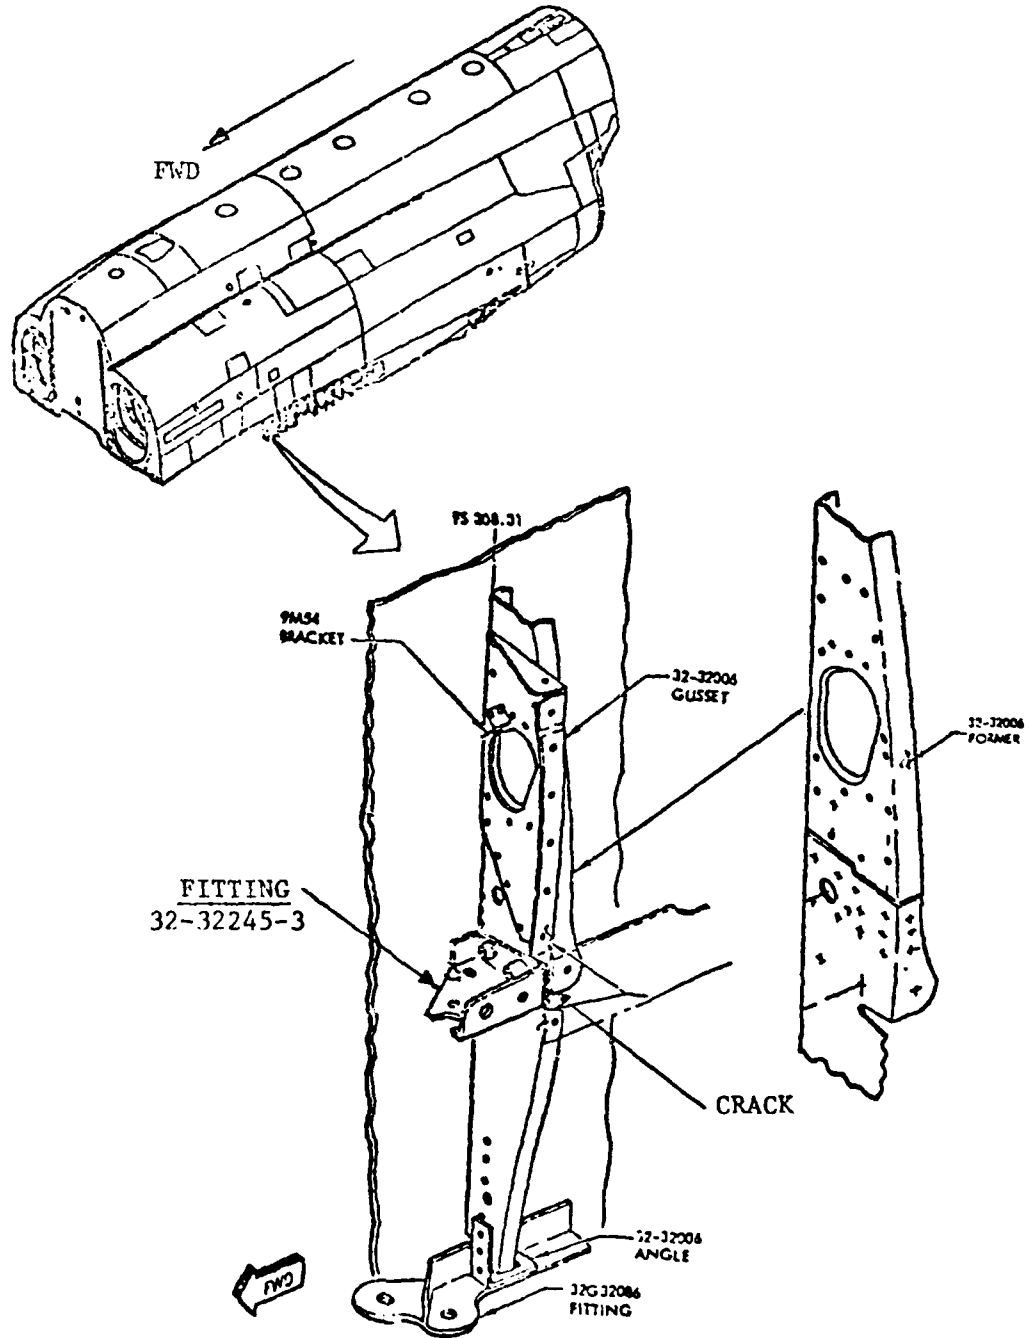
FITTING - WING PAD TO F.S. 308.31 ATTACH
32-32245-5

<u>SPECTRUM HOURS</u>	<u>DESCRIPTION OF FAILURES</u>	<u>DISPOSITION</u>
13,818	Crack in 32-32245-5 Fitting Tying Wing Pad to F.S. 308.31 Frame. (Figure 42).	Replaced
13,818	Fastener Missing Tying Front Spar to the B.L. 34 Shear Web at F.S. 249.65 on R/H Side of Aircraft.	Fastener Replaced.
13,818	32-50025 Eyebolt Tying Gate to Body of the 32-50043 Aft Inboard Engine Mount. (Figure 43).	Replaced
13,818	One of the Four Bolts Tying 32-50014-301 Forward Engine Mount Pad to the R/H Engine.	Replaced
*13,818	Cracks in 32-11215-16/-18 Tunnel Angles and in 32-11212-84 Aft Closure Angle. (Figure 44).	Replaced 32-11212-84 Angle. No Action Taken on 32-11215-16/-18 Angles.
13,818	Crack in Fire Wall Shroud Found at 10,000 Hours had Propagation Past Stop Drill Hole.	Stop Drilled with 3/8" Hole.
*13,818	Hydraulic Access Door Hinge Half Tied to Fuselage Cracked.	Replaced
*13,818	Fixed Bellmouth Rings Cracked on Both Sides of Aircraft.	Replaced

Figure 42. Wing Pad to FS-308 Frame Cracked

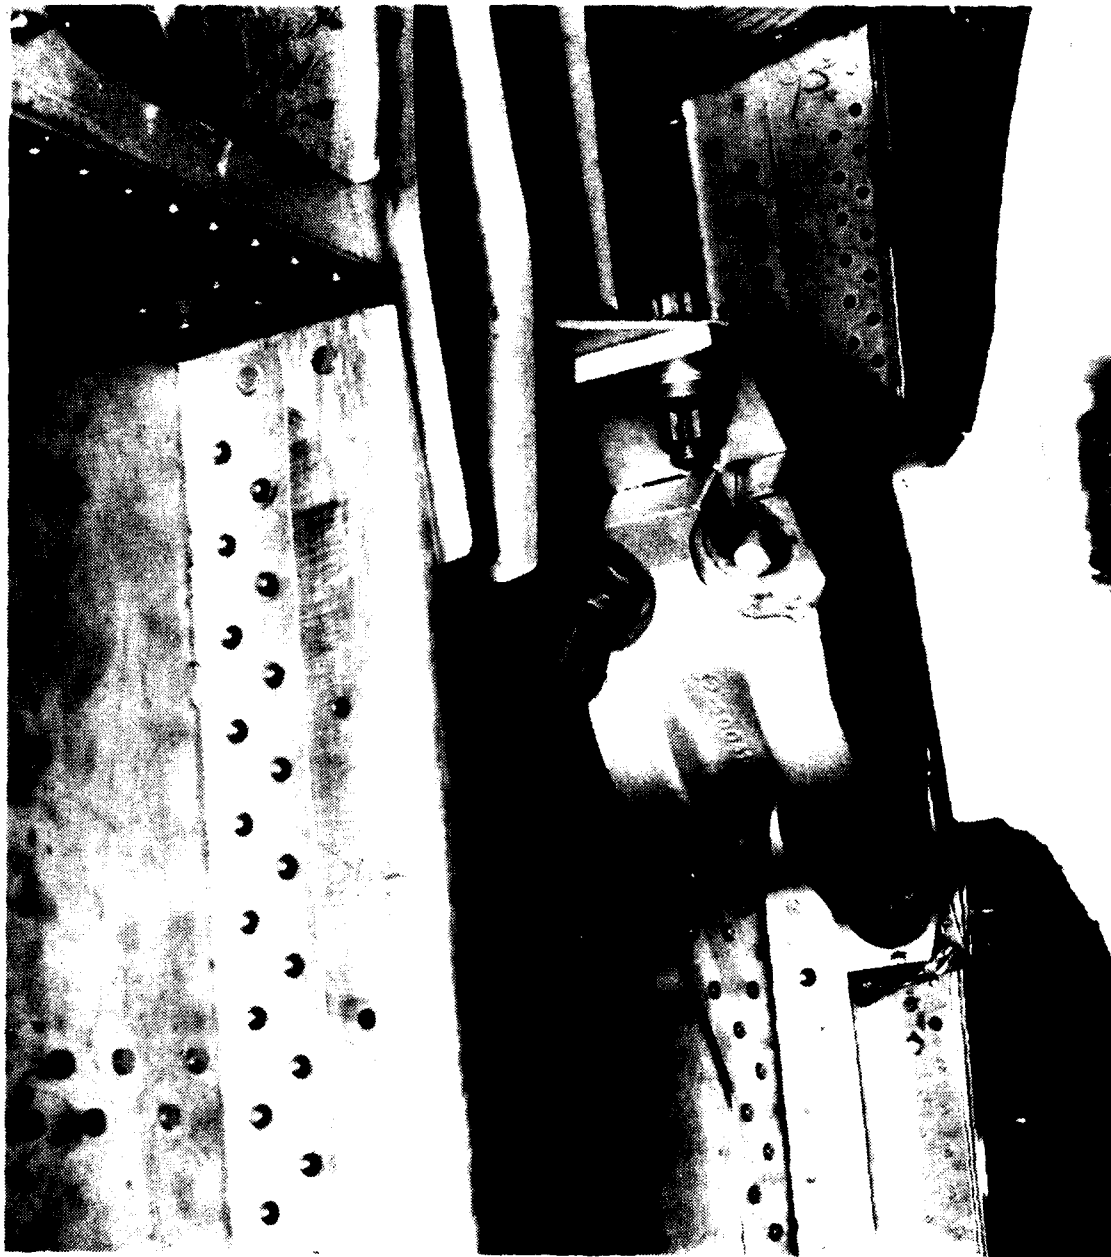
Figure 43. Eye Bolt Failed Aft Engine

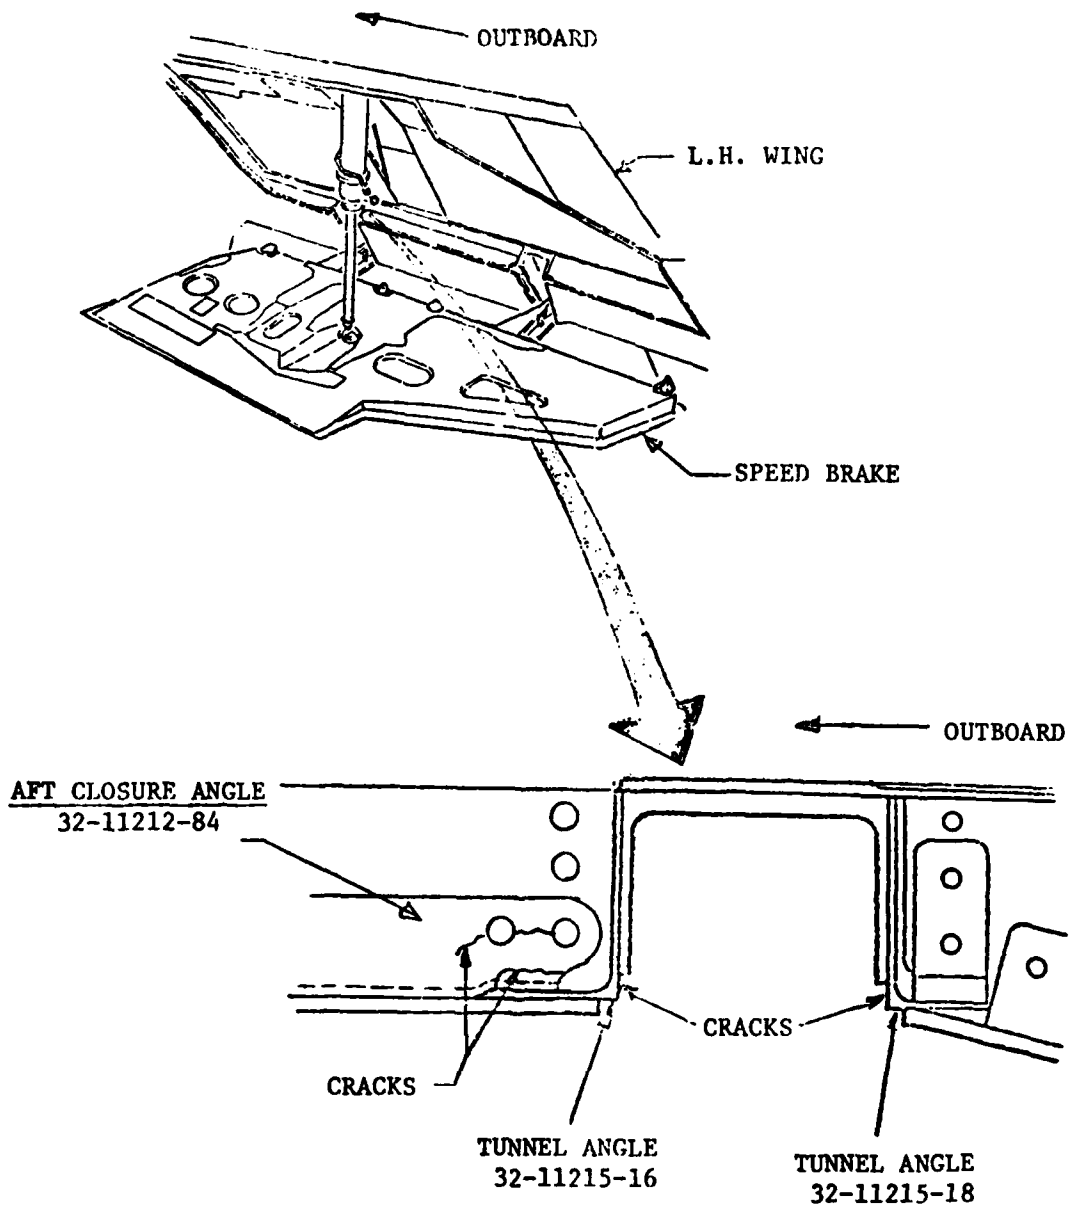
OUTBOARD SPEED BRAKE TUNNEL ASSEMBLY
32-11215-52

Figure 44. Speed Brake Tunnel Angles Cracked
