F-4C/D LIFE EXTENSION PROGRAM

Robert L. Schneider
Structures Test Branch
Structures and Dynamics Division

October 1982

Final Report for Period October 1974 - May 1981

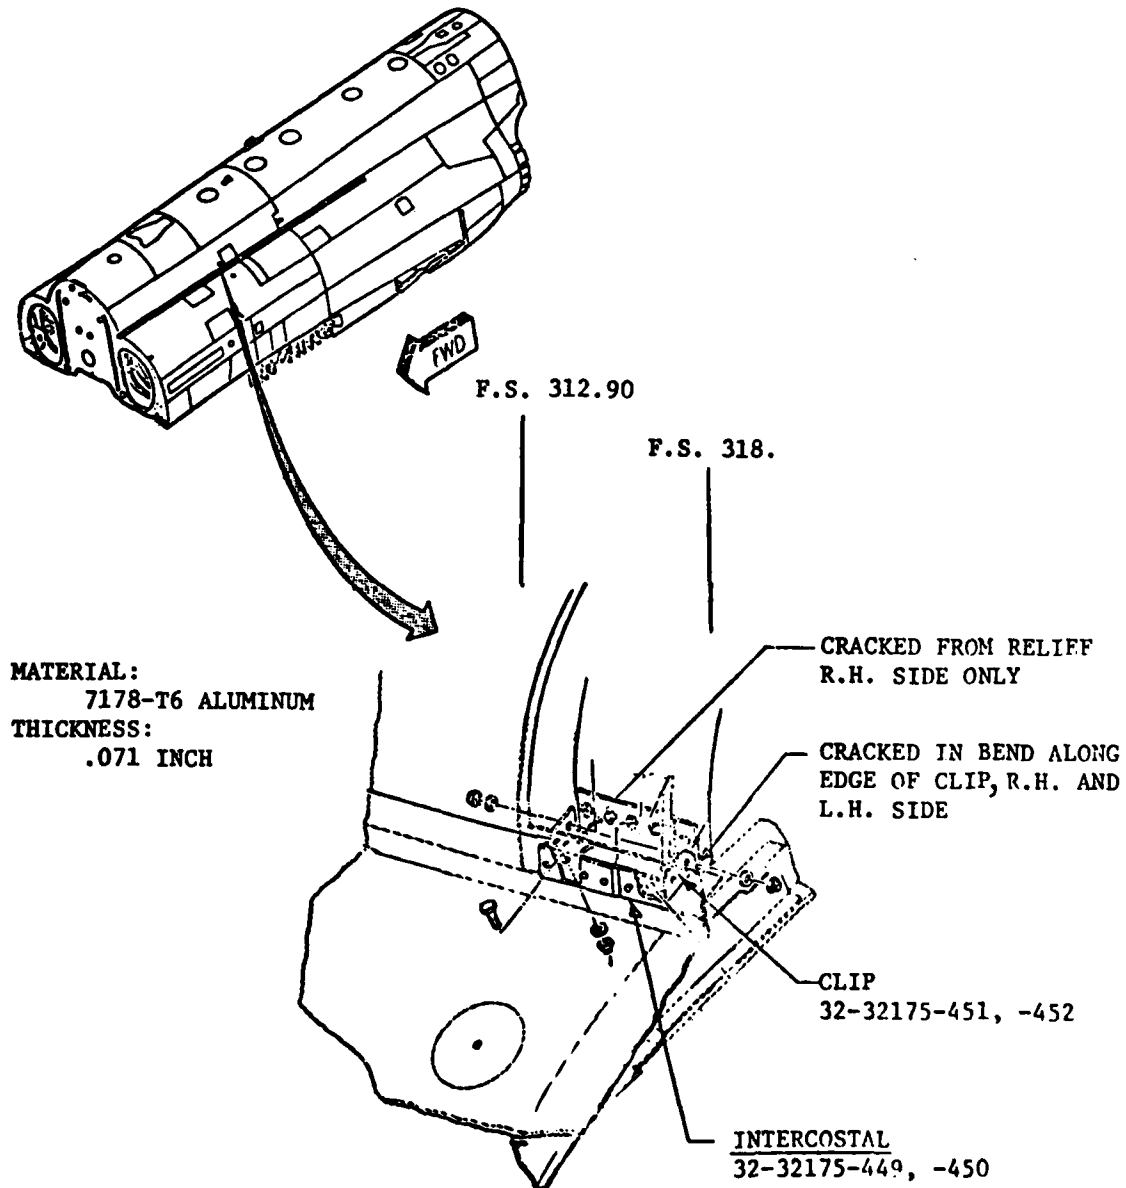
INTERCOSTAL ASSEMBLY, F.S. 312.90 TO F.S. 318
32-32175-449, -450

Figure 45. Intercoastal FS-318 Cracked

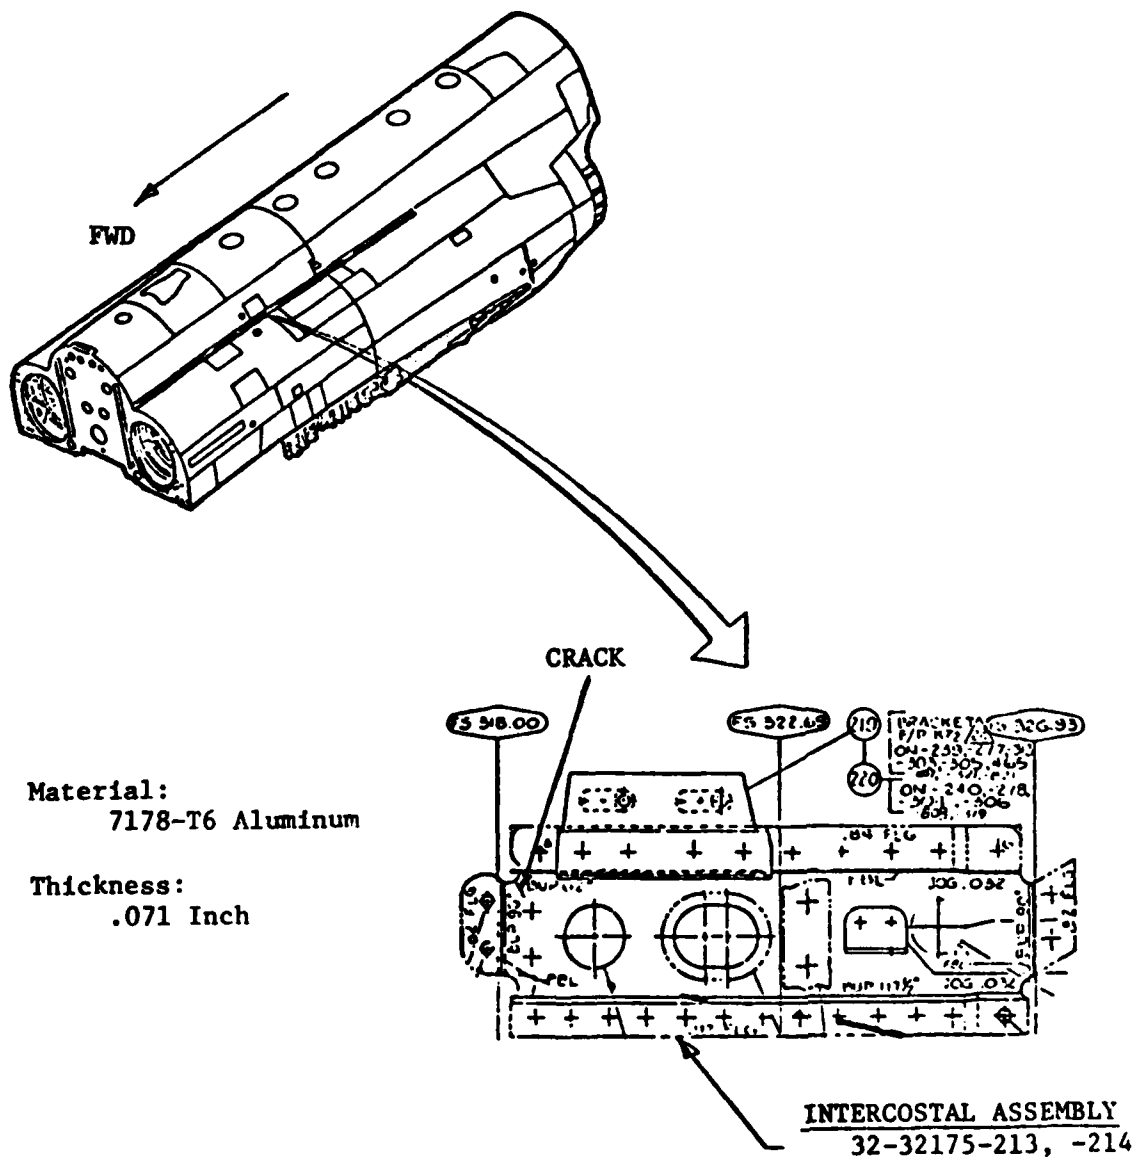
INTERCOSTAL ASSEMBLY, F.S. 318 TO F.S. 326.93
32-32175-213, -214

Figure 46. Intercostal between FS-318 & 326.9 Cracked

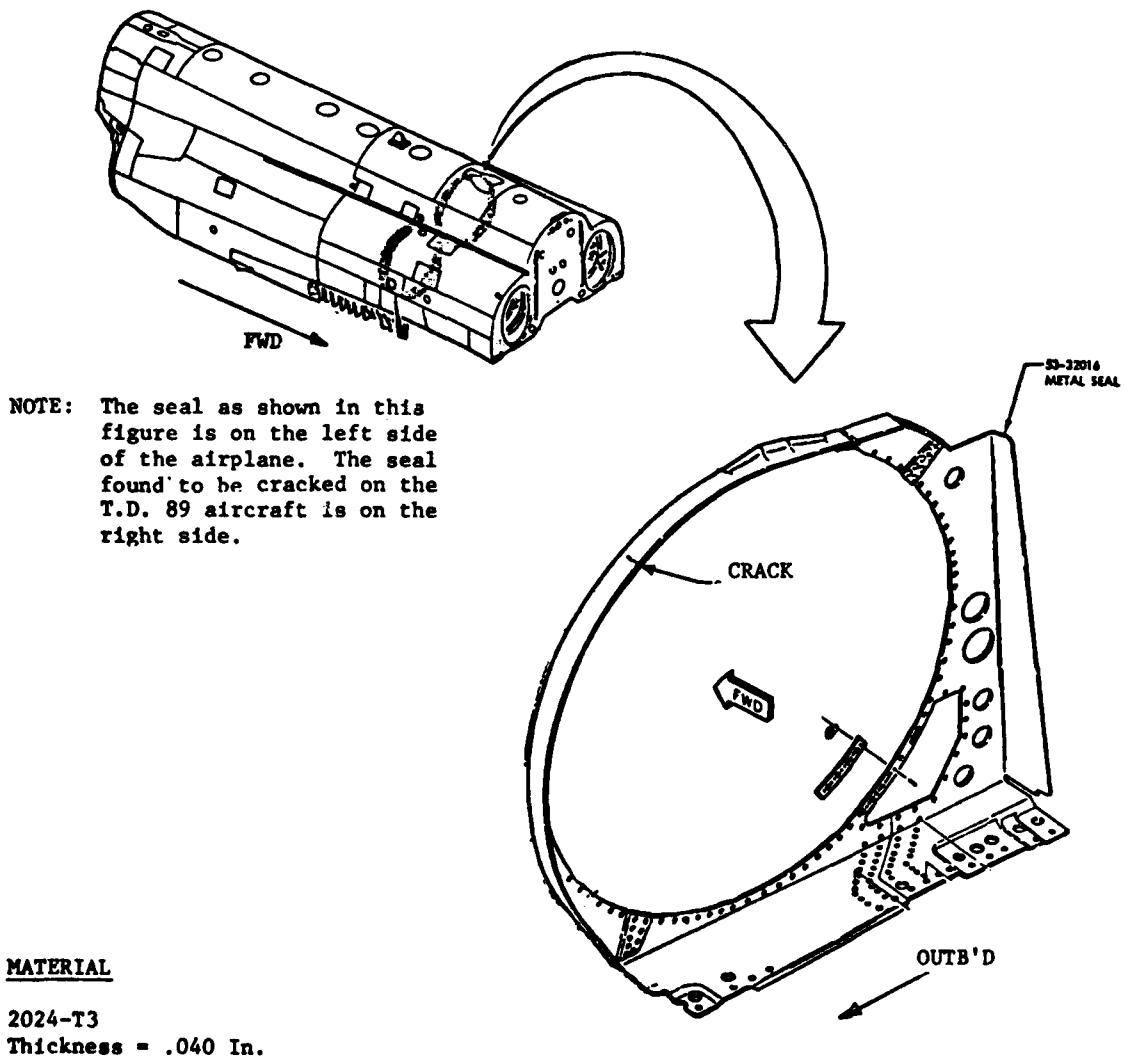
DUCT SEAL AT F.S. 303
53-32016-134

Figure 47. Duct Seal Cracked

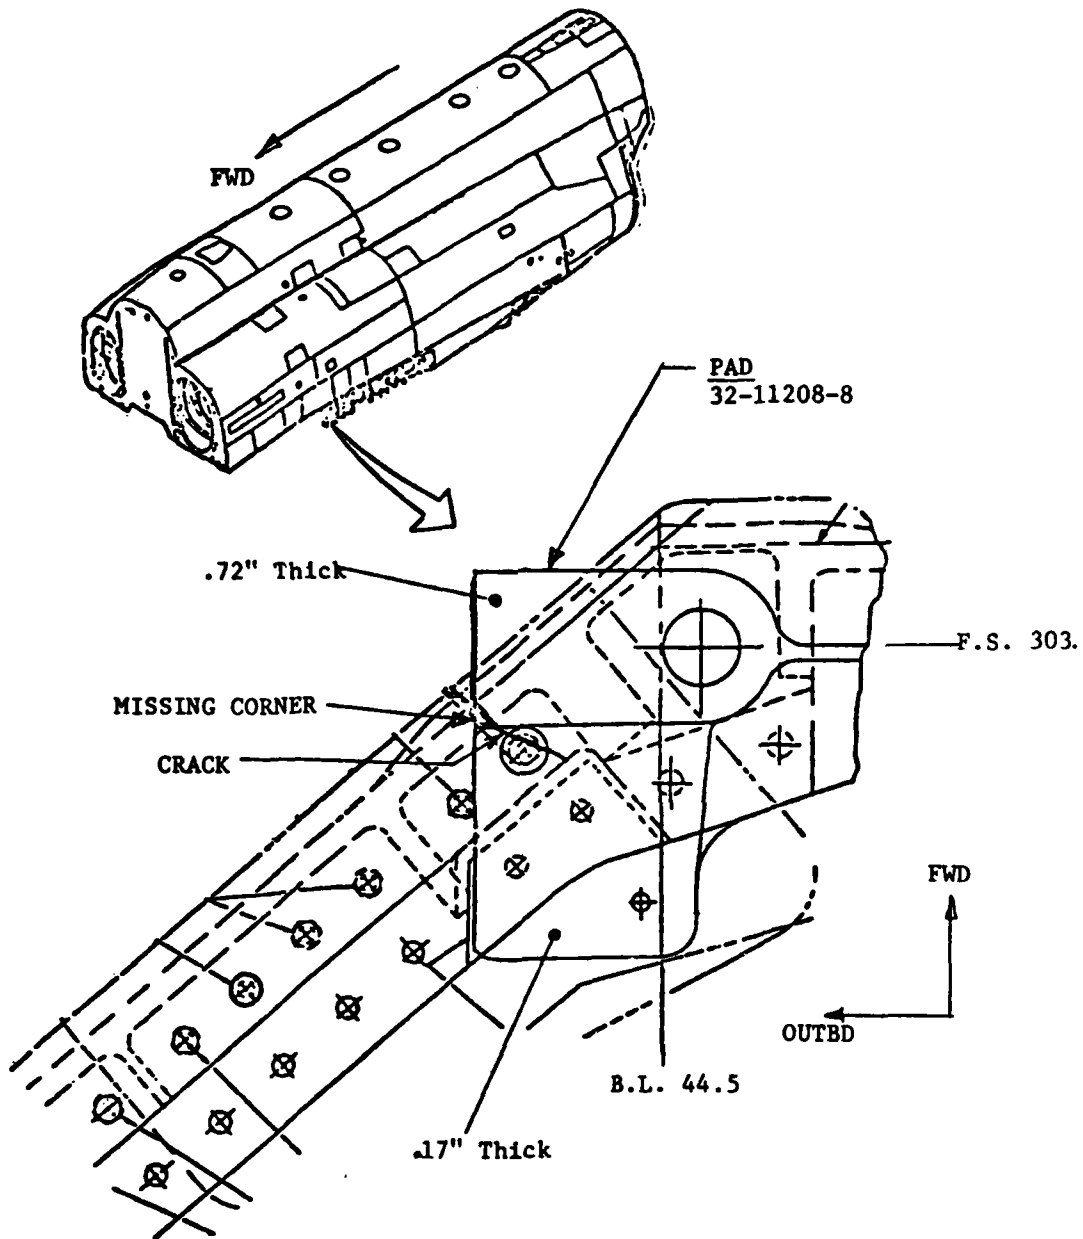
NOTE:
Assembly shown is on the left side of aircraft. However, failed pad is on right side.

Figure 48. Crack in Pad between Torque Box and 303 Bulkhead
