QTR-2191-001

QUALIFICATION TEST REPORT FOR  
450 GALLON CRASHWORTHY FUEL TANK  
FOR  
U.S. AIR FORCE H-53 HELICOPTER

FIBER SCIENCE DIVISION

QTR-2191

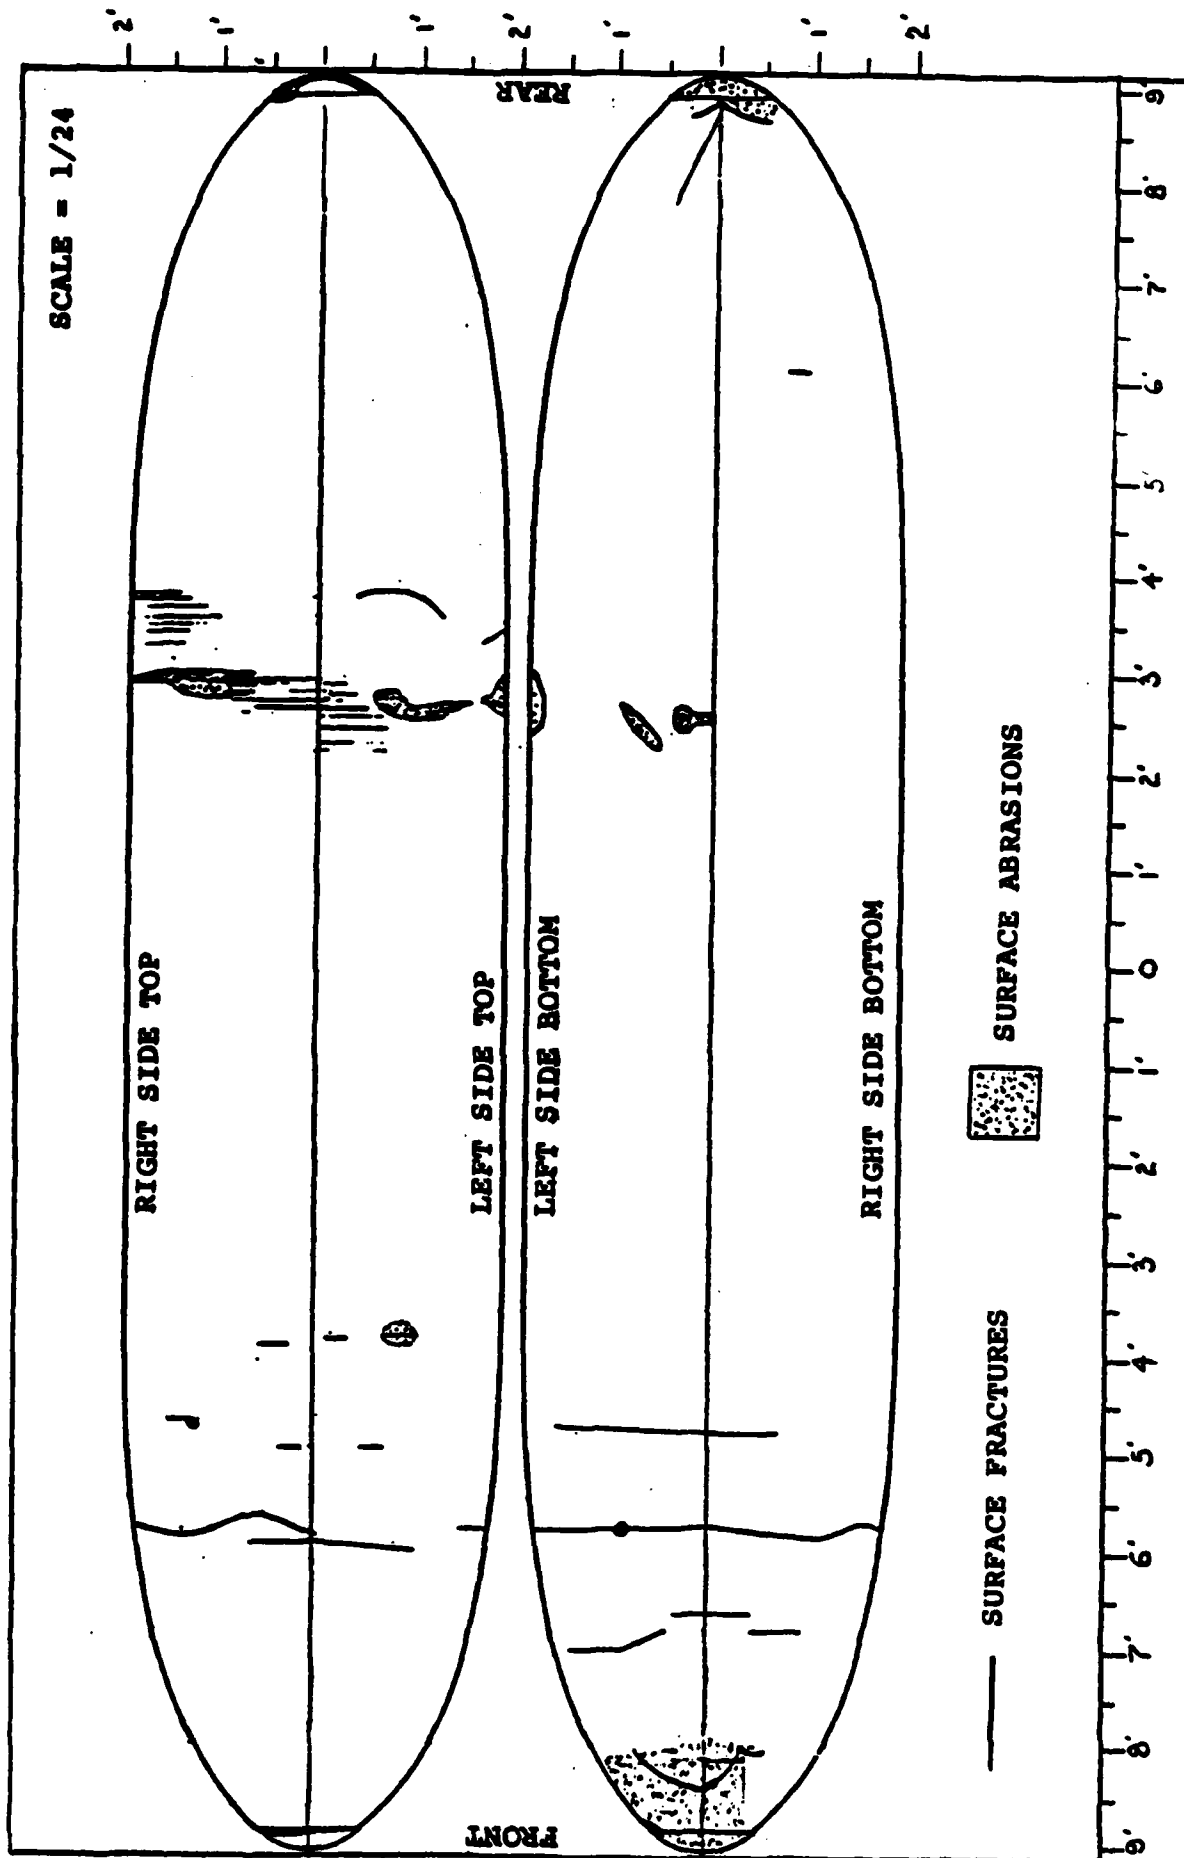
FIGURE 3-4. FUEL TANK SN0003 NON-RUPTURE SURFACE DAMAGE SKETCH.

Although the tank did not separate in pieces, its overall post-test appearance is poor. There is a significant circumferential rupture behind the pylon over the top of the tank. The nose cap is partially extruded from the front of the tank, there are jagged fractures on the underside of the tank nose and tail (the front is also partially ruptured), and there are several shallow fractures around the tank forward of the pylon. The tail cap is destroyed. However, it should be noted that a pressure transducer was cantilevered out of the end cap, approximately 6 inches beyond the end of the tank, and, due to the impact attitude, was the first object to contact the ground. This no doubt exaggerated the damage to the tail cap. Surface damage includes severe scuffing on the bottom and left side of the tank.

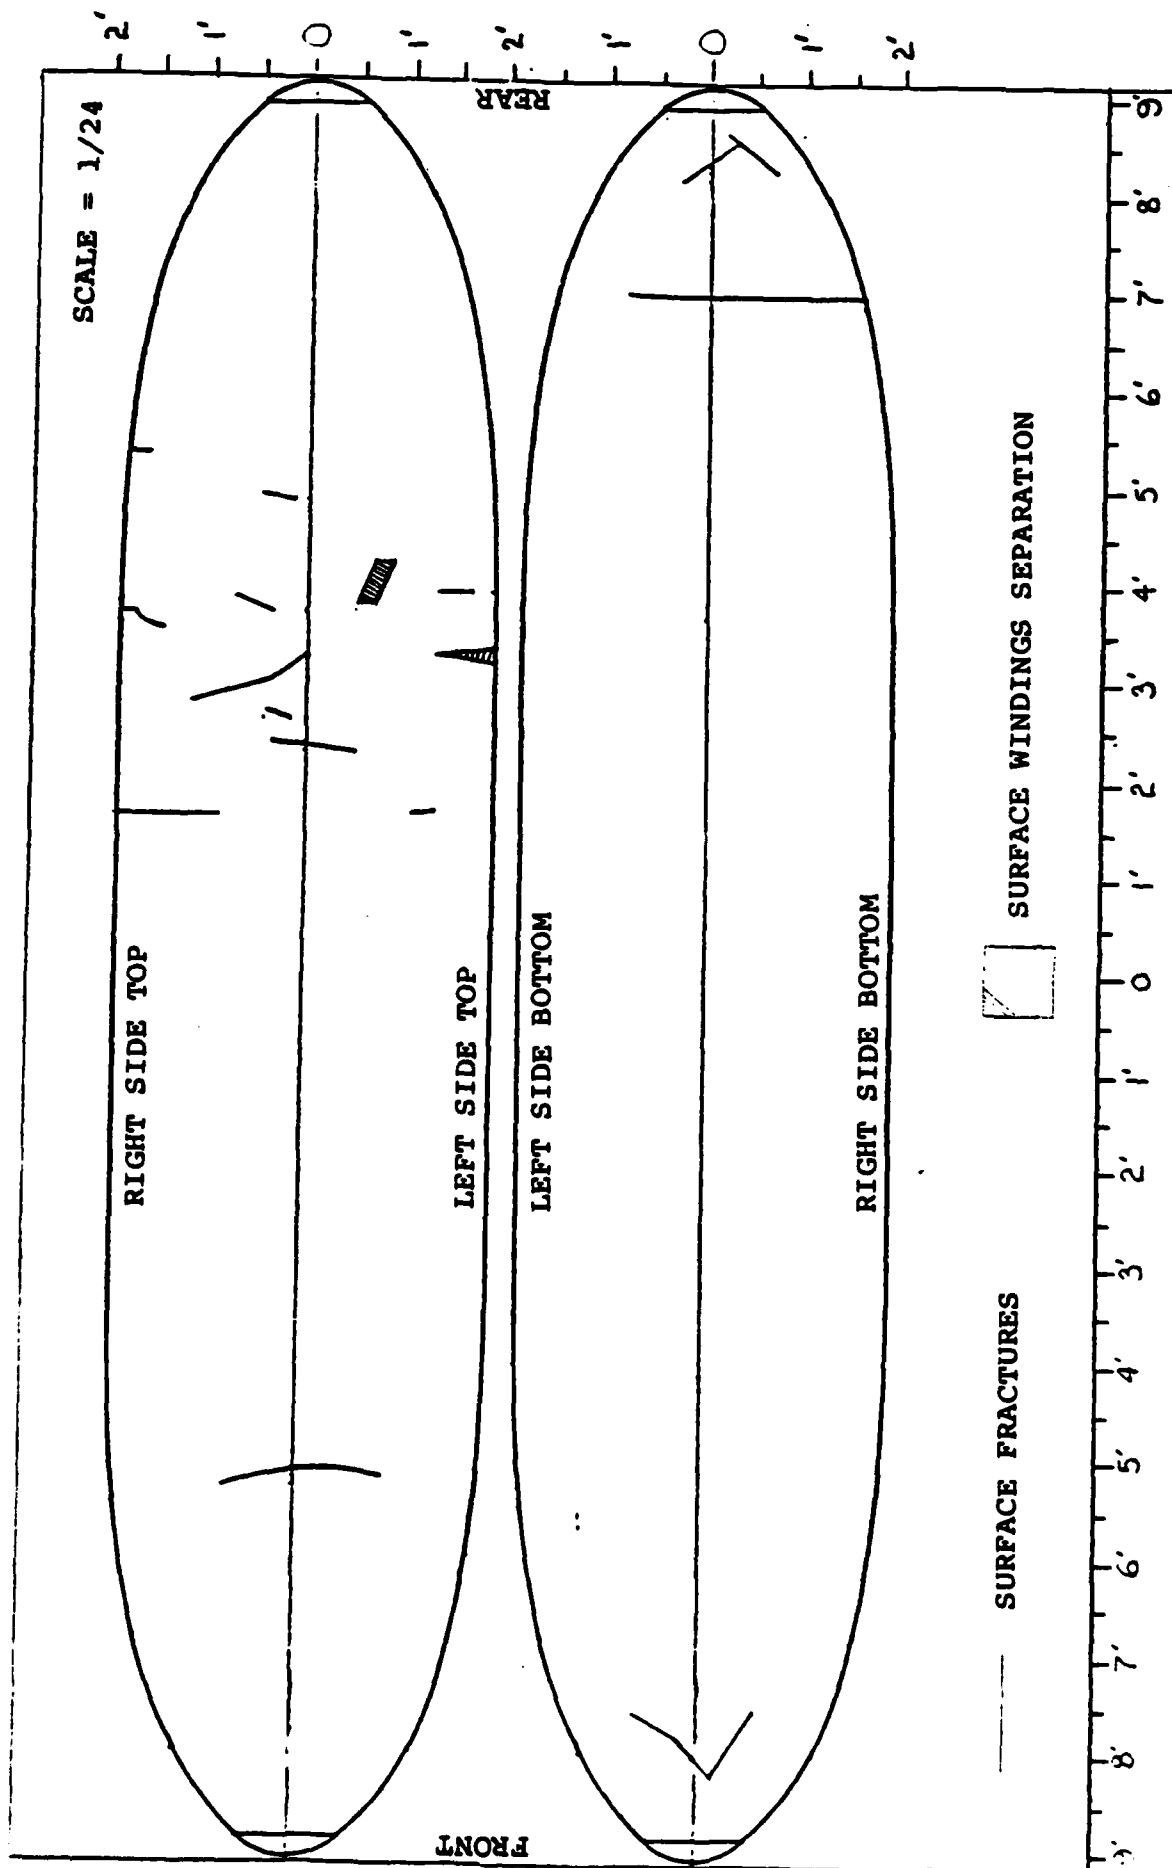
FIGURE 3-18. FUEL TANK SN0004 NON-RUPTURE SURFACE DAMAGE SKETCH.

There are some stress fractures on the top and sides of the tank. Additionally, there is a non-rupture circumferential fracture on the bottom of the tank towards the rear. At both the front and rear of the tank, on the bottom near the end caps, there are "V"-shaped stress fractures. Figure 3-18 is a scaled sketch of all tank surface non-rupture damage. Figures 3-19 and 3-20 show the "V"-shaped fractures at the front and rear of the tank, respectively.

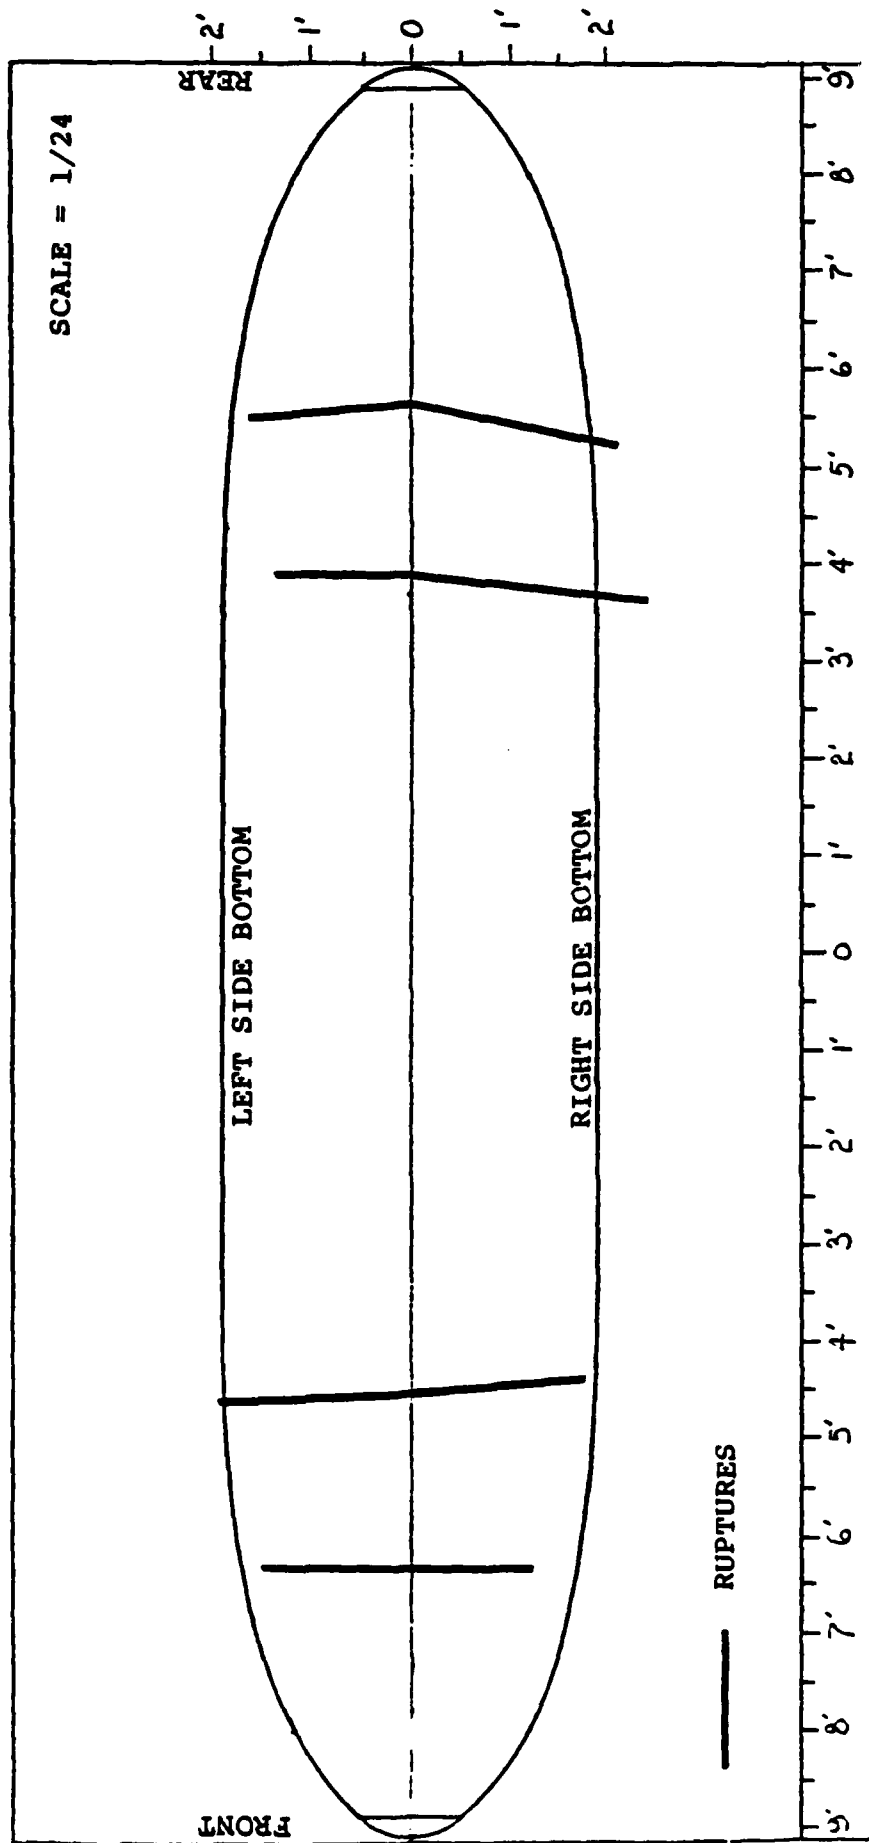
FIGURE 3-21. FUEL TANK SN0004 RUPTURE LOCATION SKETCH.

Four leakage locations were noted. Figure 3-21 is a scaled sketch of the rupture locations.

1. Approximately 6.5' forward of tank center point on bottom.
2. Approximately 4.5' forward of tank center point on bottom.
3. Approximately 3.5' aft of tank center point on bottom.
4. Approximately 5.5' aft of tank center point on bottom.

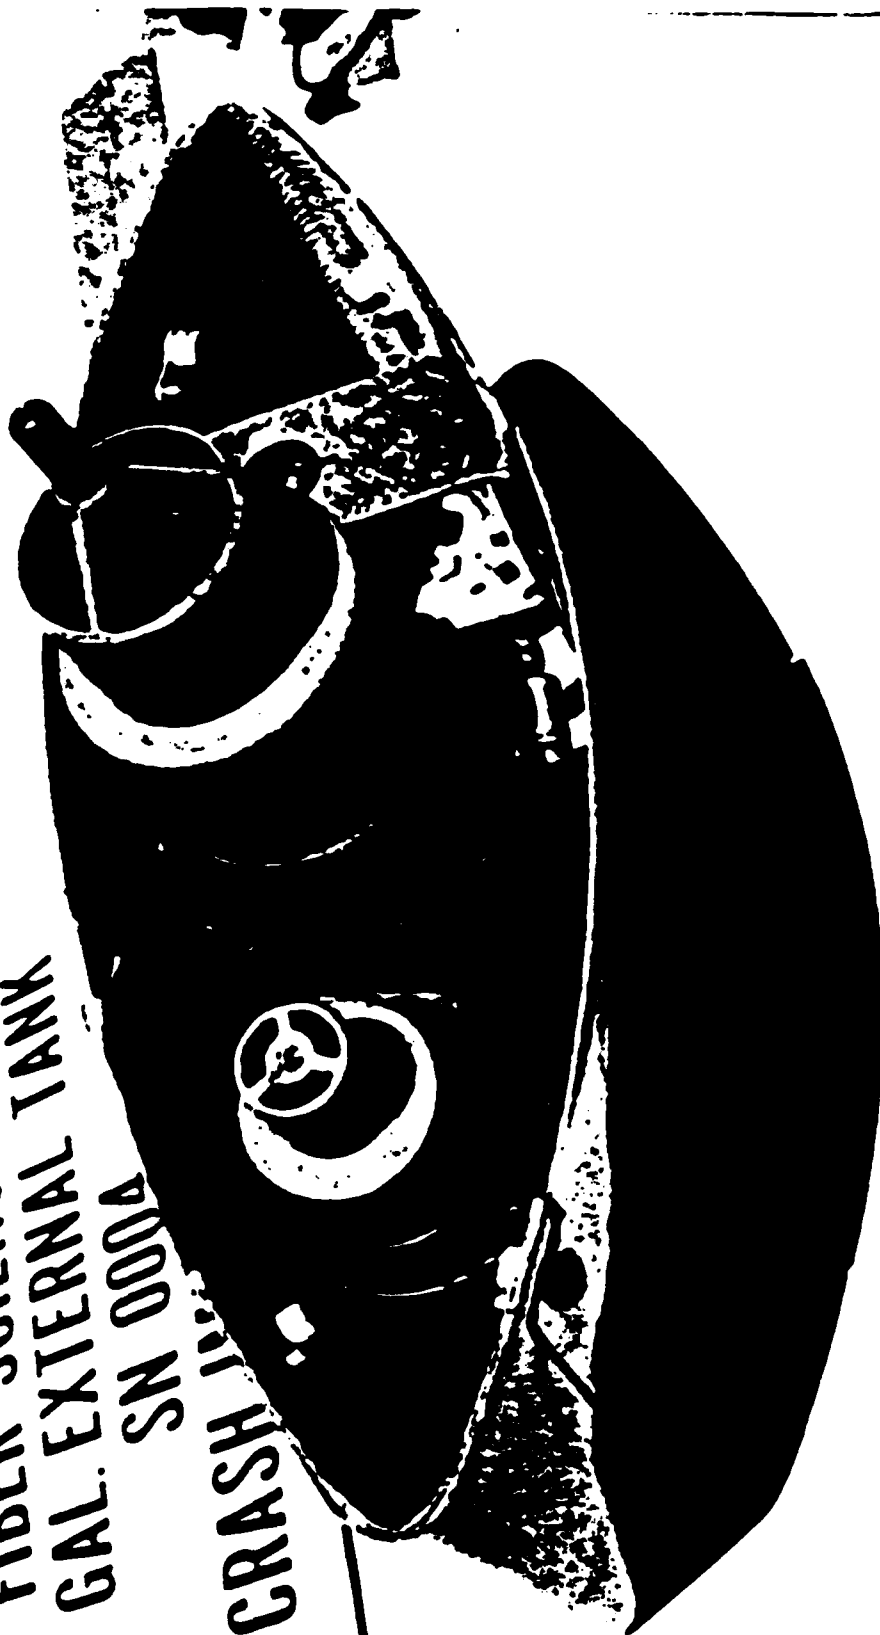
FIGURE 3-28. FUEL TANK SN0004 POST-TEST CLOSE-UP VIEW OF FUEL AND AIR FITTINGS.

Black epoxy-like material around fuel fitting valve broken away. Float switch still functional. Figure 3-28 shows the fuel and air fittings. Small cracks in fairing.
