SEABEE PRETEST RESULTS OF THE JOINT LOGISTICS-OVER-THE-SHORE (LOTS) TEST AND EVALUATION PROGRAM(U) ORI INC SILVER SPRING MD H KNIGHT ET AL.

07 DEC 77 ORI-TR-1267 MDA903-75-C-0016

Subj: ORI Technical Report No. 1267: SEABEE Pretest Results  
of the Joint Logistics-Over-the-Shore (LOTS) Test  
and Evaluation Program

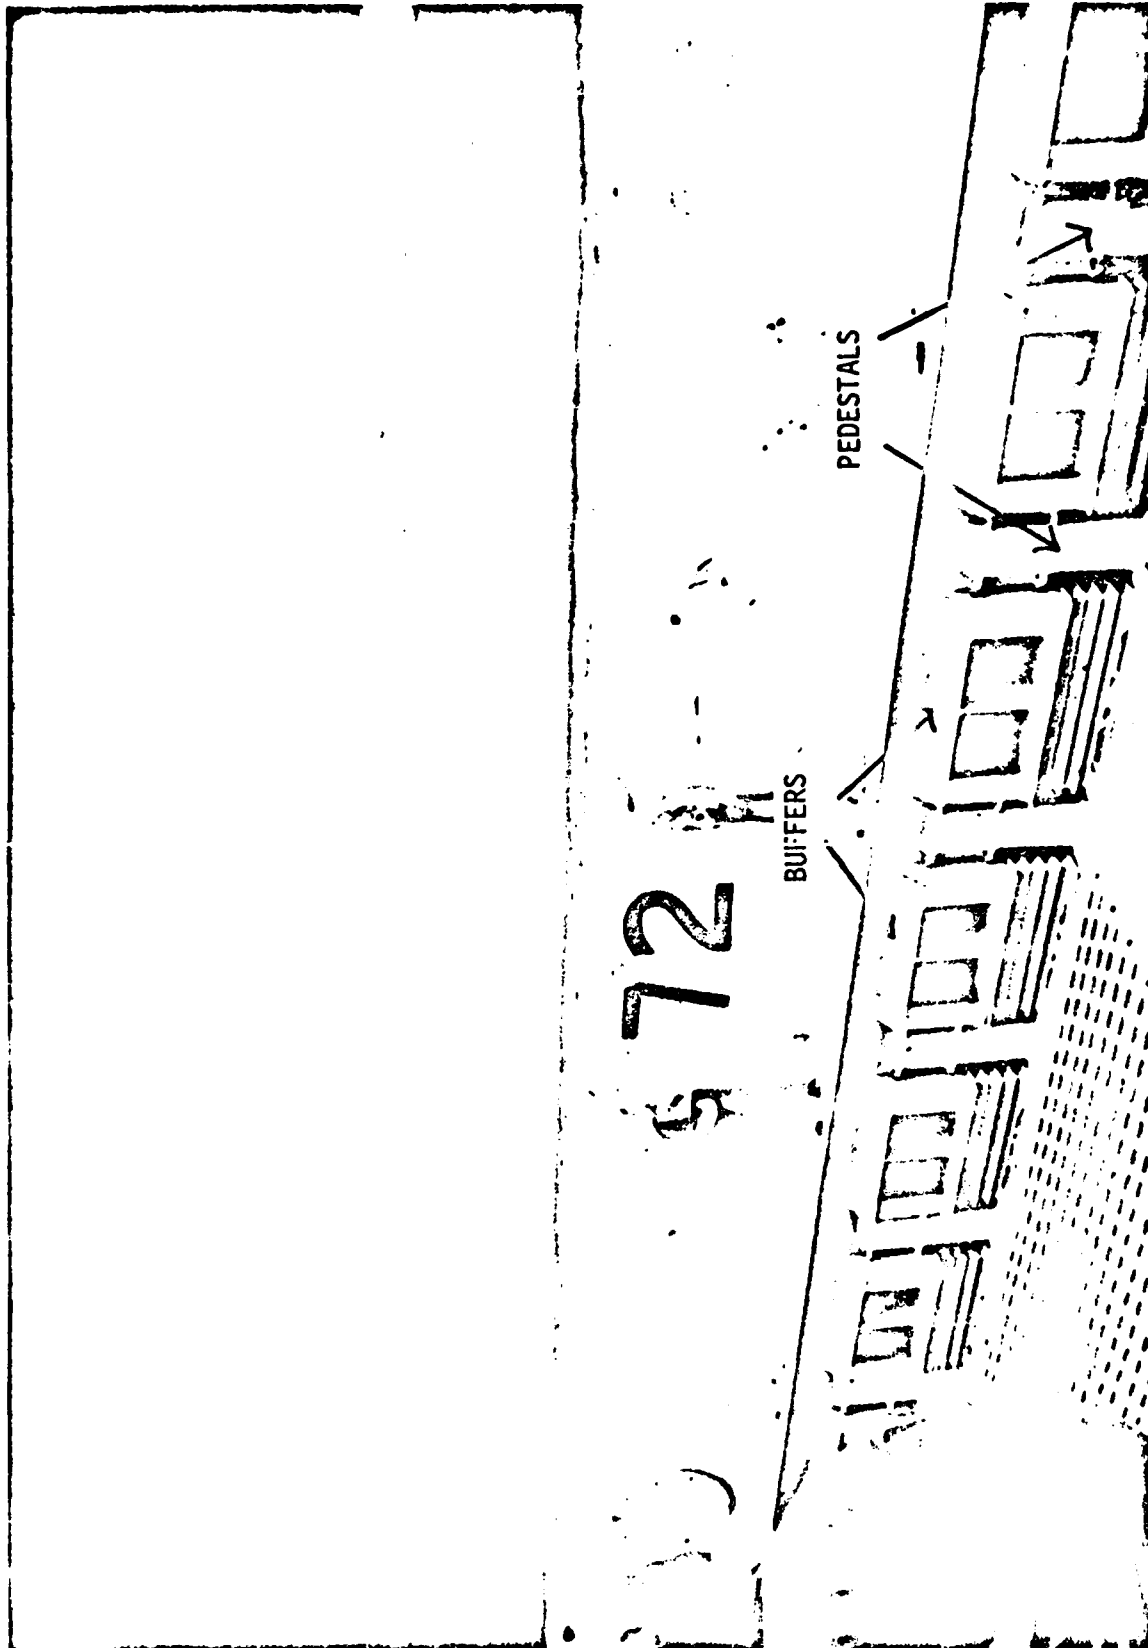
The present mode of securing frames to the support pedestals is unsatisfactory. There are no adequate places where hooks can be used. Rigging wire rope loops is time consuming and they are prone to parting. For example, when the LCM-8 was clear of the elevator platform, one of the wire loops parted. The strength of the other lashing attachments precluded them from holding the frame tightly, which caused additional stresses. Eventually, all of the lashings would have either failed or have been damaged.

FIGURE 6. SUPPORT PEDESTALS AND BUFFERS

The lashing equipment used was not suitable for the task. Shorter turnbuckles would have permitted a more vertical lead and more resistance to movement. Realistically, if three corners are properly secured, there should be an adequate bond. The fourth corner is essentially an insurance factor to maintain a tri-point lashing feature.

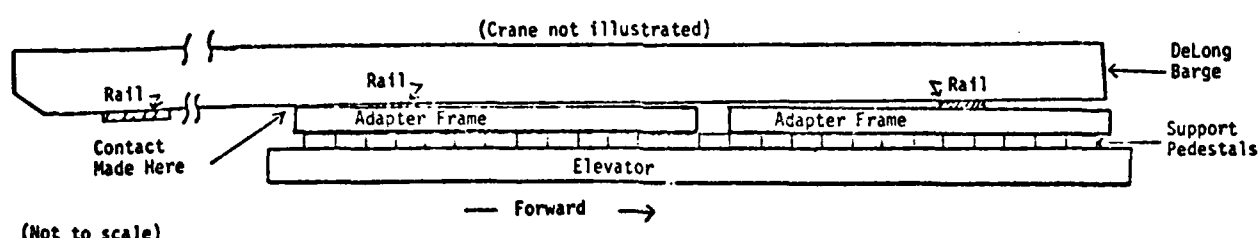
An inspection of the TCDF (see Figure A.5) revealed that it was not resting on its flat bottom as planned. Longitudinal metal rails, 6 in. by 6 in. by 8 ft 9 in., not shown on available drawings, caused the interference. Two were located 18 ft aft of the forward edge of the DeLong barge. A second set was located on each side of the midpoint of the barge. These rails were deeply imbedded into the dunnage. A third pair of rails was on the overhanging section about 18 ft from the aft edge. As a result, the forward-most rails offered two relatively small contact surfaces. The middle rails were less effective because some weight (and, surface contact) was noted on the aft edge of the aft adapter frames. Although the TCDF in this position could probably have been safely made, there appeared to be severe stresses at the contact points along the aft end of the adapter frames. These stresses, unknown in magnitude, could have caused significant damage to the frames which had a purchase price in 1972 of almost \$30,000 each. Accordingly, the TCDF test lift was terminated at this point. After an investigation of the alternatives, a decision was made to add dunnage to the adapter frames to accommodate the rails rather than try to remove them from the bottom of the barge. If time permitted at the conclusion of the debarkation exercises, another TCDF lift would be attempted. The TCDF was lowered into the water and retracted by the tugs without any incident.

FIGURE A.5. TCDF'S POSITION ON THE ELEVATOR
