### *Detection of cavities under concrete pavement*

# CRREL Report 83-18

July 1983

Austin Kovacs and Rexford M. Morey

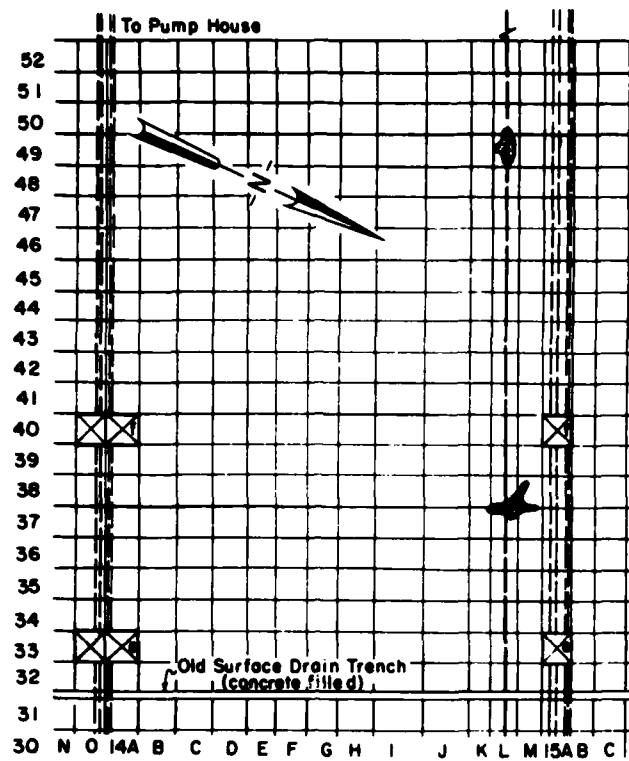
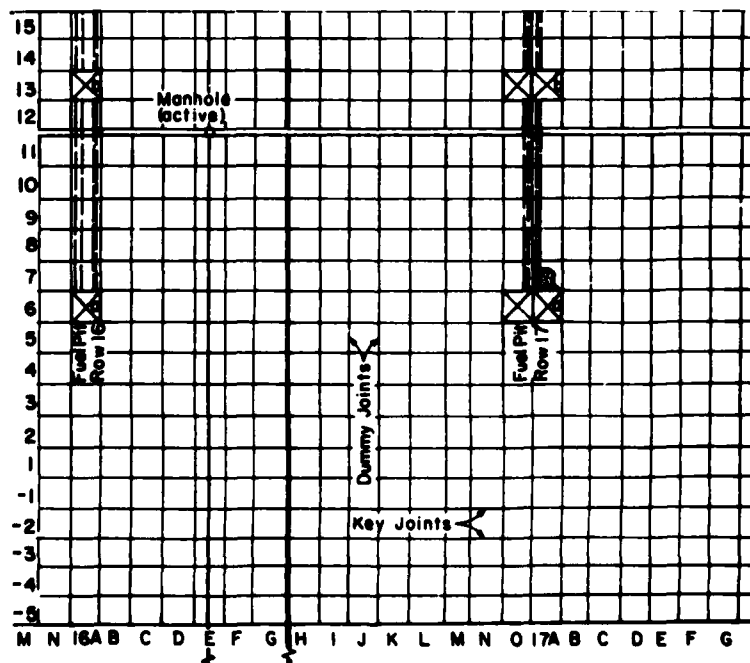
Figure 28. Location of cavities (hatched areas) under rows 14L and 14M and 17A.
