CHARACTERIZATION OF ELECTRICALLY ACTIVE  
DEFECTS IN SI USING CCD IMAGE SENSORS

Texas Instruments Incorporated

Quarterly Technical Report  
1 September 1977 - 30 November 1977

TI Report No.  
08-78-03

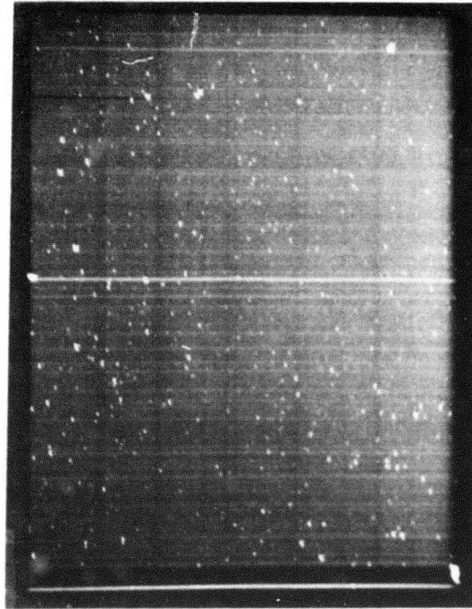
A typical dark current pattern observed in devices made on this material is shown in Figure 1. The random distribution of dark current spikes illustrated in this figure is typical of all imagers that were operated on the slice.

Figure 1 Dark Current Patterns: Czochralski - Control Group

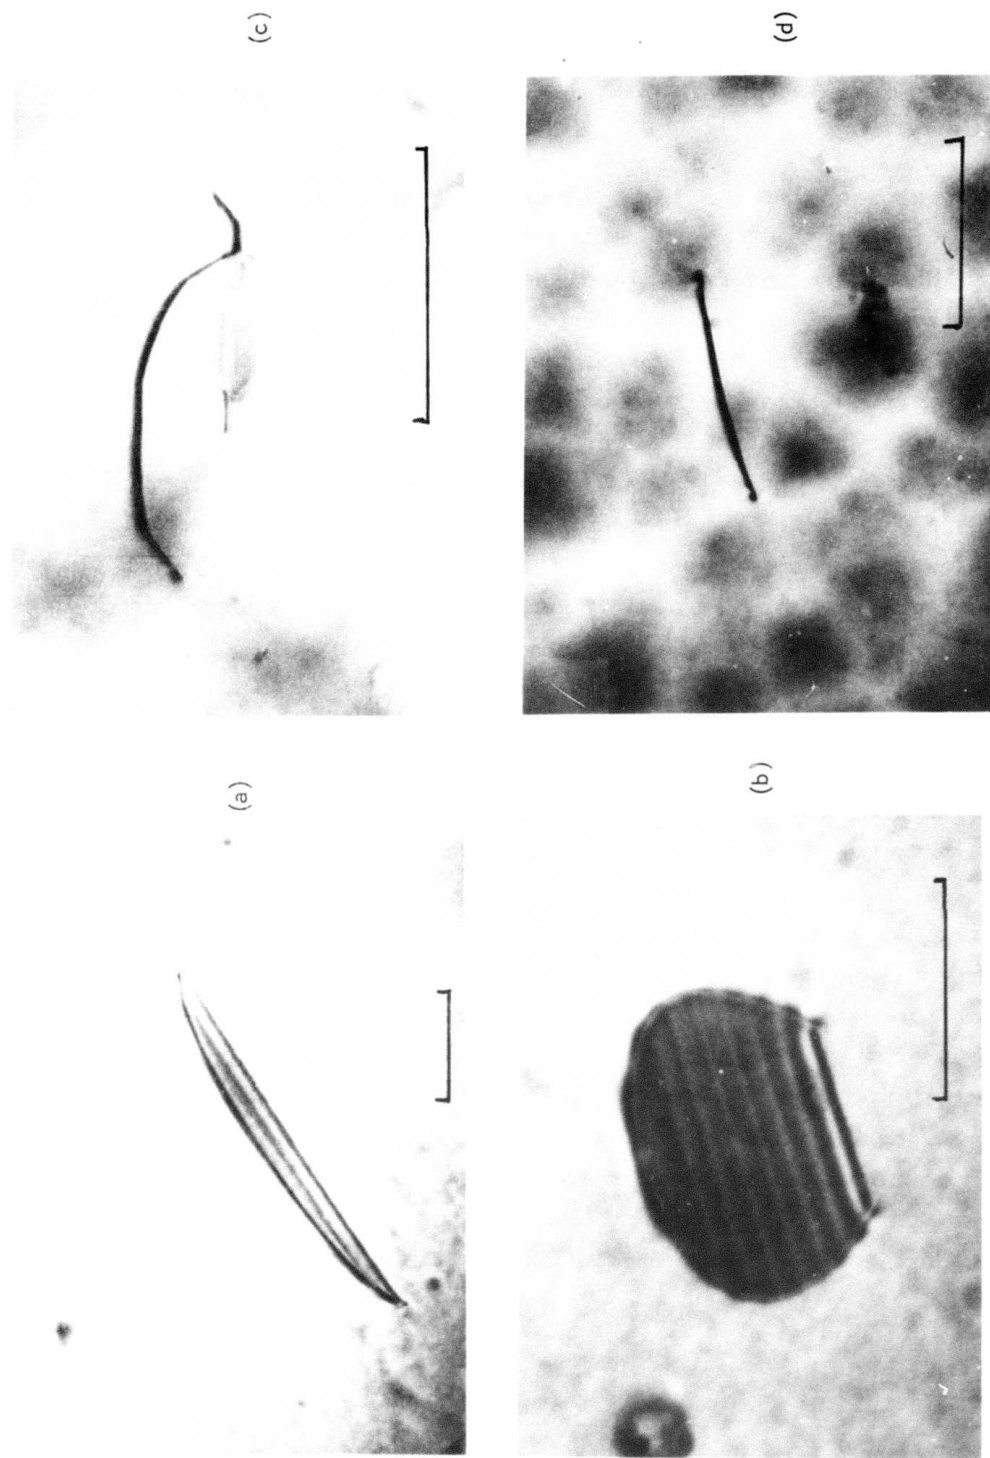
Figure 3 TEM Micrographs of Defects in Czochralski - Control Group Devices. (a) and (b), stacking faults in channel stops; (c) and (d), dislocations in channels. All markers = 0.5  $\mu\text{m}$ .

Our observations further support a bulk origin of the stacking faults. The almost circular stacking fault in Figure 3(b) is typical of a stacking fault that has been growing in the interior of the crystal and has just intersected the surface. It is difficult to explain such a shape from a surface nucleation mechanism. In addition, the size of the majority of the stacking faults is about the same as that of stacking faults we found in the bulk of "swirled" material, which were clearly of bulk origin.<sup>1</sup> We therefore conclude that the stacking faults were nucleated from bulk nuclei.

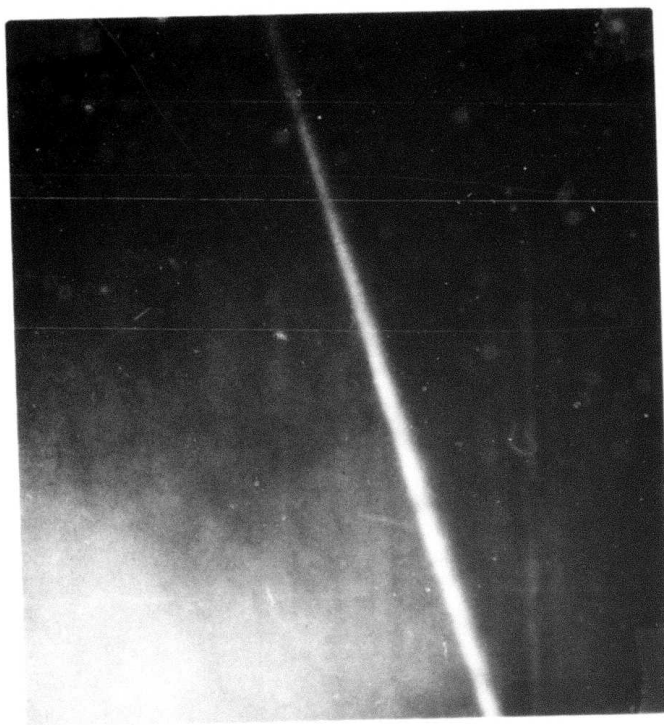
Figure 5 Weak Beam (400) Micrograph of Pure Edge Dislocation in Czochralski - Control Group. The dislocation is not dissociated.

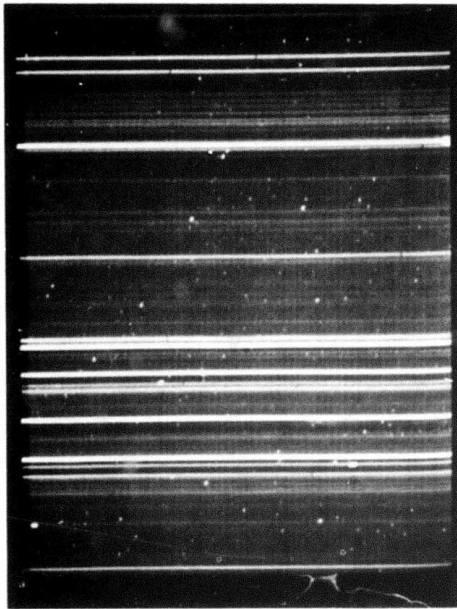
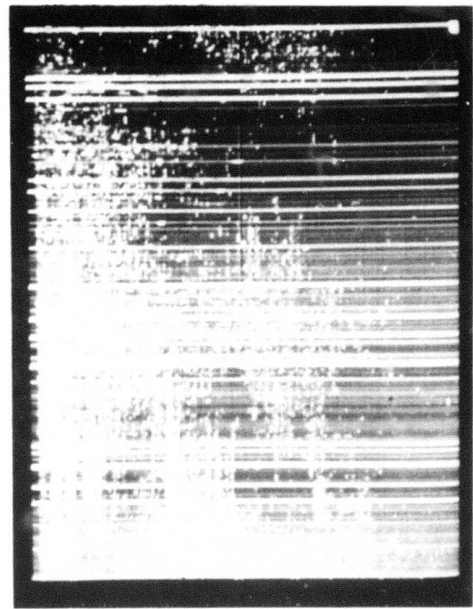
Dark current patterns from imagers on float-zoned material fell into two distinct categories. Devices in the central region of one slice and about the periphery of all slices showed dense patches of dark current lines running in  $\langle 110 \rangle$  directions on the slice [Figure 6(a)]. Devices outside of these regions showed a moderately low density of randomly distributed isolated dark current spikes [Figure 6(b)].

Figure 6 Dark Current Patterns - Float-Zoned Group

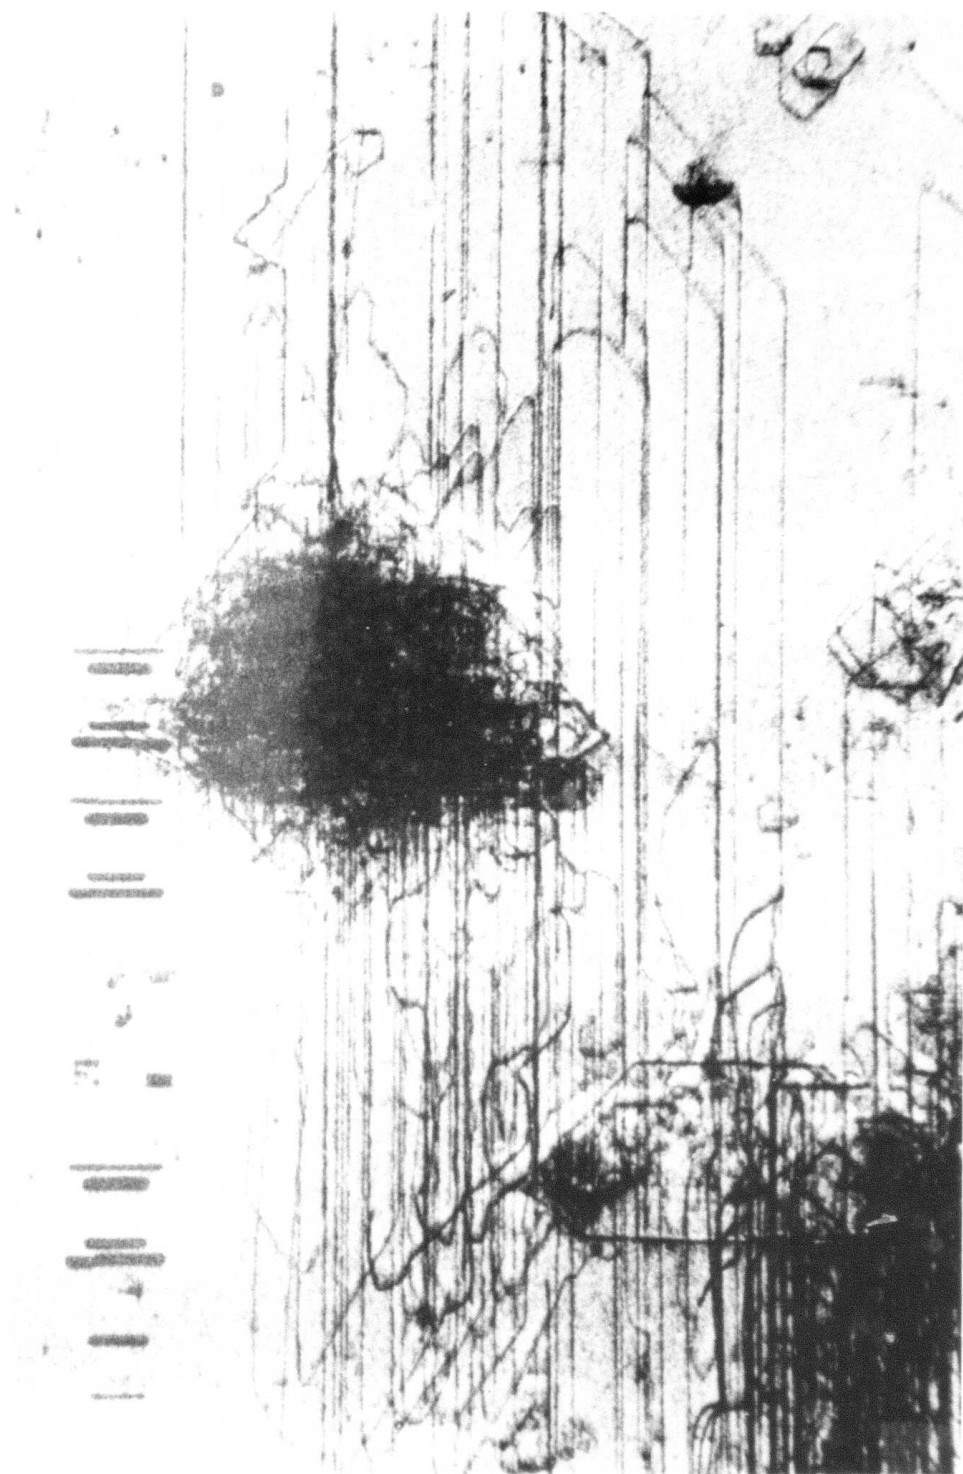
The wafer containing the center patch of dark current was selected for study by x-ray topography and transmission electron microscopy. Transmission topographs of this wafer showed that the center patch of dark current was caused by dislocations introduced from the backside of the wafer (Figure 7). Comparison of this topograph with others taken on other slices processed in the same batch showed that the origin of the backside damage was in the process. In contrast to the float-zoned slice, the dislocations induced in the Czochralski slices were confined to the backside and did not propagate to the front surface. It should be noted that the process used has been optimized for Czochralski wafers. Enlargements made from the transmission topographs show the propagation of the dislocations from the backside to the frontside (Figure 8).

Figure 8 Enlargement of (220) Transmission Topograph Showing Dislocations Emanating from Backside-Damaged Regions

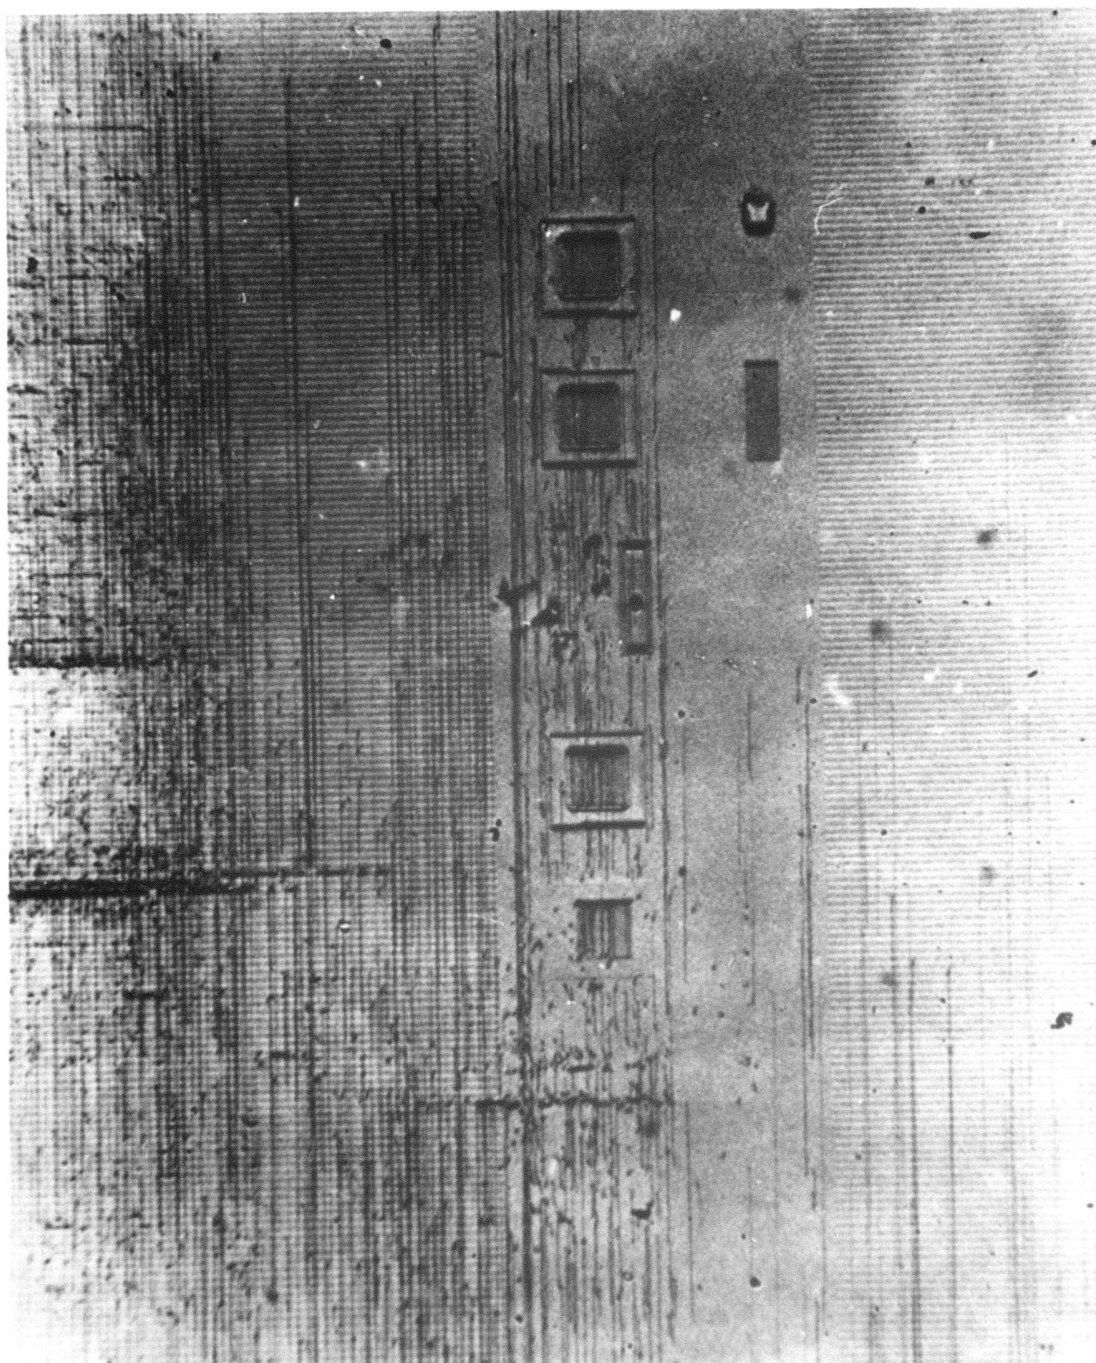
Figure 9 Enlargement of (224) Reflection Topograph of Dislocated Region in Float-Zoned Region

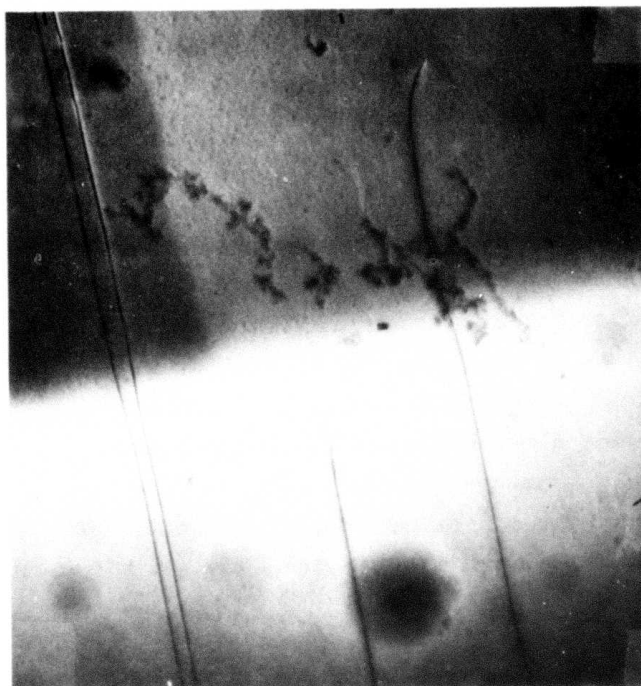
type, i.e., their Burgers vectors are in  $\langle 110 \rangle$  directions that do not lie in the plane of the surface (Figure 10).

Figure 10 Transmission Electron Micrograph of 60° Dislocations Near Front Surface of Float-Zoned Wafer

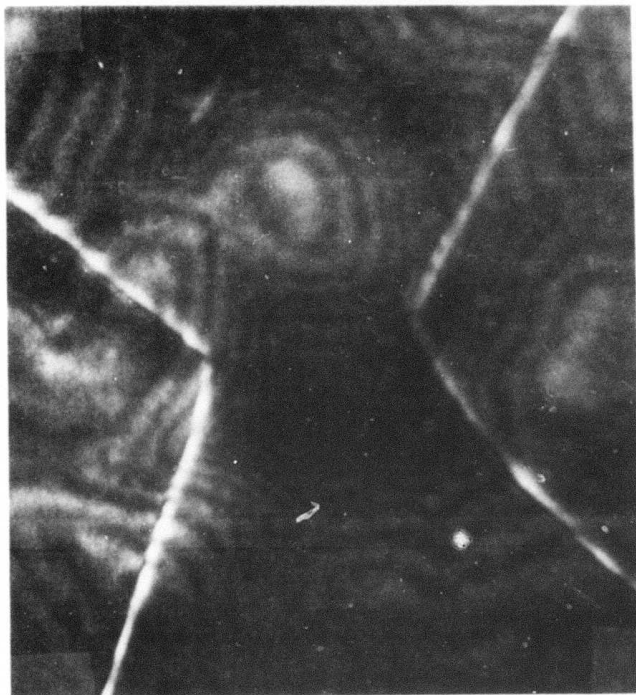
Figure 11 Dark Field Transmission Electron Micrograph of Float-Zoned Wafer Showing Dislocation Reaction. Two perpendicular  $60^\circ$  dislocations moving on two different slip planes, but with the same Burgers vectors, have reacted to form nearly right-angle configuration.

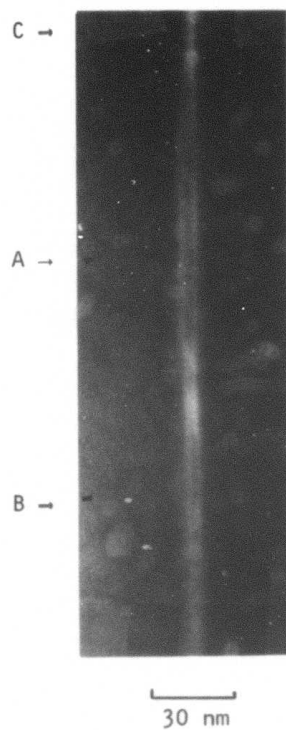
Three of these dislocations have been examined using the weak beam method.<sup>2</sup> All these dislocations were found to be extensively dissociated; a typical example is shown in Figure 12. The separation at A in this image is 65 Å. Since the partial dislocations lie on an inclined  $(111)$  plane, their true separation is approximately 100 Å. At B in this same figure the dislocations also appear to be dissociated by approximately 50 Å. At C there is a constriction where the dislocation is not dissociated.

Figure 12 Weak Beam (400) Micrograph of Partially Dissociated Dislocation. Separation in image at A is 6.5 nm, 3.5 nm at B, and no dissociation at C.

The dissociation in Figure 12 proceeds according to the reaction.  $\frac{1}{2}\langle 101 \rangle \rightarrow \frac{1}{6}\langle 21\bar{1} \rangle + \frac{1}{6}\langle 112 \rangle$ . The two partial dislocations are separated by a stacking fault on the (111) plane. The Burgers vectors and dislocation line orientation of both the perfect and partial dislocations are also found in this same plane. A similar situation exists for any dislocation that is in a configuration to move by a glide process.

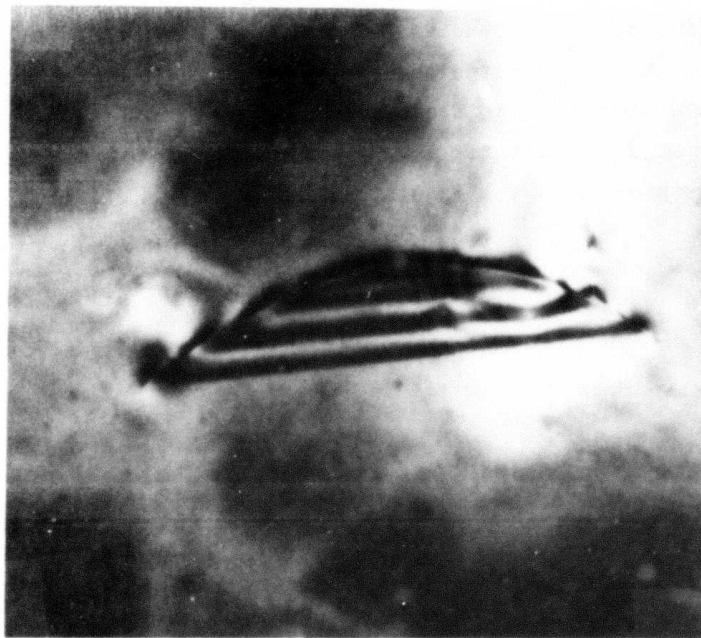
In addition to the dislocations, a small number of small stacking faults was observed in the channel stop (Figure 13). All the stacking faults were of the same length.

Figure 13 Transmission Electron Micrograph of Stacking Fault in Channel Stop of Float-Zoned Wafer

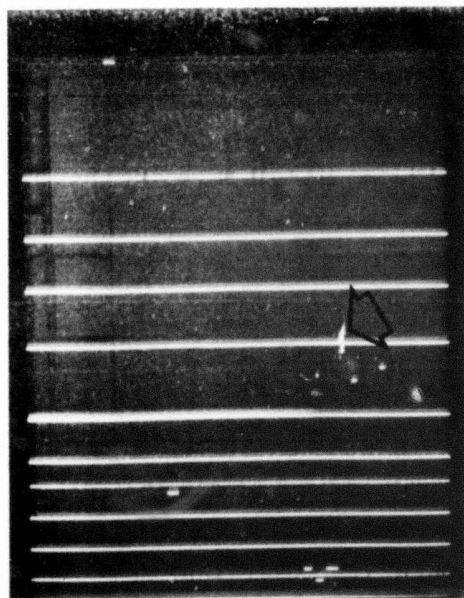
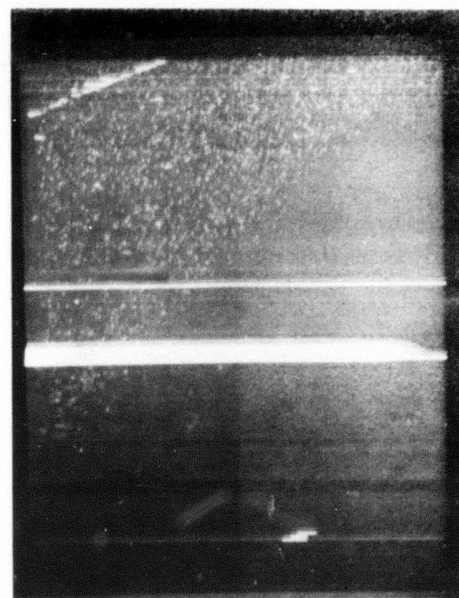
Dark current defect patterns in imagers on this material fell into two classifications. Near the periphery of the wafer there was a high density of defects in a discernible pattern [Figure 14(a)]. Devices in the center of the wafer showed a very low density of dark current defects. These frequently extended over more than one pixel [Figure 14(b)]. These slices had backside mechanical damage by sandblasting with glass beads over half the slice. There was a slight reduction in the defect density for imagers over the backside damaged portion of the slice. (See Table 1 of the last quarterly technical report.<sup>1</sup>)

Figure 14 Dark Current Patterns - Czochralski Group 1. Defect at arrow in (b) is shown in topograph, Figure 15 (a).

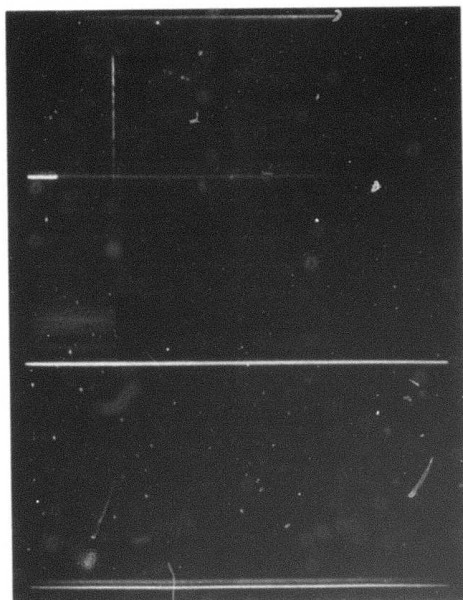
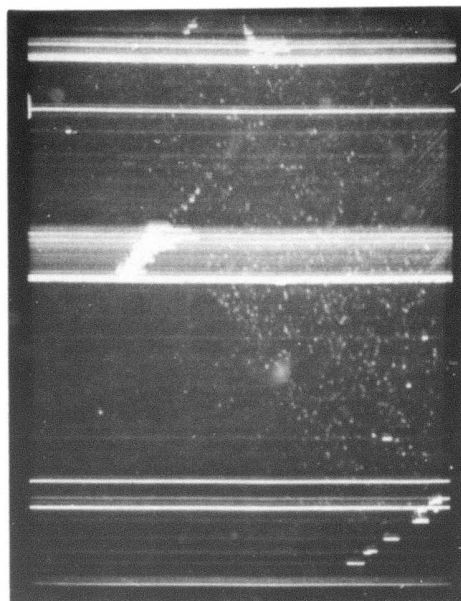
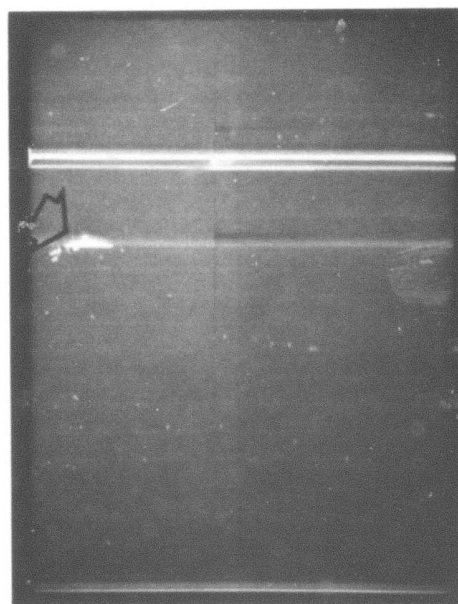
The dark current spike behavior of this material was similar to that of Czochralski - Group 1. Imagers at the periphery of the slice had a moderately high density of weak dark current spikes, many of which were in a discernible pattern (Figure 16), while those near the center of the slice had a relatively low density of dark current spikes. Backside mechanical damage by glass bead sandblasting had no discernible effect on the dark current spikes.

Figure 16 Dark Current Patterns of Three Adjacent Devices, Czochralski Group 2  
Defect at arrow in device 3 is shown in topograph, Figure 17.

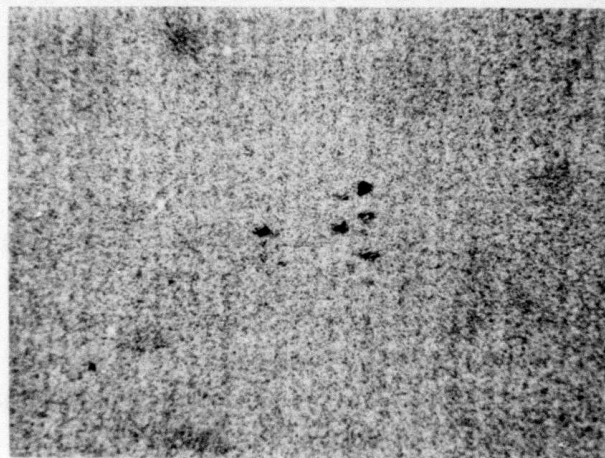
Only a few defects were imaged in reflection topography. These defects correlated with the more intense dark current spikes near the center of the slice. A typical example is shown in Figure 17, which correlates with the indicated dark current defect in device 3 of Figure 16. From the pattern of dark current defects of this type that were visible in the imagers and the topographs, it appears that their origin is frontside damage caused by handling of the slice before processing. (The backside damage was applied after the completion of the frontside polish.) No defects were imaged in reflection topography that correlated with the moderate number of dark current defects visible in some of the imagers.

Figure 17  $224$  Reflection Topograph of Dark Current Defects in Czochralski Group 2. Defect is marked in Figure 16, device 3.

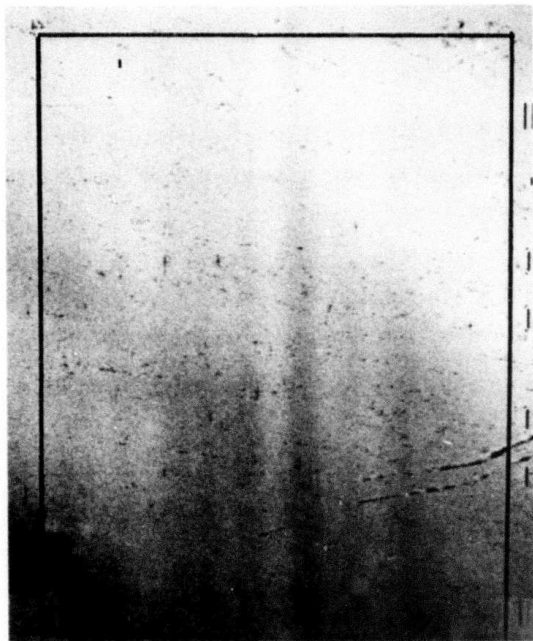
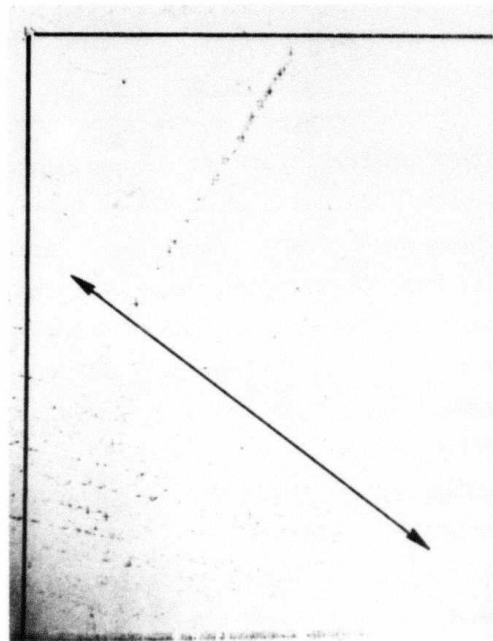
Figure 18 (220) Transmission Topograph of Two Devices Whose Dark Current Signature is Shown in Figure 16. Bulk swirl precipitation region is the darkening most noticeable in device 1. Arrow in device 2 indicates line above which there are numerous dark current defects. Black spots and lines on topograph are defects on the backside of the devices.

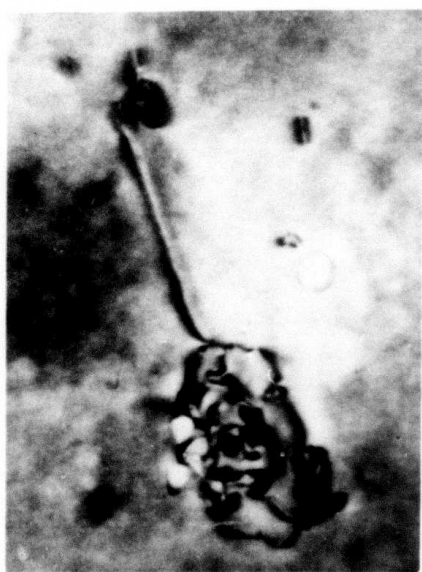
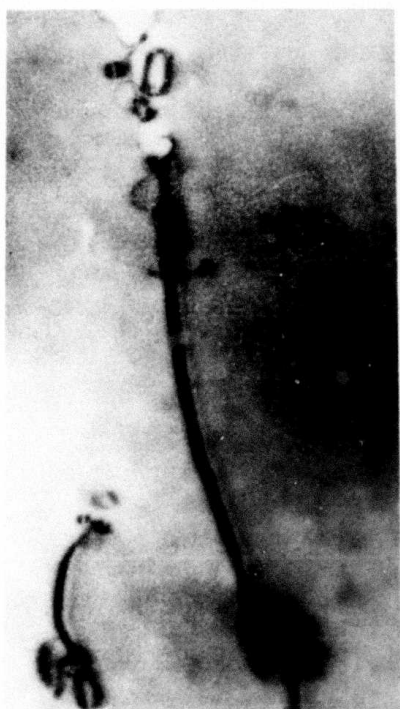
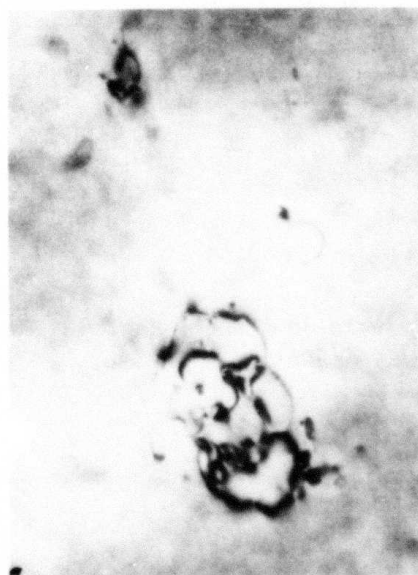
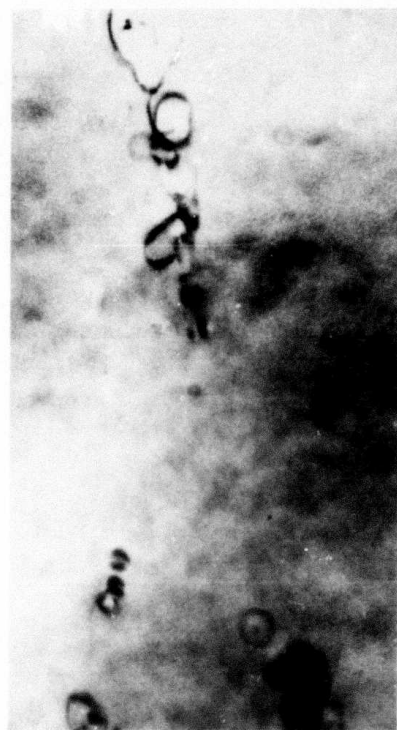
Samples taken from high defect regions of other devices had the dislocation clusters shown in Figure 20. Limited contrast experiments in the electron microscope showed that the long dislocation line in these clusters, which was oriented in a  $\langle 110 \rangle$  direction, was of pure edge type. All these dislocation clusters were located in the channel stop.

The defects that were imaged (Figure 20) appear to have originated from a stacking fault.

Figure 20 Dislocation Clusters in Channel Stop Region. The longer dislocation lines are pure edge.

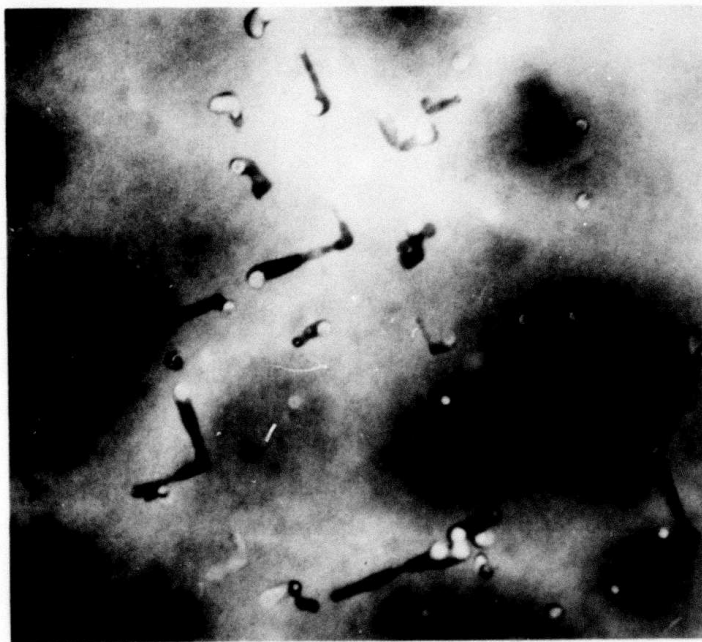
An additional type of defect was seen in the channels (Figure 21). These defects were located underneath the aluminum electrode and primarily near the edge of a neighboring polysilicon electrode. Their nature is not clear at this time.

Figure 21 Defects in Channel Region. The defect lines are oriented in  $\langle 100 \rangle$  directions.

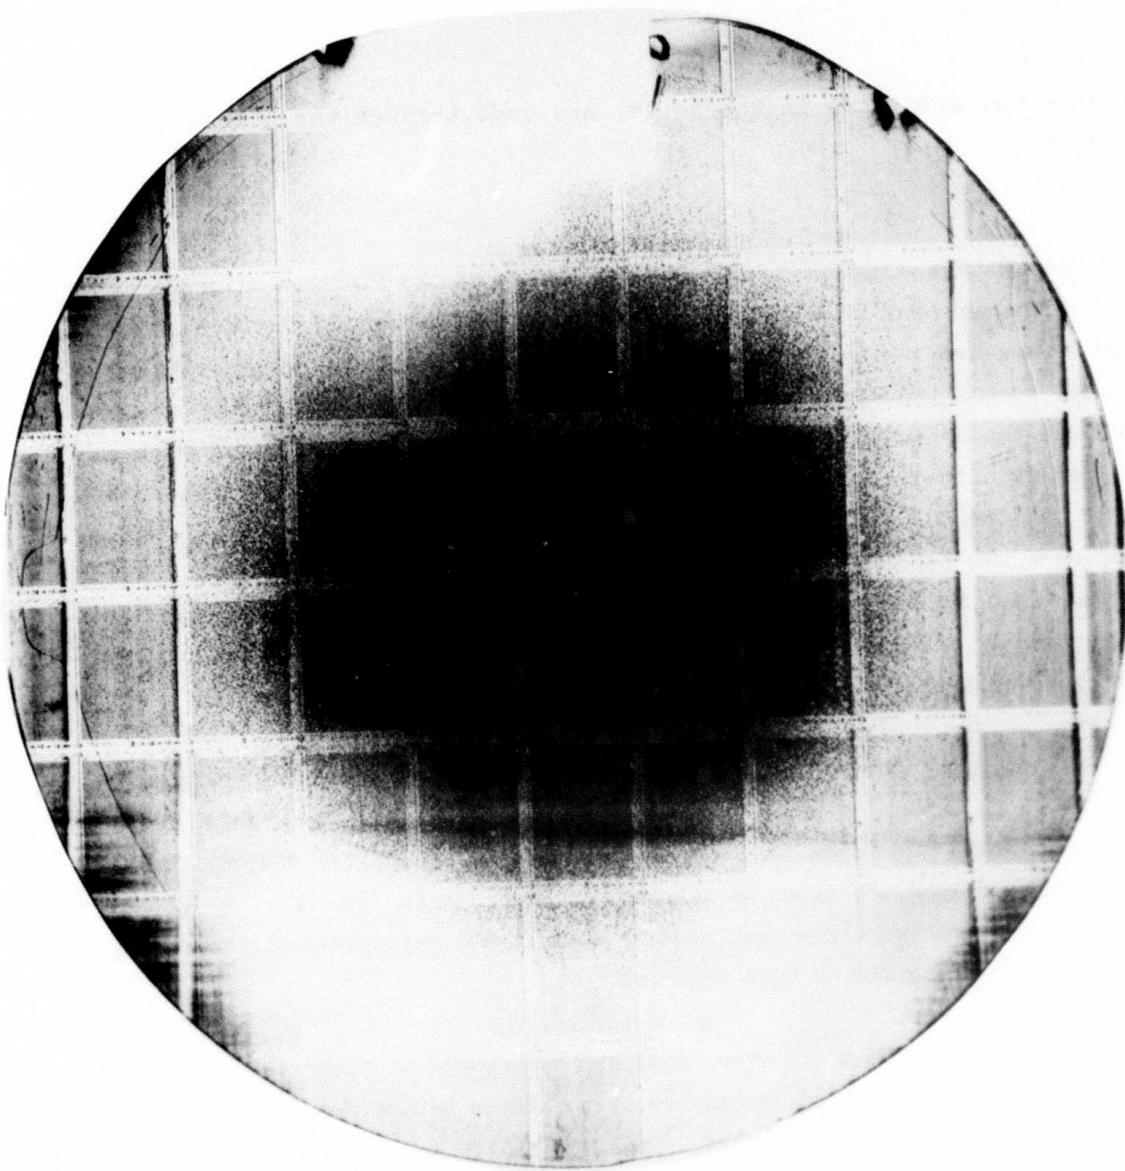
X-ray transmission topographs were taken of the finished slices (Figure 22). This superposition of device geometry with the damage pattern reveals that there are six devices at the slice center where the damage pattern is uniform across the whole device. At first sight, it would seem that one way to judge the effectiveness of ISS would be to compare the quality of these six devices with that of devices on the same slice that come from the outer, undamaged part. Such a comparison is invalid, however, because the slices that were not ISS-treated do not display a uniform density of dark current spikes (see Section II.C). Rather, the efficacy of ISS must be judged by a comparison of the center six devices on ISS-treated material with those on untreated material.

Figure 22 (220) Transmission Topograph Showing Pattern of ISS Backside Damage

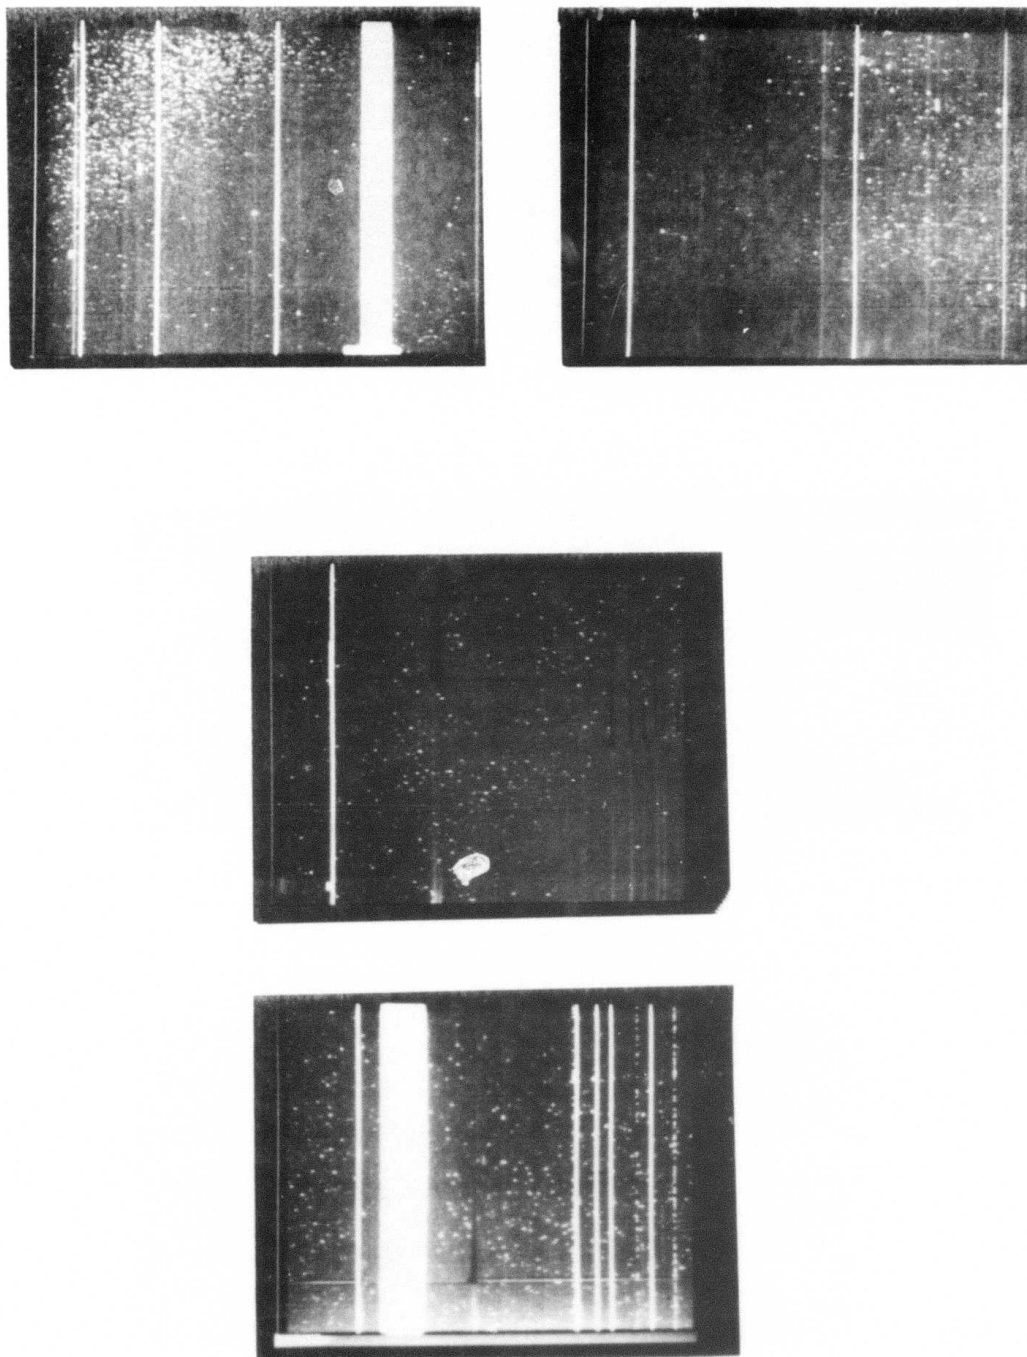
Typical results for the untreated control slices are shown in Figure 23. Here, two adjacent devices from two slices illustrate the range of dark current spikes found on the center six devices. Typical devices from the ISS-treated slices are shown in Figure 24. From these results, we conclude that the ISS treatment does not lead to significant improvement in the density of dark current spikes on this material.

Figure 23 Dark Current Readout of Typical Devices on Control Slices Not Treated with ISS

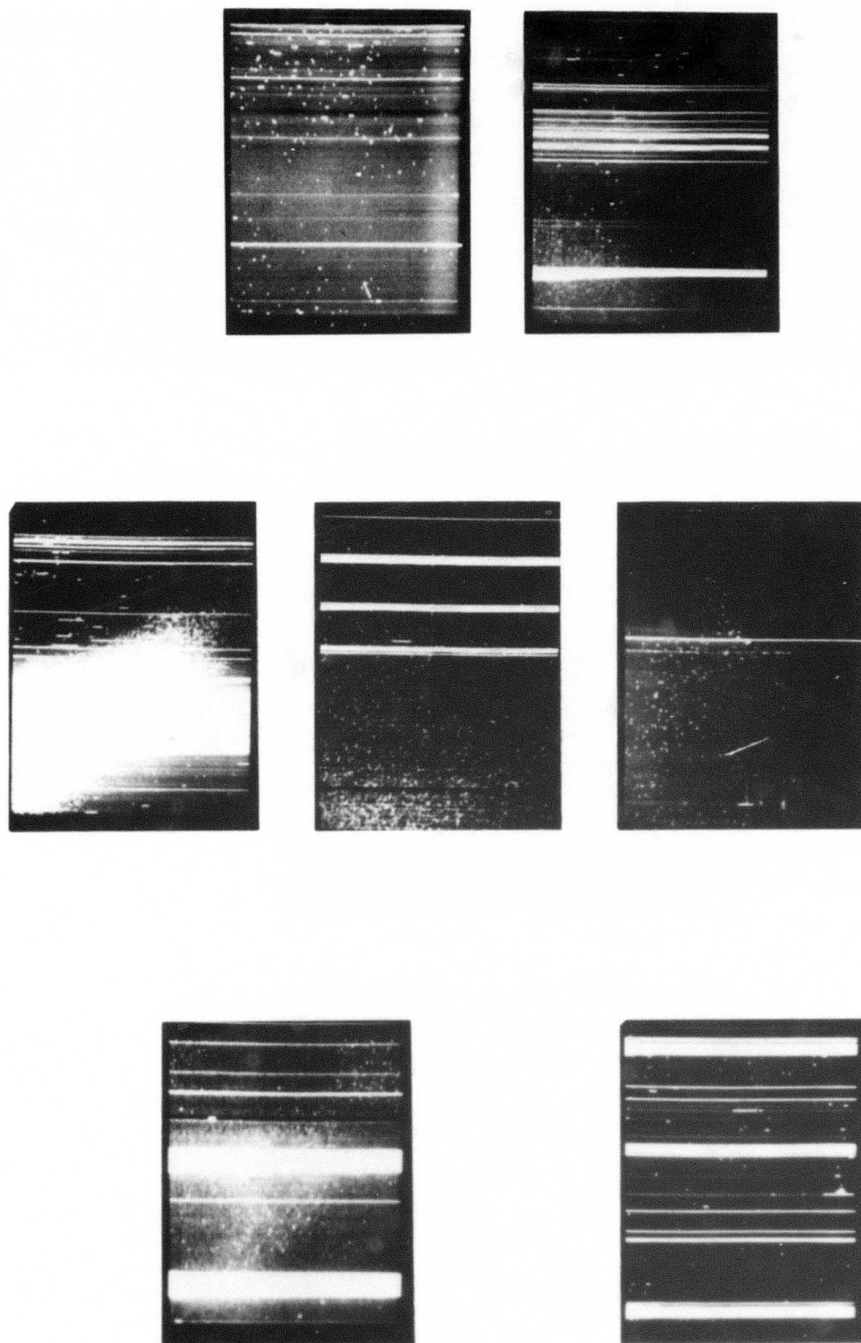
Figure 24 Dark Current Readout of Typical Devices from Slices Treated with the ISS Backside Damage
