# CONSTRUCTION FOUNDATION REPORT

**SOUTH PLATTE RIVER BASIN  
BEAR CREEK LAKE, COLORADO**

**VOLUME I  
TEXT AND PHOTOS**

**US Army Corps  
of Engineers**  
Omaha District

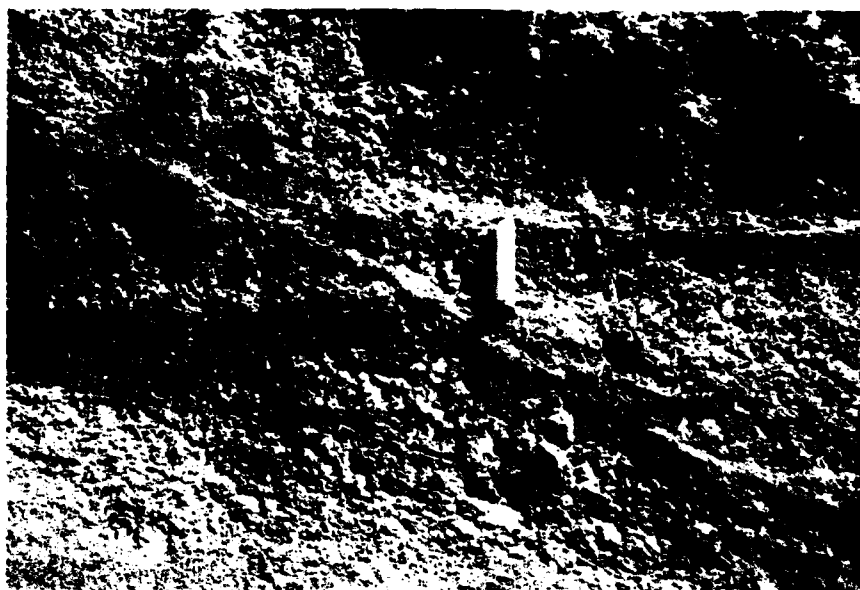
PHOTO NO. 23. Fault with 1' displacement on right face, Sta. 8+33, el. 5503. Looking south. 4/24/75.
