TECHNICAL REPORT ARLCB-TR-83022

**METALLOGRAPHIC STUDIES OF EROSION  
AND THERMO-CHEMICAL CRACKING  
OF CANNON TUBES**

**R. M. FISHER  
A. SZIRMAE  
M. H. KAMDAR**

**MAY 1983**

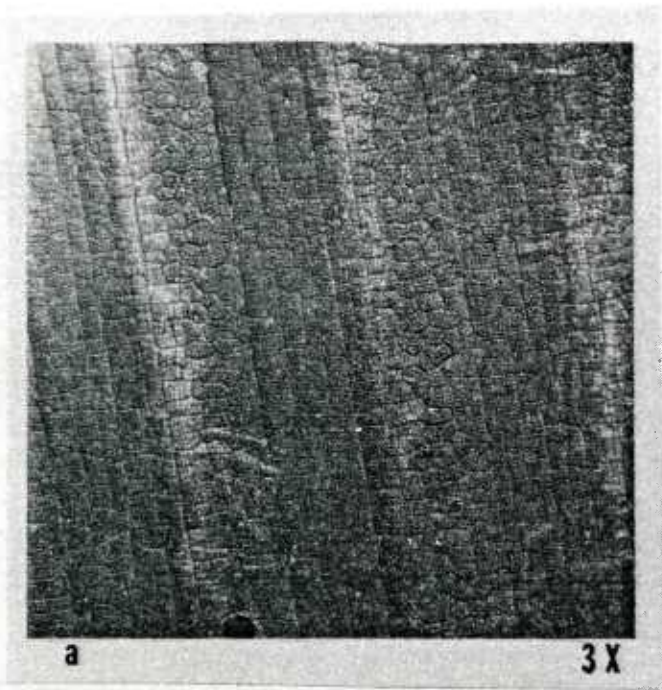
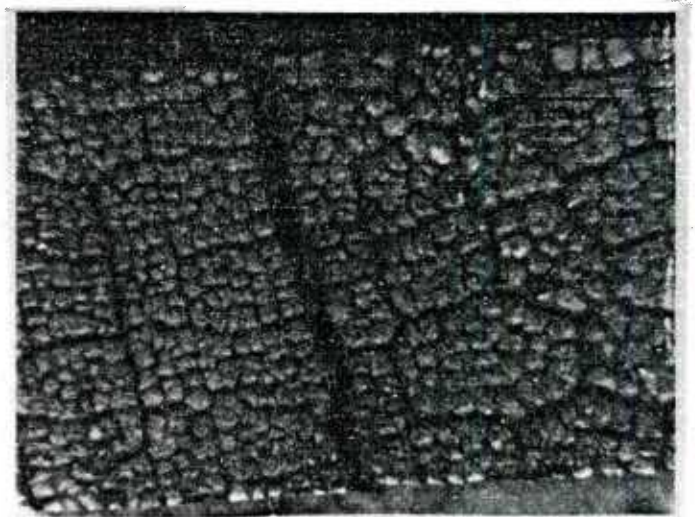
Figure 1. Cannon Tube T-45, Bore Surface.

The characteristic heat-checking pattern and deep cracks parallel to the rifling are illustrated in Figure 1. The bright areas are abrasion marks caused by the rotating Cu band. The appearance of this surface in the SEM is shown in Figure 2, along with an EDX spectrum illustrating the occurrence of a considerable amount of Ti and lesser concentrations of Al, S, K, and Cu. Point-to-point probing revealed that the Fe signal from the steel base largely came from the spaces between the hillocks and that the Cu was associated with the abrasion marks.

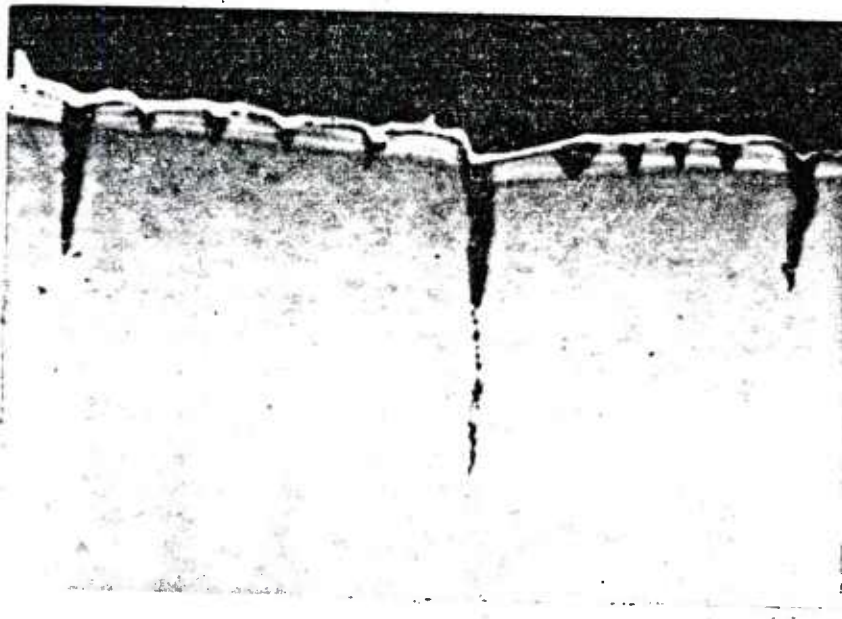
Figure 3. Cannon Tube T-45, Cross-Section. (50X)

A Ni plated, polished, and lightly etched cross-section of sample T-45, illustrating the alternating pattern of shallow, deep, and very deep cracks that is typical of fired cannons, is shown in Figure 3.

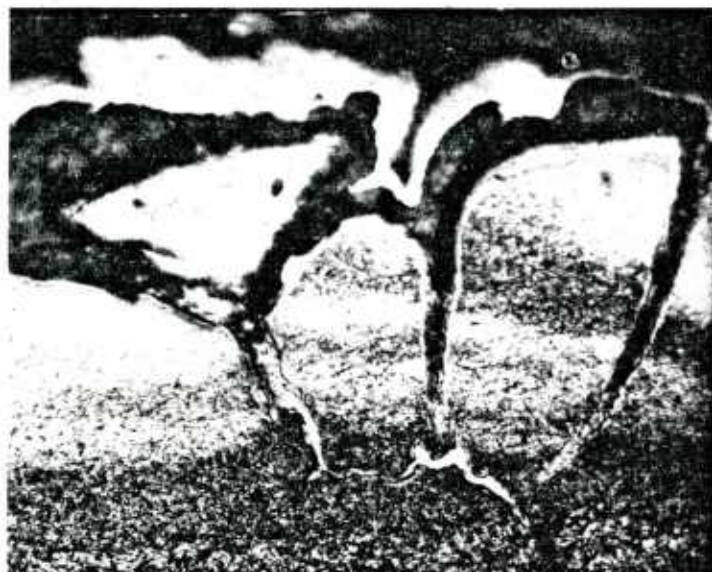
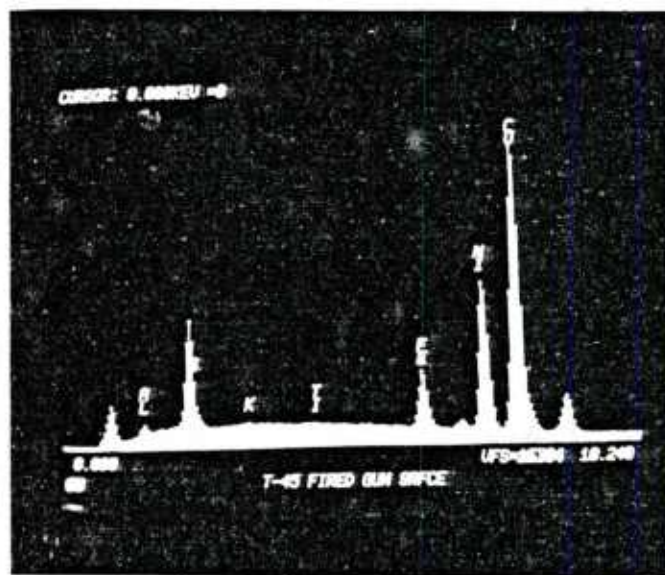
Figure 4. Cannon Tube T-45, Taper Sections.

The near-surface structure of this sample can be seen in more detail in the optical micrograph of a 15° taper section shown in Figure 4a. EDXS analysis of this same area in the SEM revealed that a considerable amount of Cu, and some S and Al were present in the altered ferrite region below the white layers. Penetration of Ni during plating demonstrated that these cracks were open to the bore surface.

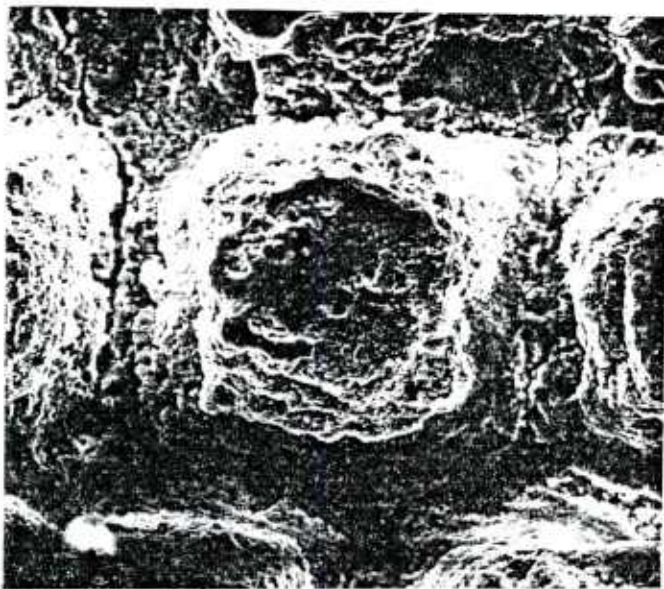
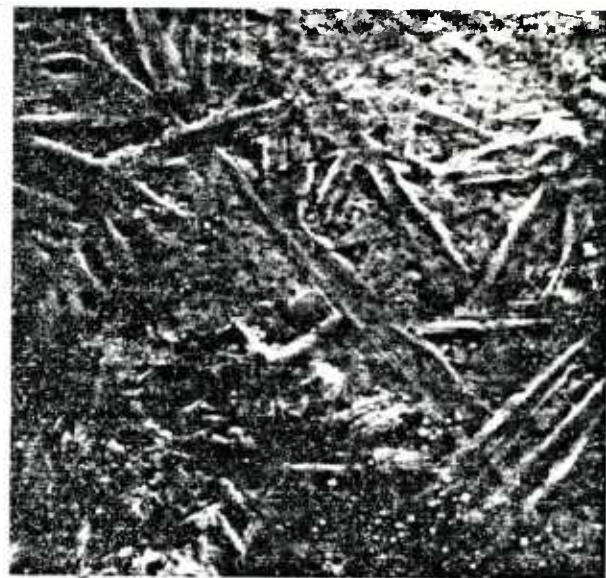
Figure 5. Cannon Tube 6326, Bore Surface.

Examination of the bore surface of cannon tube 6826 (no additive in the propellant) in the SEM revealed a rather different appearance, as illustrated in Figure 5. The small crystals visible on the surface at higher magnification were suspected to be cementite ( $\text{Fe}_3\text{C}$ ). This opinion was confirmed by subsequent Auger, Mossbauer, and SIMS analyses of the surface, and by stripping the surface film and obtaining direct electron diffraction evidence for  $\text{Fe}_3\text{C}$ .

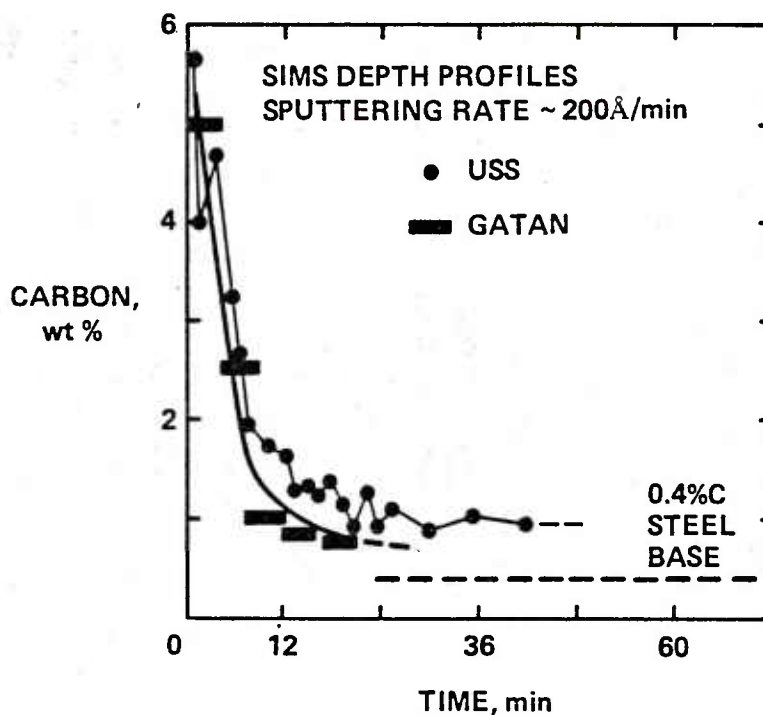
Figure 6. Cannon Tube 6826, Bore Surface.

The carbon concentration in the white layer region was determined by several techniques including a Mossbauer surface analysis method, depth profiling by Auger and SIMS, and profiles on cross-sections by electron probe analysis using a special light element detector. All of these methods indicated the presence of 0.25 to 0.5  $\mu\text{m}$  of  $\text{Fe}_3\text{C}$  on the surface and a subsurface layer of about 2 to 10  $\mu\text{m}$  of austenite containing two percent carbon near the surface and about one percent carbon in the interior. The very rough surface of eroded corrosion tubes precludes obtaining more than an estimate of the thicknesses of the white layer constituents by profiling. An example of a SIMS depth profile is illustrated in Figure 6.

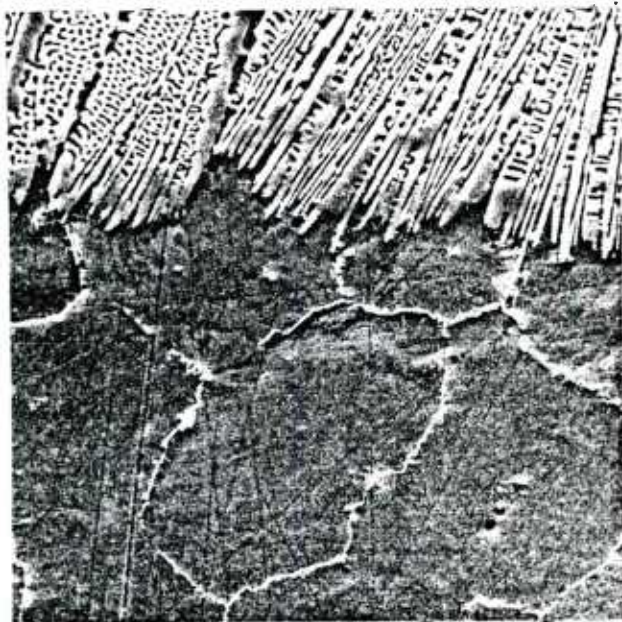
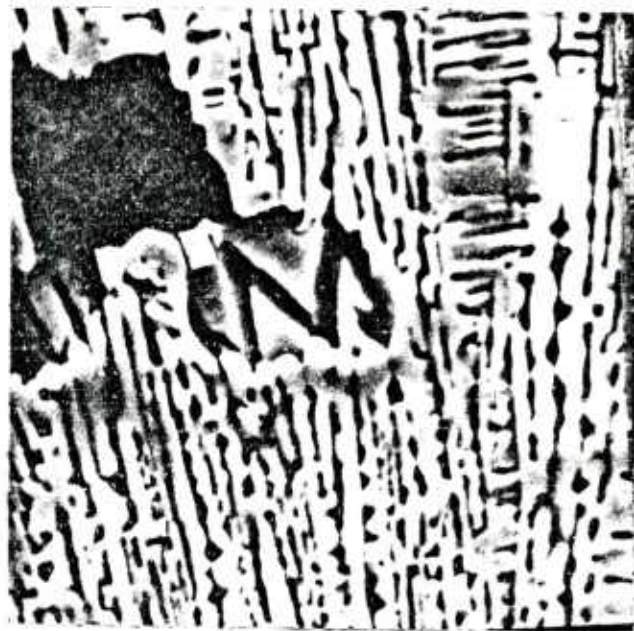
Figure 7. Simulation Specimen Pulse Heated in Methane.

The effects of chemical alteration of the surface of 4340 steel during pulse heating in high pressure methane are illustrated in Figure 7. Polished and etched 6° taper sections reveal the appearance of the surface eutectic structure (with pools of austenite) and the grain boundary carbides in the subsurface austenite. The very fine scale of the eutectic suggests an extremely rapid solidification rate. An example of transformation of a surface austenite pool to martensite is illustrated in Figure 7a.

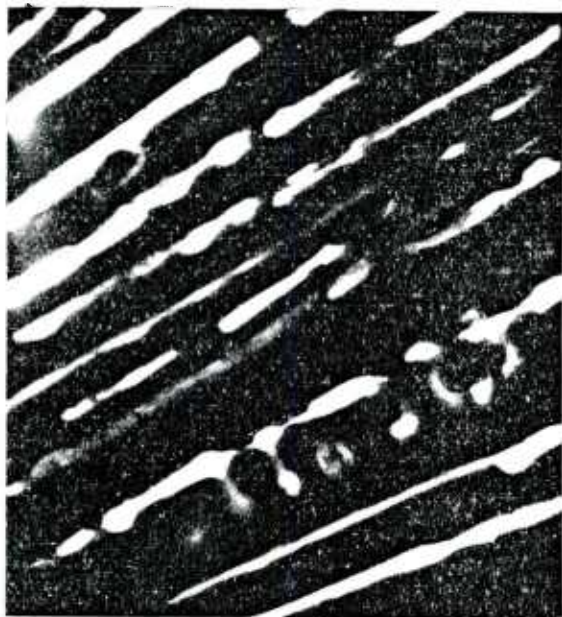
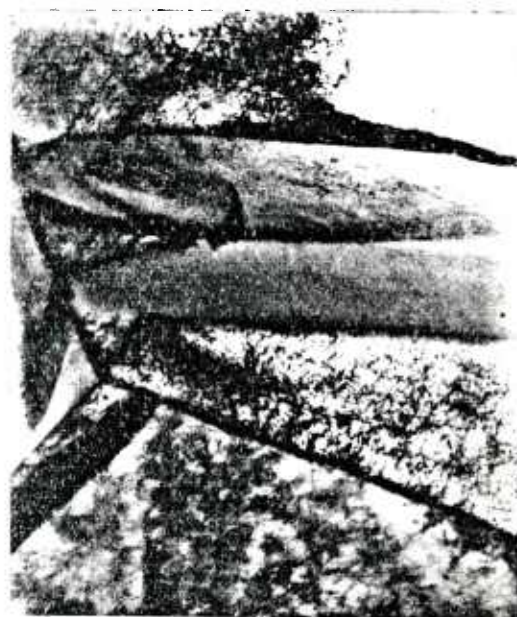
Figure 8. Simulation Specimen Pulse Heated in Methane.

Transmission electron micrographs illustrating the lamellar structure of the surface carbide film and an example of the high carbon plate martensite which formed in the subsurface austenite region are shown in Figure 8. The electron diffraction pattern from this film confirmed that it was  $\text{Fe}_3\text{C}$ , i.e., identical to that observed for fired cannon specimens.

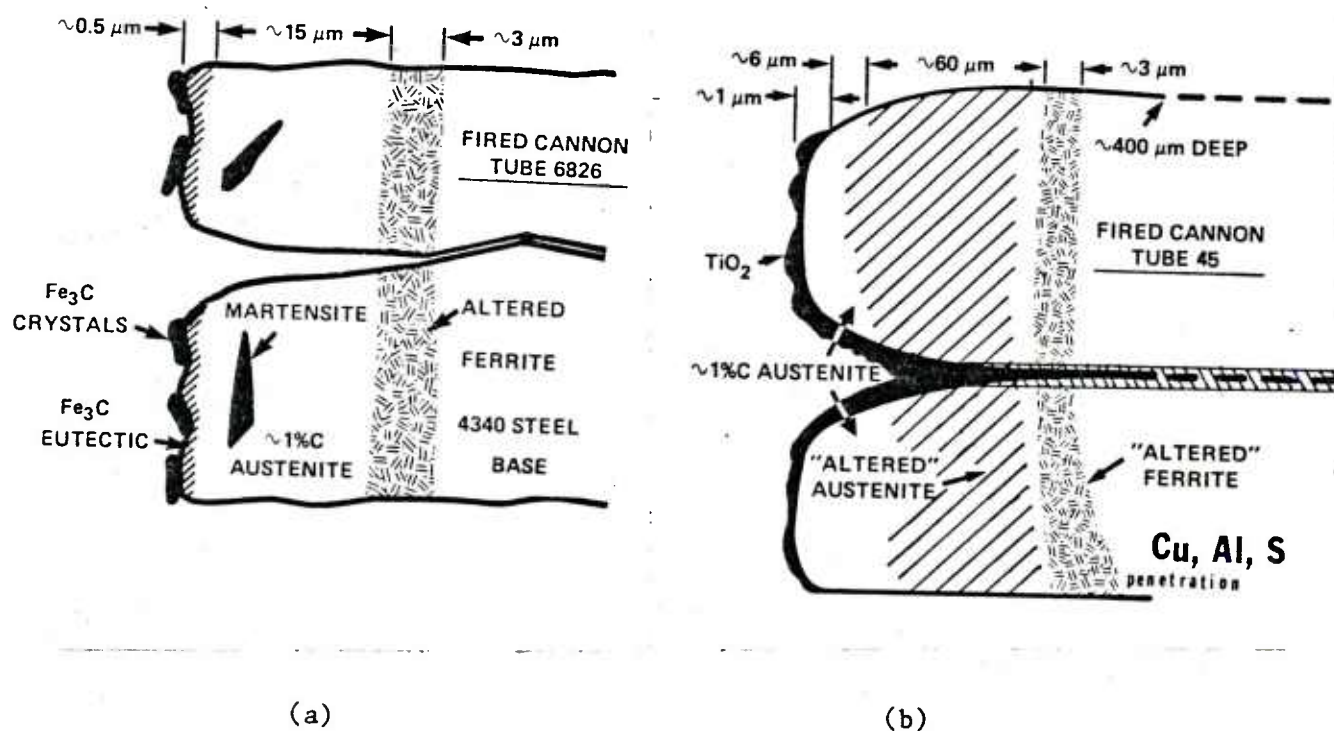
Figure 9. Schematic Illustration of Cannon Bore Surface.

The deep penetrating cracks in fired cannon tubes were found to contain Cu, and lesser amounts of Al and S right to the tip of the crack, i.e., more than 400  $\mu\text{m}$  in some cases. The results of all of the various observations and analyses of eroded bore surfaces from two cannons are summarized schematically in Figure 9.

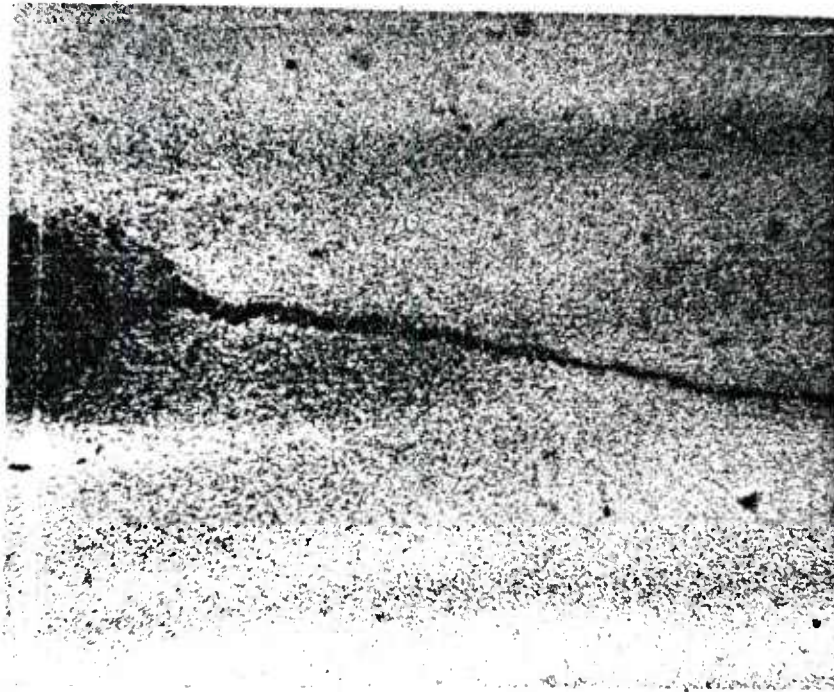
Figure 10. Notched, Cu Plated, and Pulse Heated 4340 Steel (50X).

The observations of Cu penetration deep into the longitudinal cracks prompted some analogous experiments to pulse-heat specimens that had been Cu plated. An example of the cracks that developed at the root of the notch (used to localize the heating) is shown in Figure 10. The presence of Cu could be detected by EDXS in the cracks but penetration to their tips did not occur in any of the pulse-heated specimens.

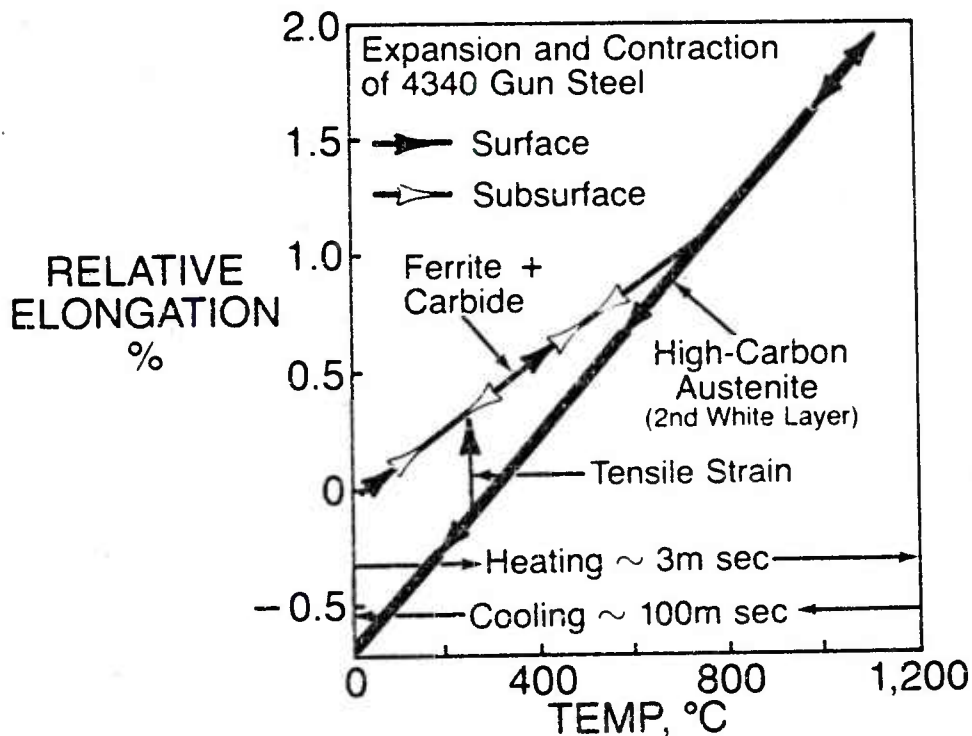
Figure 11. Illustration of Origin of Heat Checking.

### Heat Checking
