TECHNICAL REPORT SL-83-6

# AN EVALUATION OF THE SEPARATED BAY CONCEPT FOR A MUNITION ASSEMBLY COMPLEX; AN EXPERIMENTAL INVESTIGATION OF THE DEPARTMENT OF ENERGY BUILDING 12-64 COMPLEX

Structures Laboratory

September 1983

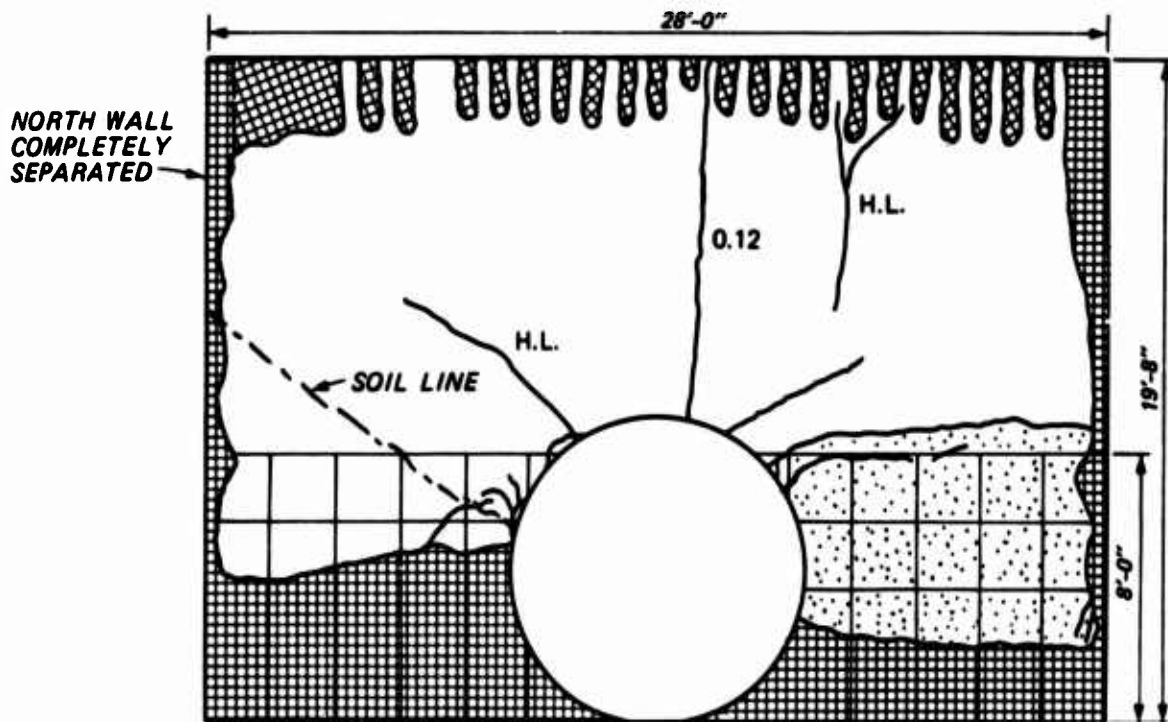
Figure 4.13. Posttest damage to east donor bay wall.

SIX #5 DOWELS REMAINED IN TOP OF WALL

- ☐ INNER FACE REINFORCEMENT EXPOSED DUE TO WALL ROTATION
- ▣ FRAGMENTED BUT NOT SPALLED
- ⊠ REBAR PULLED OUT OF CONCRETE
- H.L. HAIRLINE CRACKS

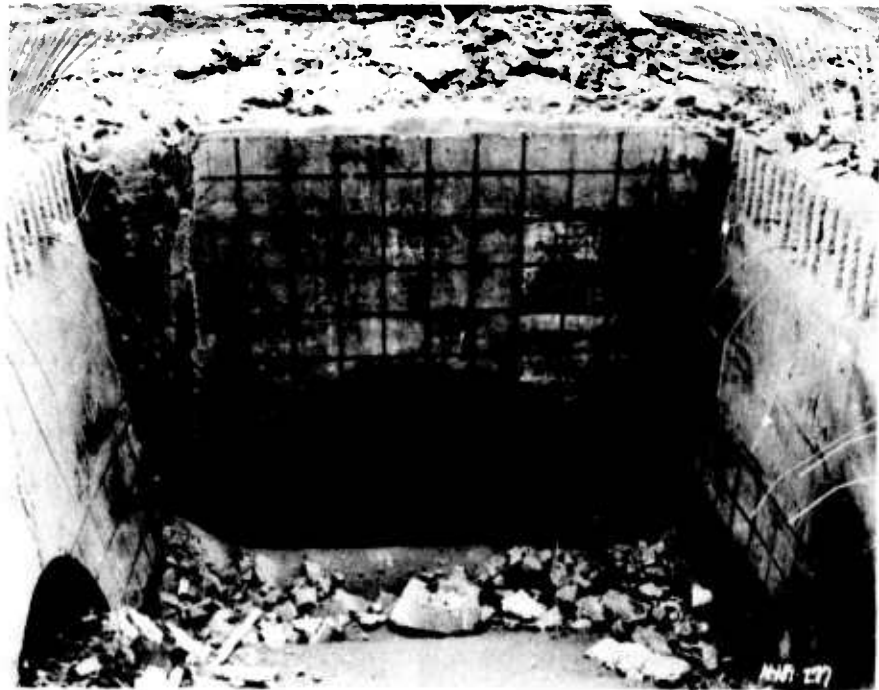
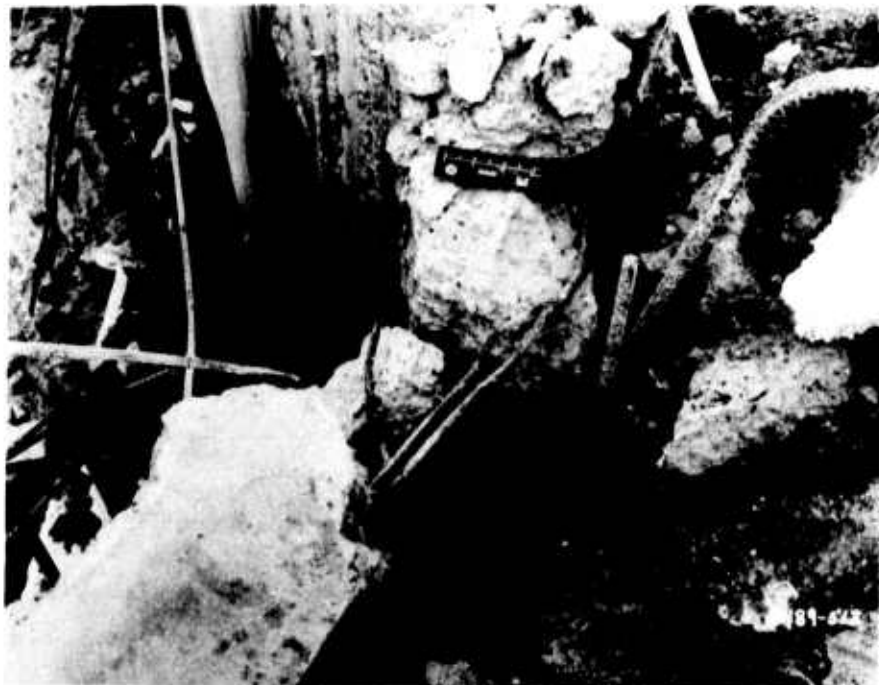
Figure 4.14. Posttest damage to donor bay south wall (Sheet 1 of 3).

a. Overall view.

b. Exterior of southeast corner.

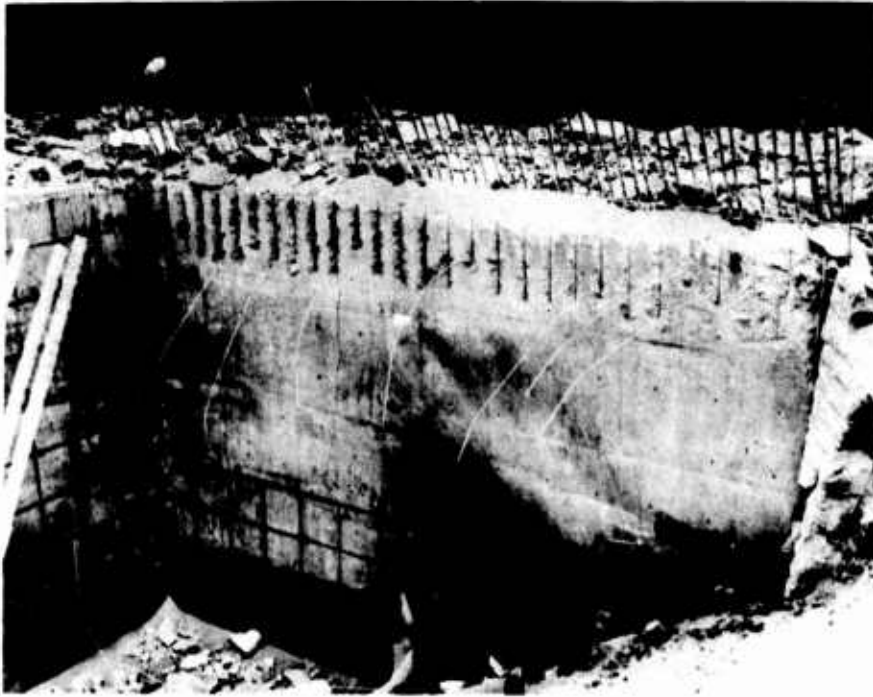
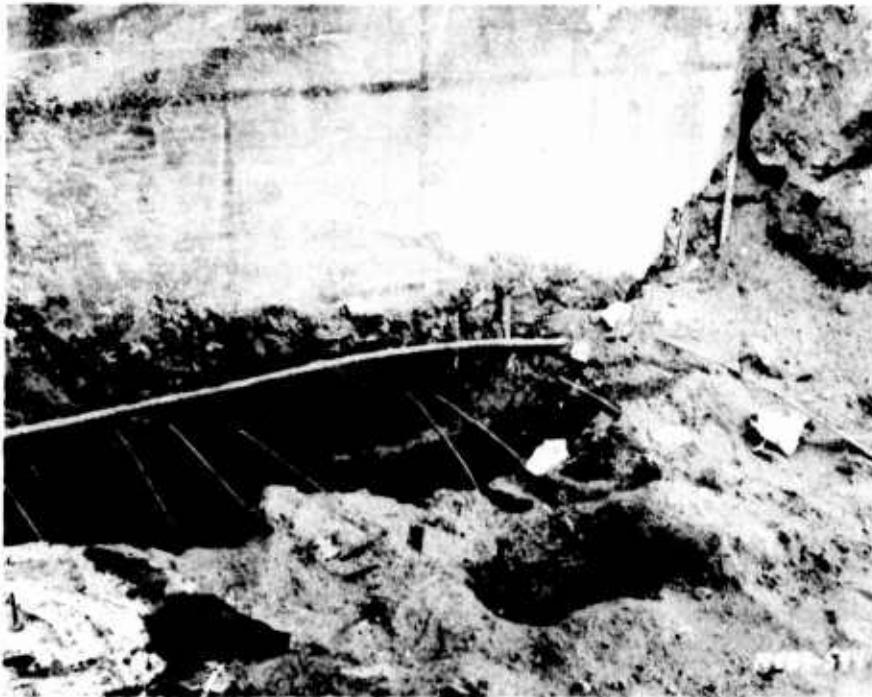
Figure 4.16. Posttest damage to west donor bay wall.

b. Base of wall at the north end.

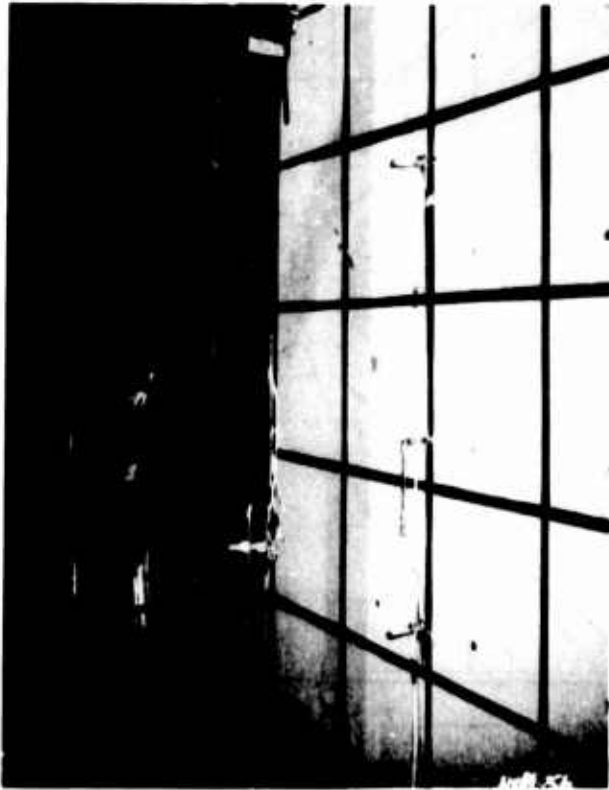
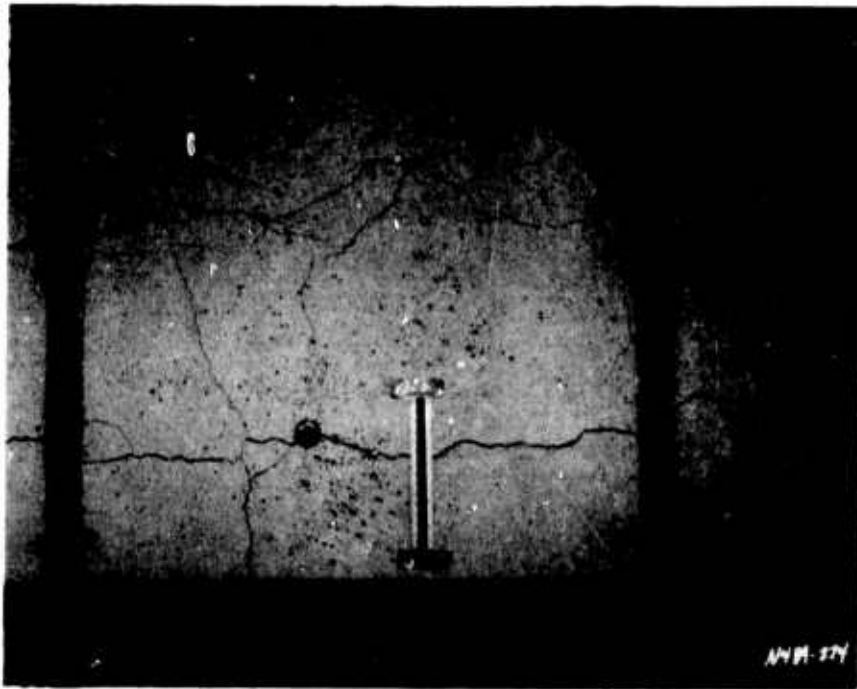
Figure 4.18. Posttest view of acceptor bay south wall.

b. Detail of widest cracks.

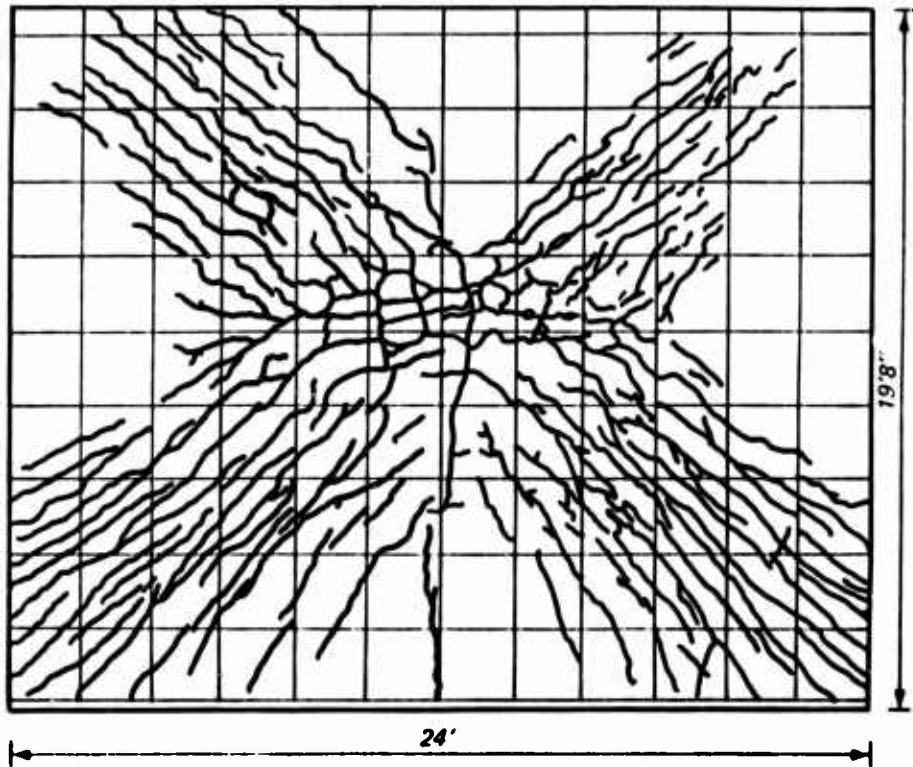
Figure 4.19. Posttest crack pattern on acceptor bay wall.

ALL CRACKS LESS THAN 1 mm WIDE  
 GRID IS 2 FEET ON CENTERS

The crack pattern and posttest deflections show that the acceptor bay wall responded in a flexural mode. This is consistent with the load distribution measured on the face of the wall. There was no indication of a punching shear failure.

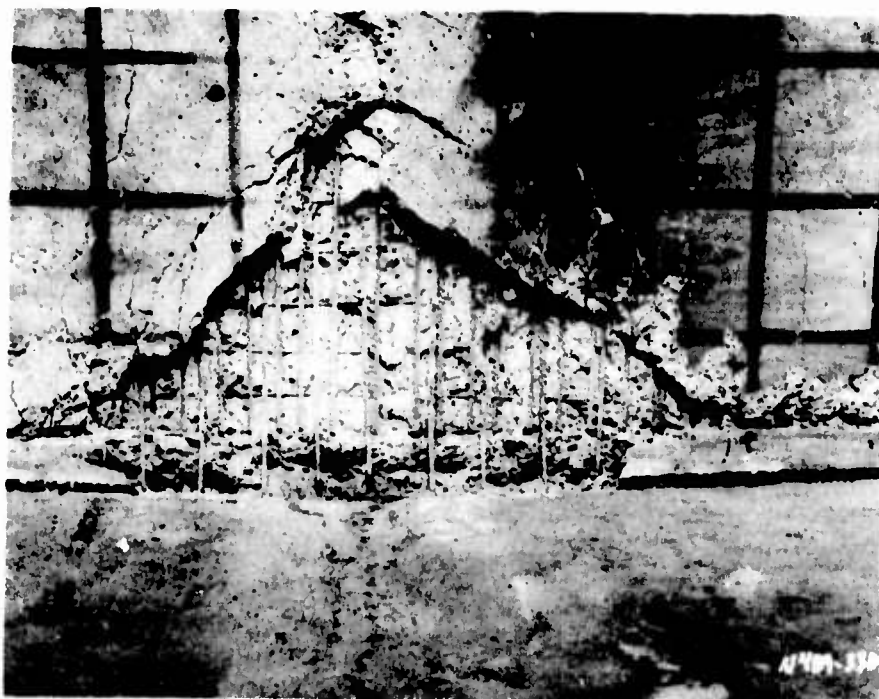
Figure 5.6. Posttest view of north donor bay wall  
(Sheet 1 of 2).

b. Damage adjacent to explosive charge.

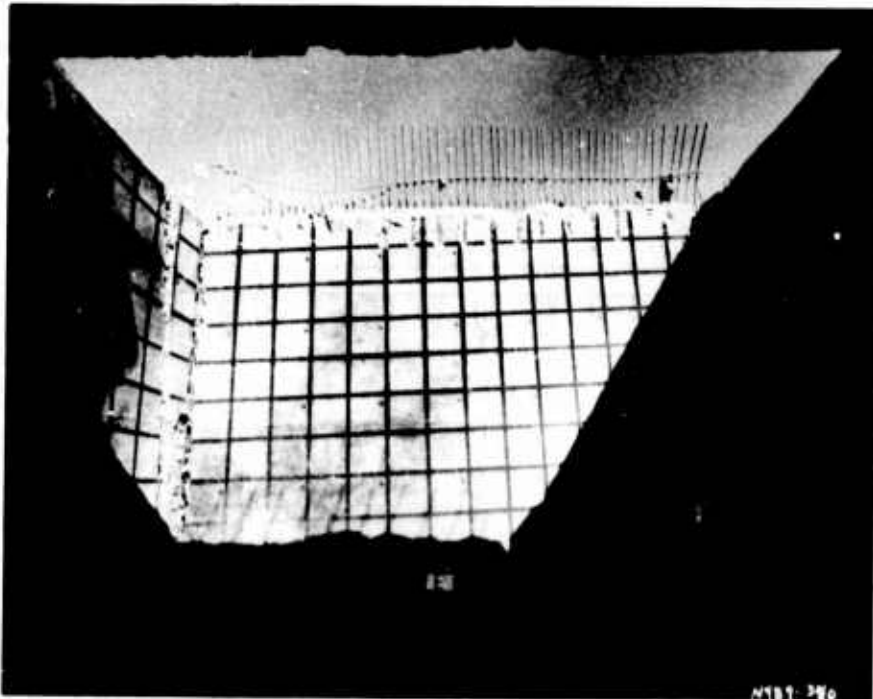
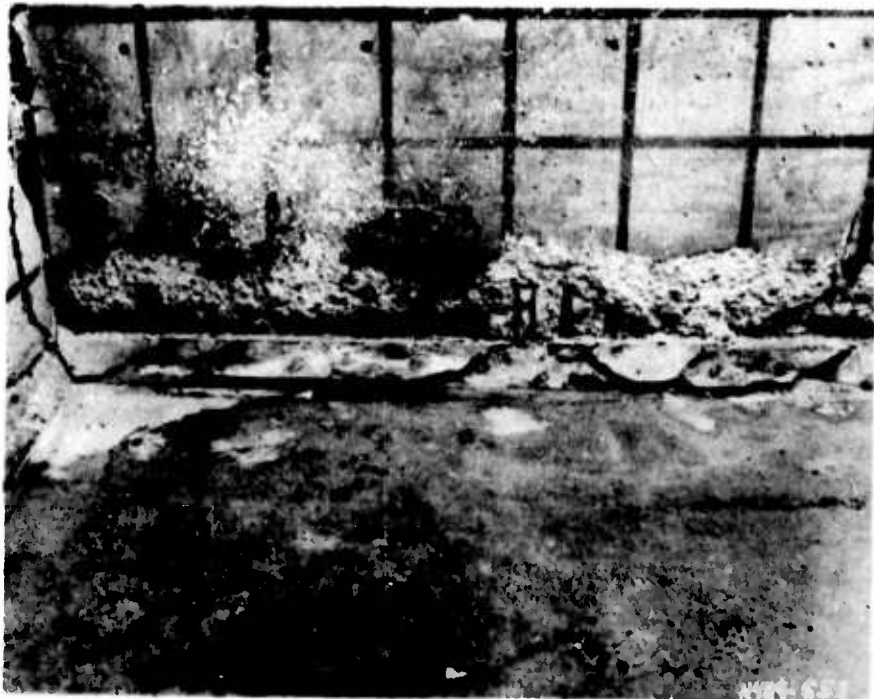
Figure 5.8. Posttest view of donor bay east wall.

b. Damage to lower north corner.

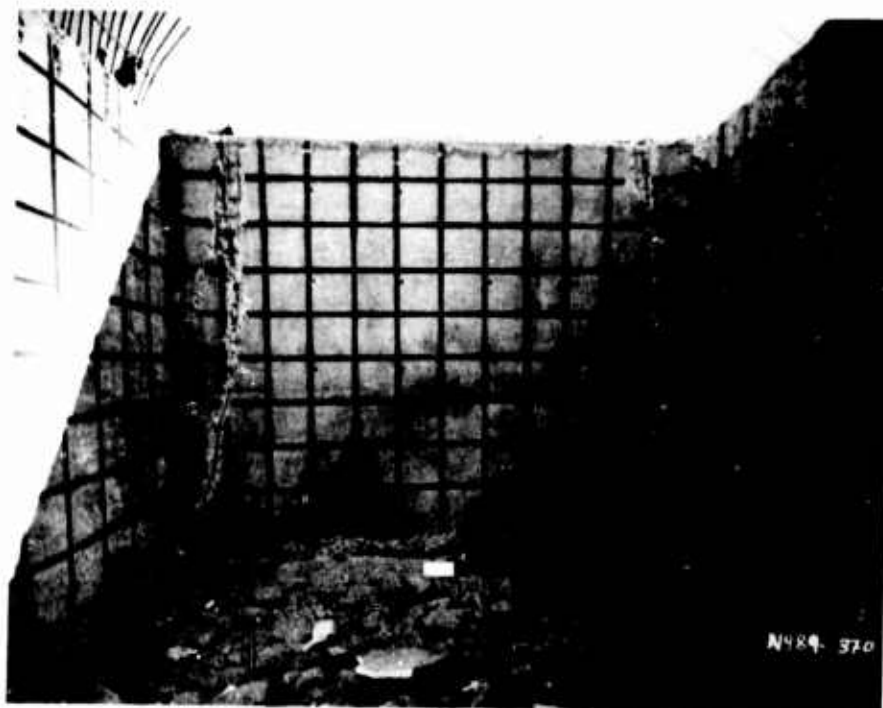
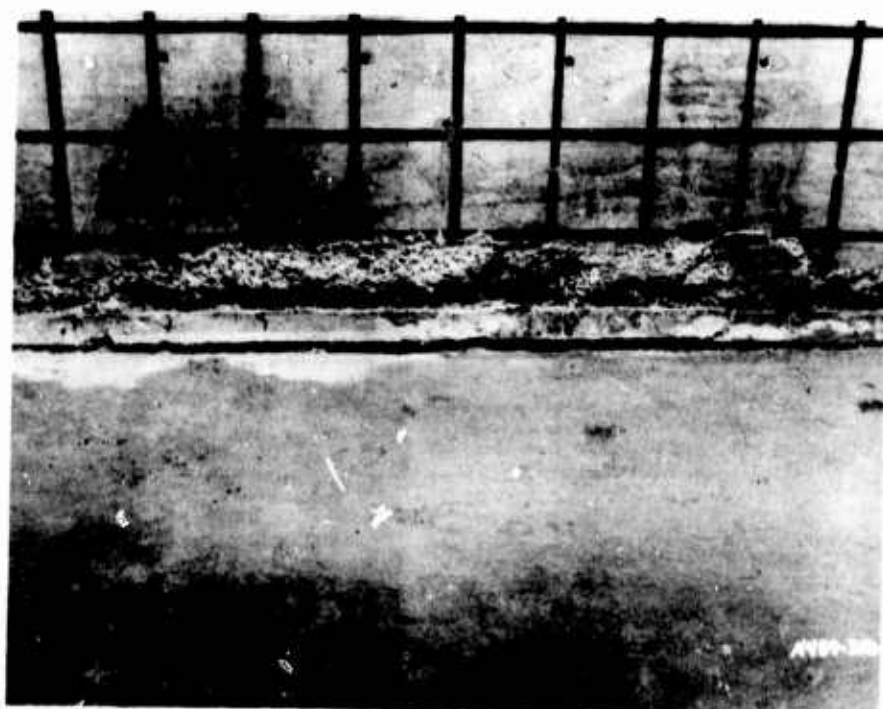
Figure 5.10. Posttest view of south donor bay wall  
(Sheet 1 of 2).

b. Damage to lower edge.

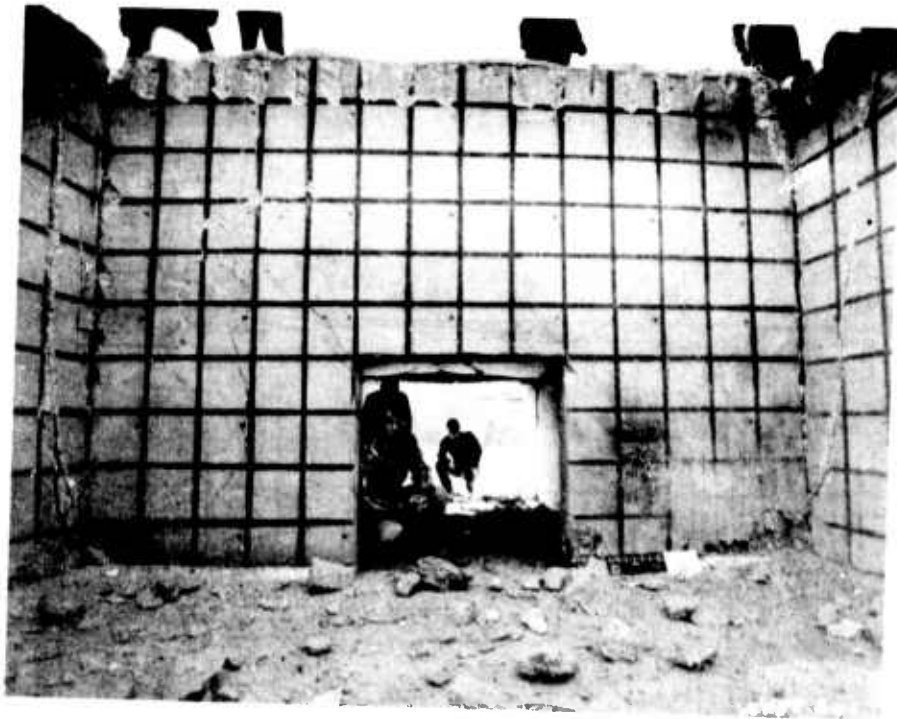
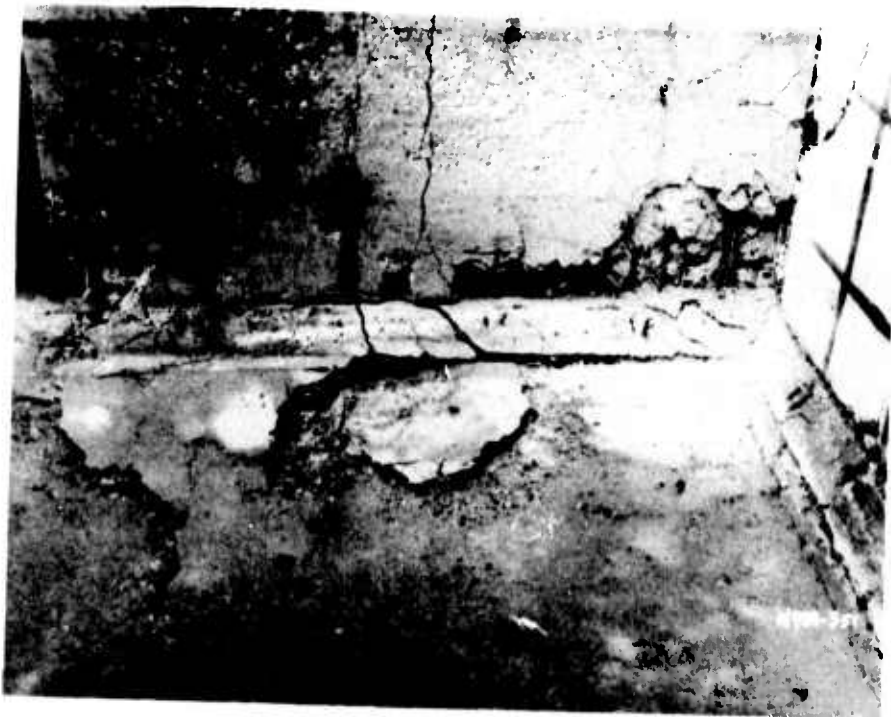
Figure 5.12. Posttest view of west donor bay wall.

b. Damage to lower north corner.

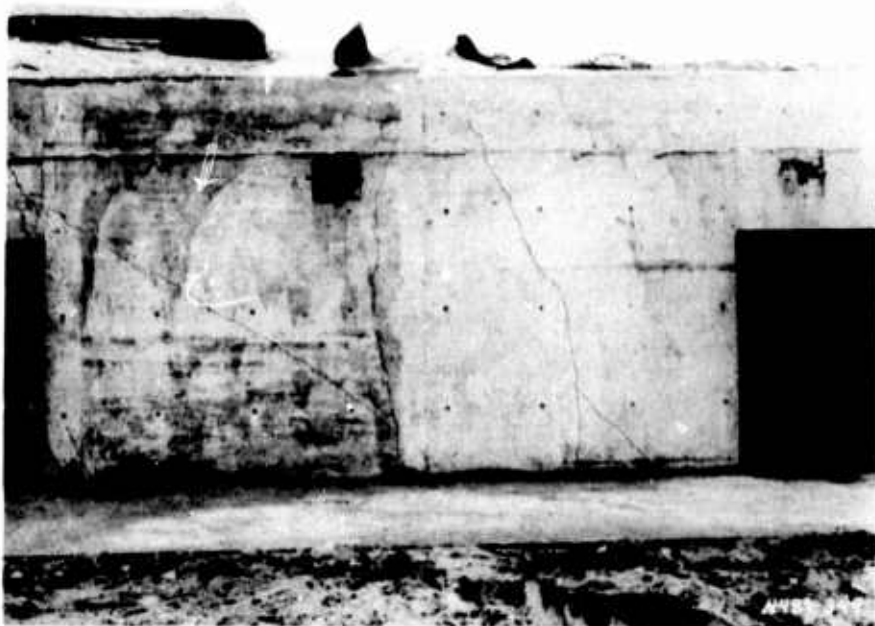
Figure 5.23. Posttest cracking in retaining wall.

b. South of donor air lock.

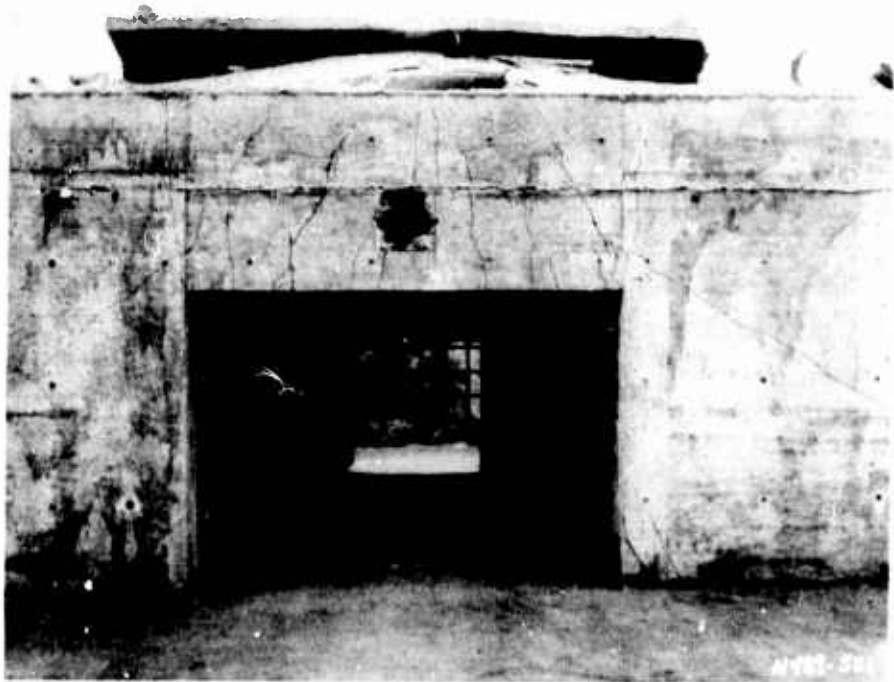
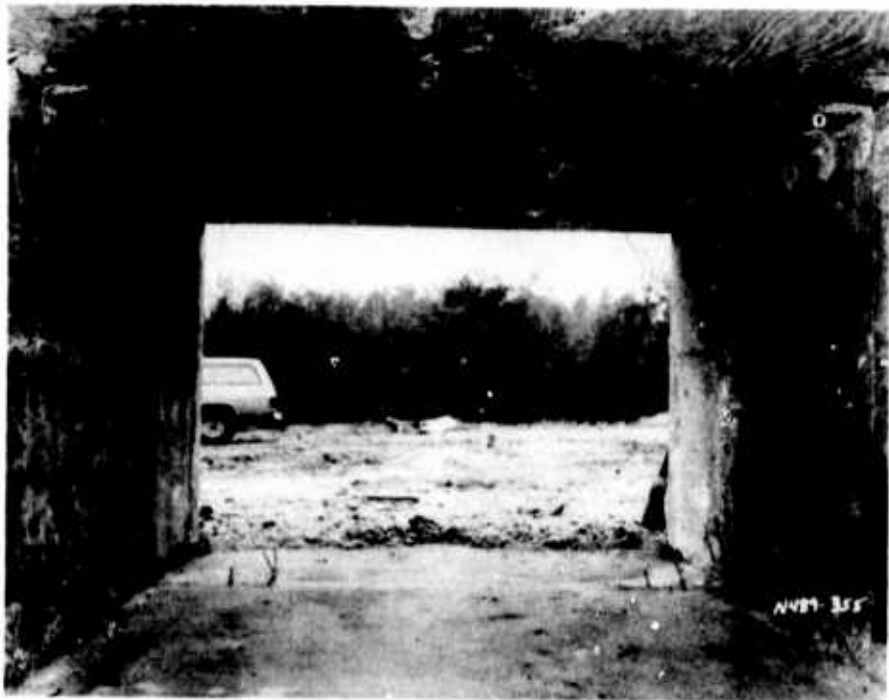
Figure 5.24. Damage to donor bay air lock.

b. Internal view at door bulkhead.

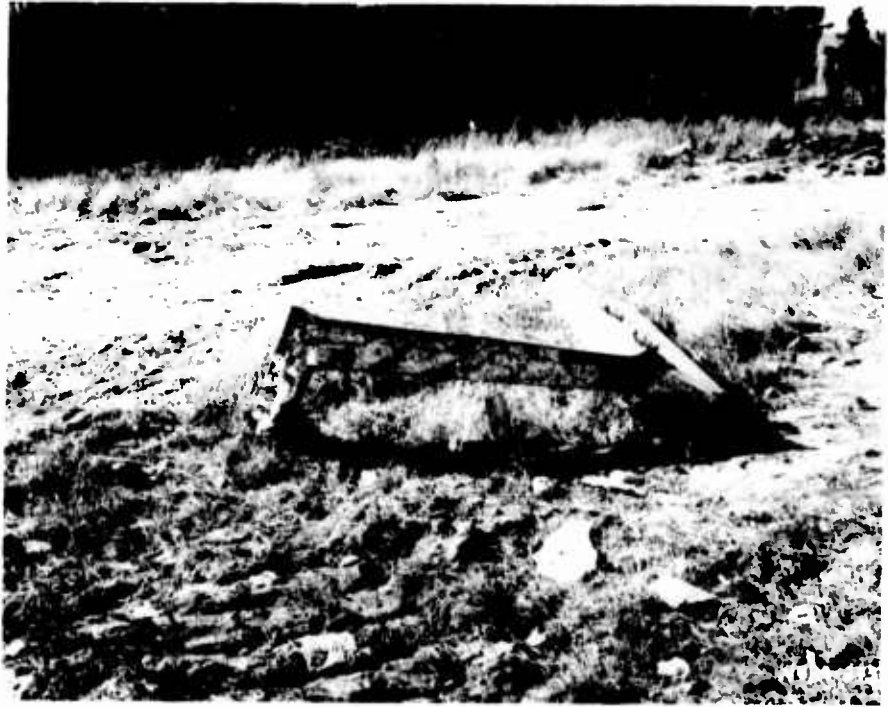
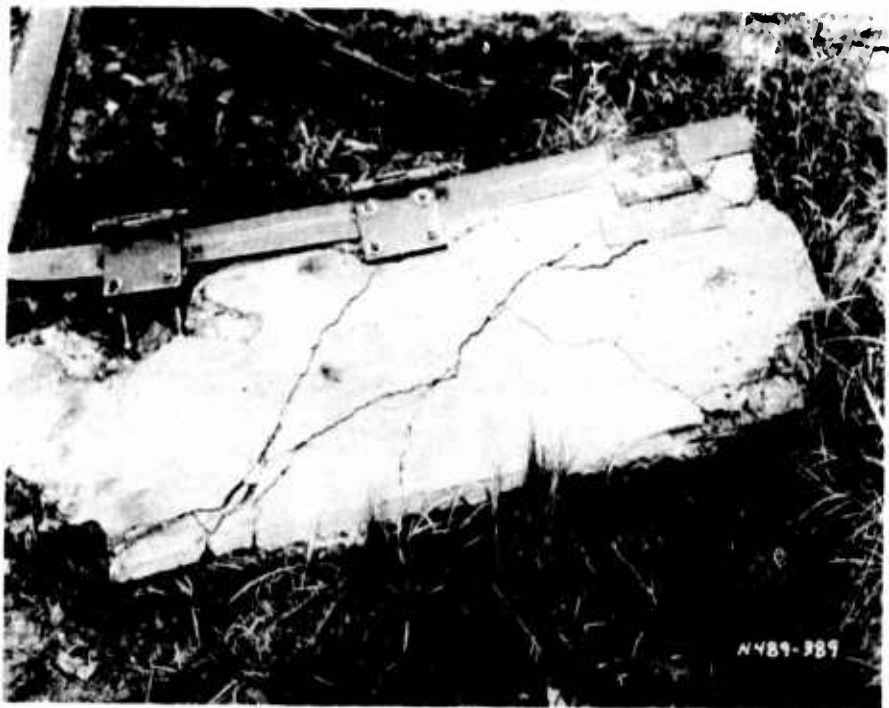
Figure 5.27. Damage to donor bay blast door frame and north part of bulkhead (Sheet 1 of 2).

b. Detail of north side.
