MULTIPLE-PURPOSE PROJECT KANSAS RIVER BASIN REPUBLICAN  
RIVER KANSAS MILFO. (U) CORPS OF ENGINEERS KANSAS CITY  
MO KANSAS CITY DISTRICT S D MARKWELL ET AL. OCT 83

| REPORT DOCUMENTATION PAGE | | READ INSTRUCTIONS<br>BEFORE COMPLETING FORM |
|---|---|---|
| 4. TITLE (and Subtitle)<br>MULTIPLE-PURPOSE PROJECT KANSAS RIVER BASIN<br>REPUBLICAN RIVER MILFORD LAKE<br>OPERATION AND MAINTENANCE MANUAL<br>APPENDIX IV<br>CONSTRUCTION FOUNDATION REPORT | | 5. TYPE OF REPORT & PERIOD COVERED<br>Construction Foundation<br>Report<br>From June 1962 to Dec 1966 |

APPENDIX IV  
CONSTRUCTION FOUNDATION REPORT

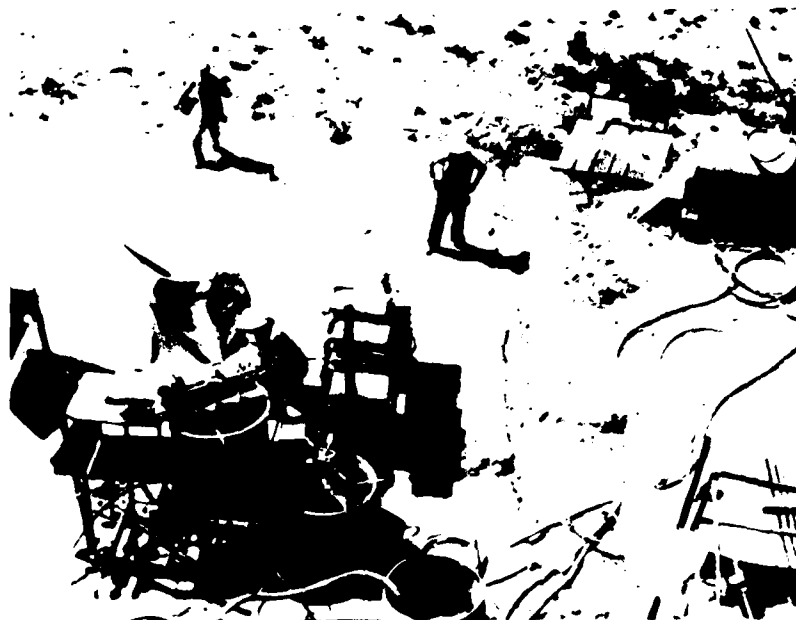
46. Milford Dam,  
July 1963,  
Neg. No.  
294-P3-4.  
Grout filled  
joint at  
station 0+46U  
in conduit  
foundation.
