TR-0084(4930-01)-2 SD-TR-83-92

# Pulsed D<sub>2</sub>-F<sub>2</sub> Chain-Laser Damage to Coated Window and Mirror Components

S. T. AMIMOTO, J. S. WHITTIER, A. WHITTAKER,  
A. CHASE, and R. HOFLAND, Jr.  
Aerophysics Laboratory  
Laboratory Operations  
The Aerospace Corporation  
El Segundo, Calif. 90245

15 December 1983

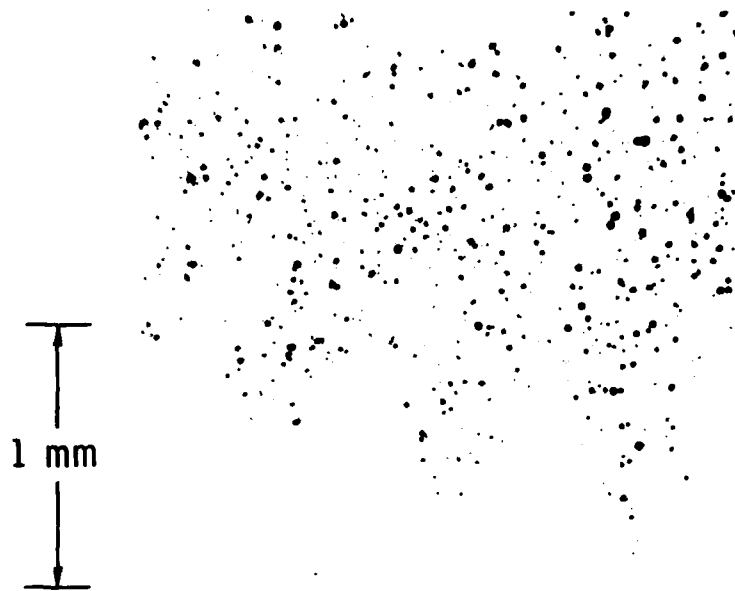
58 J/cm<sup>2</sup>. The carbyne-coated copper samples consistently failed at low fluences of 9.5 J/cm<sup>2</sup> or less. During the coating of copper samples, one half of each substrate was masked from the hot carbon source. Figure 6a gives clear evidence that particulate carbon contamination occurred on the half of the copper mirror that was considered to have been shielded from the heated carbon source. A method for interception of these carbon particulates must be devised for future coating studies. The irradiation of the carbyne vapor stream by a high-power laser beam would be one technique for interception of particulate material before its impingement on a substrate surface. Figure 6b is a micrograph showing laser damage to a carbyne film deposited on half of a polished copper substrate. Preferential damage at carbon-bearing sites is seen to be the failure mechanism, as was observed for the case of carbyne coatings on CaF<sub>2</sub> samples. We speculate that carbyne films on reflective optics would possess high damage resistance in the absence of these particulate carbon sites.

Fig. 6b. Unmasked Mirror Segment. Lower half not exposed to laser radiation. Upper half exposed to  $9.5 \text{ J/cm}^2$ . (Original magnification 37.5X)
