NAVAL CIVIL ENGINEERING LABORATORY  
Port Hueneme, California

FIELD STUDY ON MOISTURE PROBLEMS IN EXTERIOR WALLS OF  
FAMILY HOUSING UNITS AT NAVAL AIR STATION PENSACOLA, FLORIDA

February 1984

An Investigation Conducted by  
H.R. TRECHSEL ASSOCIATES  
P.O. Box 211  
Germantown, MD 20874

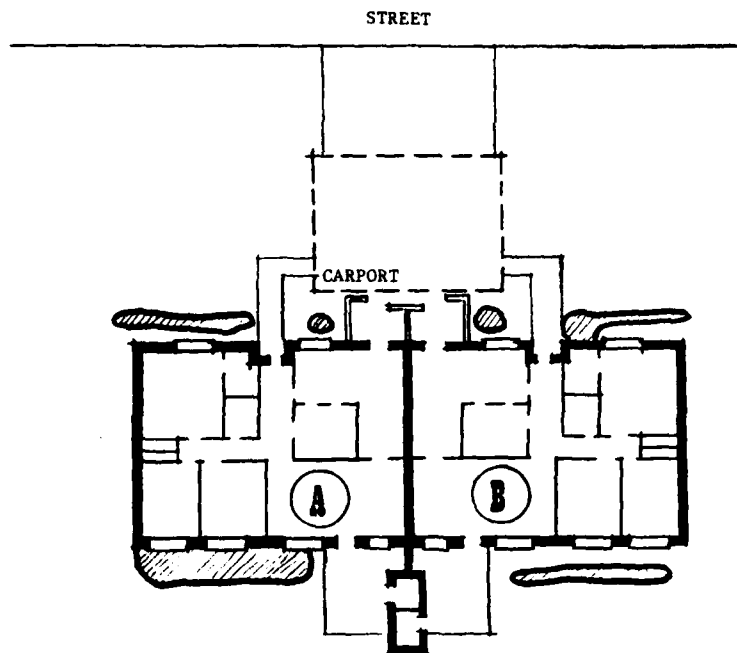
Figure 12. Diagram of Standing Water Near Houses 2310 A and B, Classified as "Heavy" Amount Standing Water

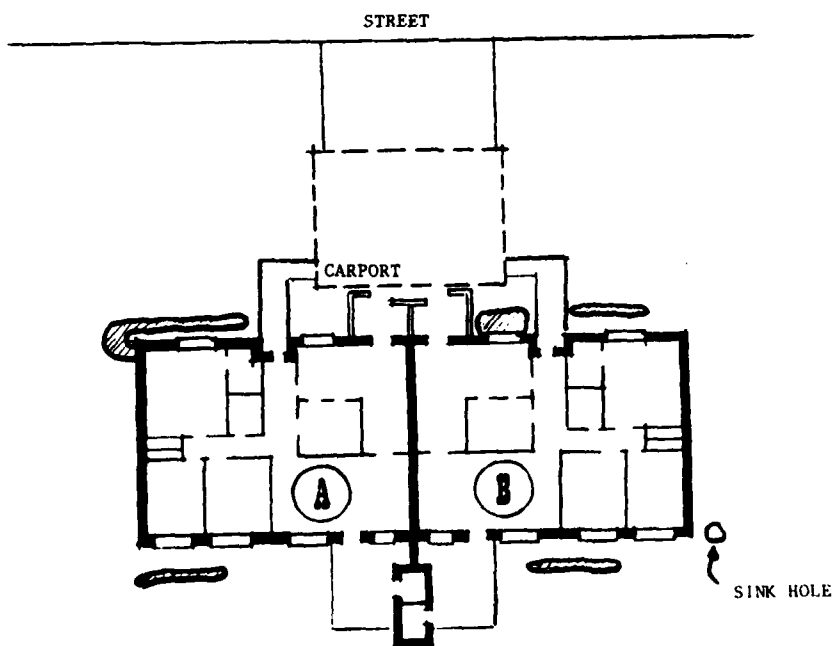
Figure 13. Diagram of Standing Water Near Houses 2381 A and B, Classified as "Moderate" Amount Standing Water

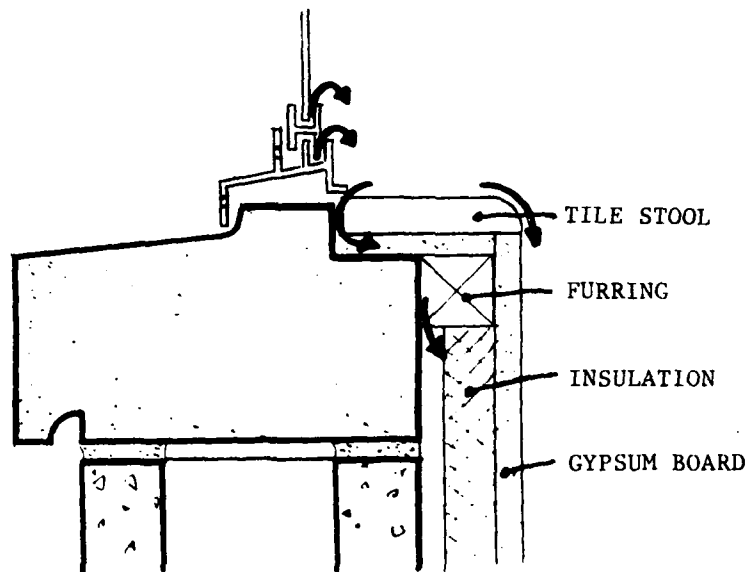
Figure 14. Leakage Paths of Water at Window Sill

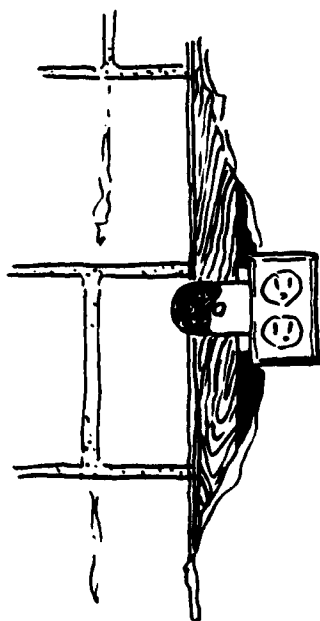
Figure 15. Rusted Mounting Bracket of Electric Outlet Near Leakage Site
