REPORT NO. NADC-83123-60

## PERFORMANCE EVALUATION OF THE HI-SPEED EJECTION LIMB PROTECTION SYSTEMS (HELPS)

Ken Miller  
Aircraft and Crew System Technology Directorate  
NAVAL AIR DEVELOPMENT CENTER  
Warminster, PA 18974

PHASE REPORT  
PROGRAM ELEMENT-63216N  
Work Unit No.-W0584001

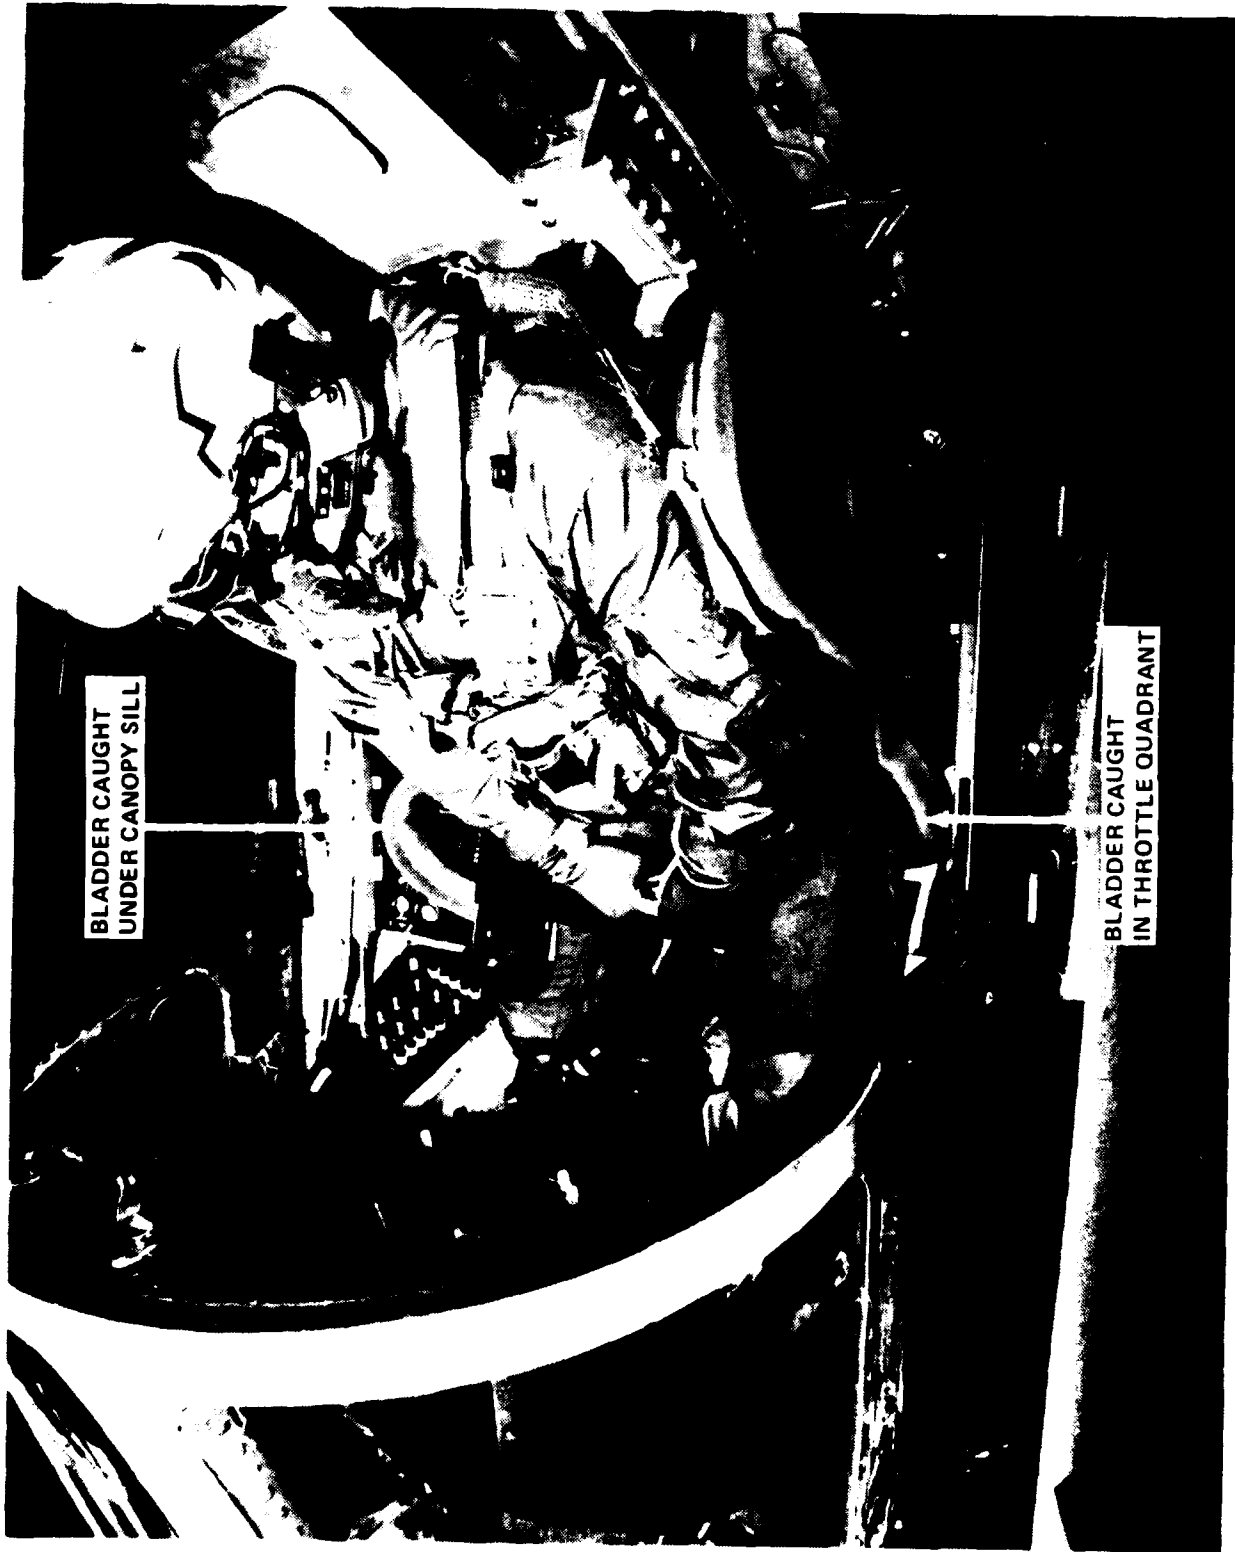
Figure 4. Helps Deployment Inside an F-14 Cockpit

The HELPS failed to deploy properly in each test. The leg deployment bladders were the source of failure each time. The bladders snagged on aircraft components at two different points inside the cockpit. These points were the aircraft throttle quadrant and the underneath of the canopy sill. Figure 4 shows a bladder snagged at each location.

Proper deployment of the leg deployment bladders is necessary to separate and position the shoulder restraint straps and to properly position the leg restraint straps. It has been shown that proper deployment of the leg restraint bladders, as currently configured, can be prevented by the seat occupant or aircraft cockpit components.

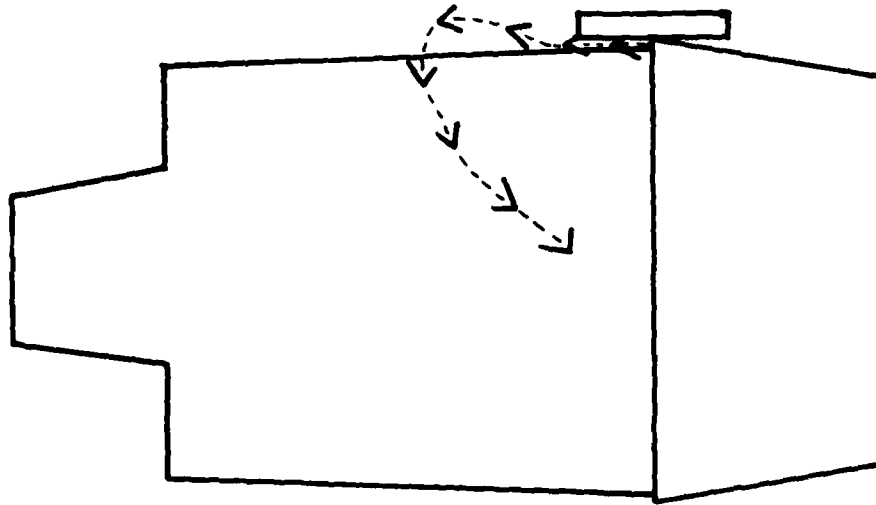
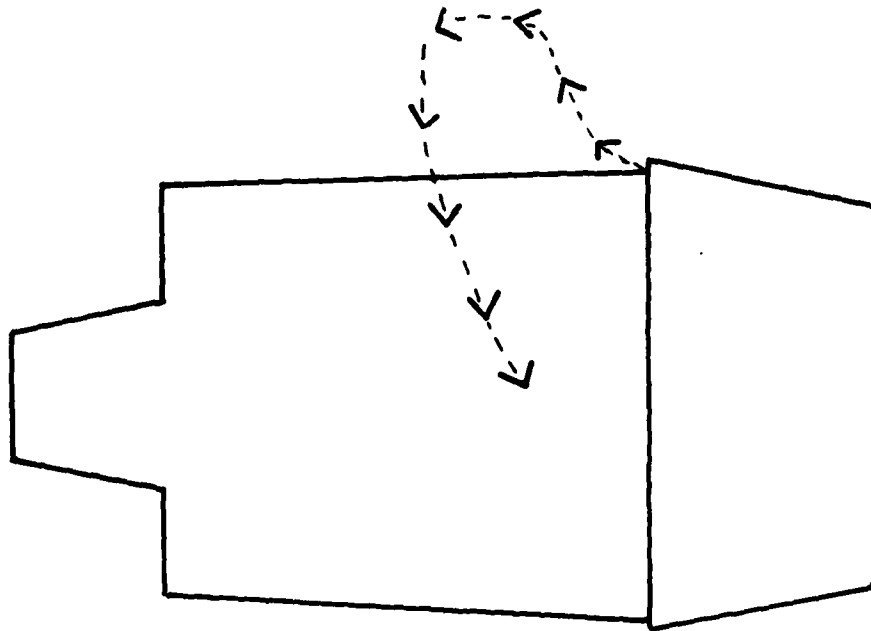
Figure 5. Sketch of Leg Deployment Bladder Travel

The leg deployment bladders inflate by traveling outward and up from their stowage channel. They complete their deployment moving forward and towards the centerline of the seat. Figure 5(a) shows the approximate path of the top of the leg deployment bladder. The outward travel of the leg deployment bladder is the cause of the snagging problem and will likely occur in all aircraft types.

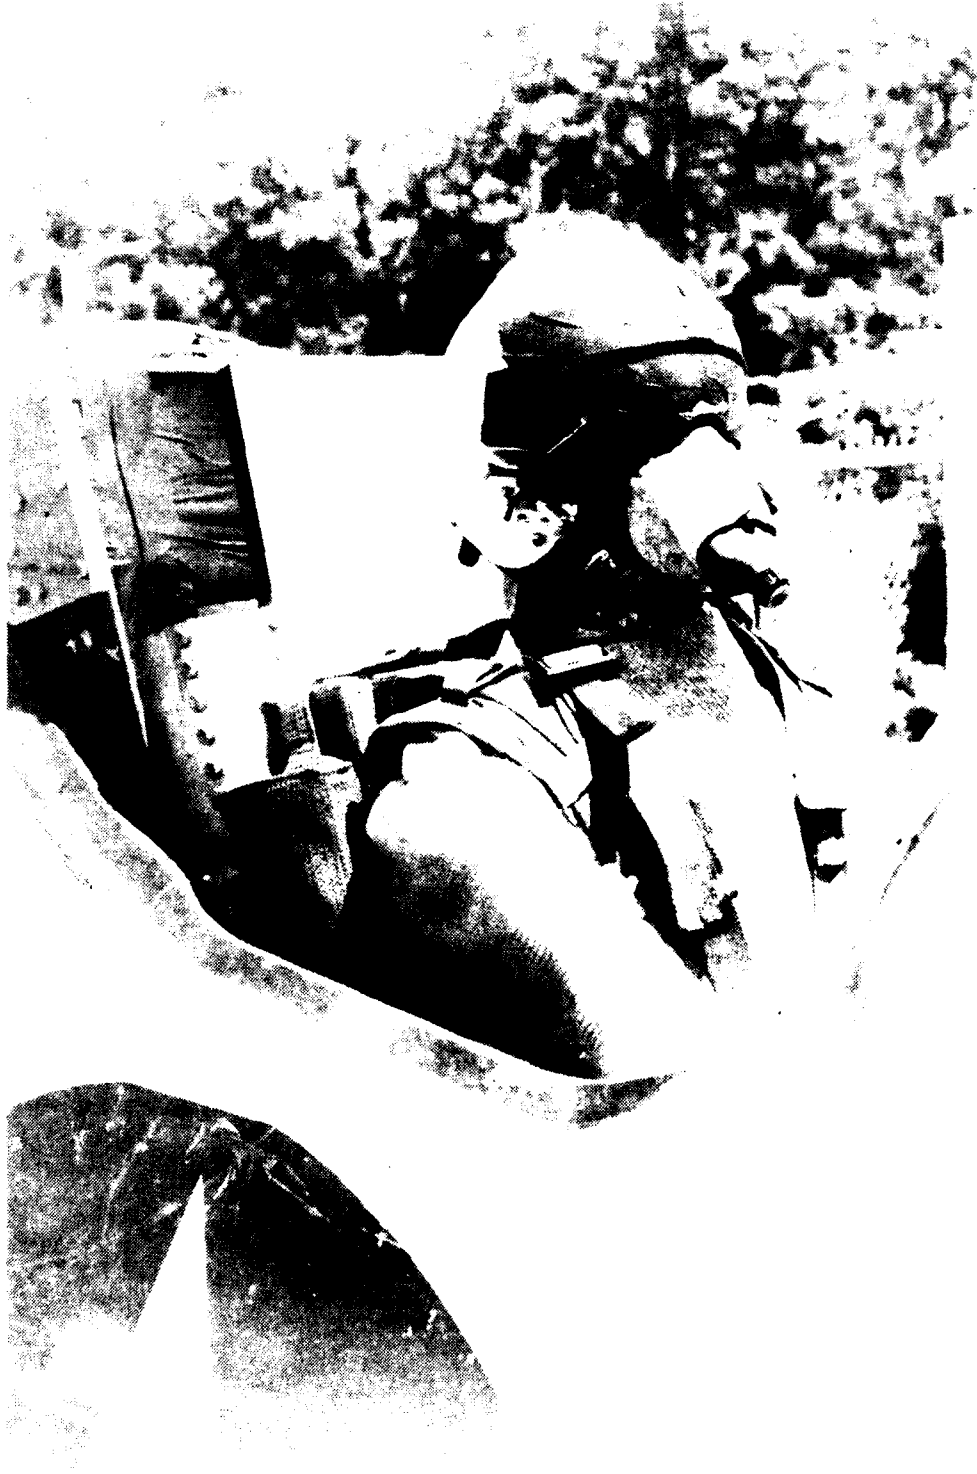
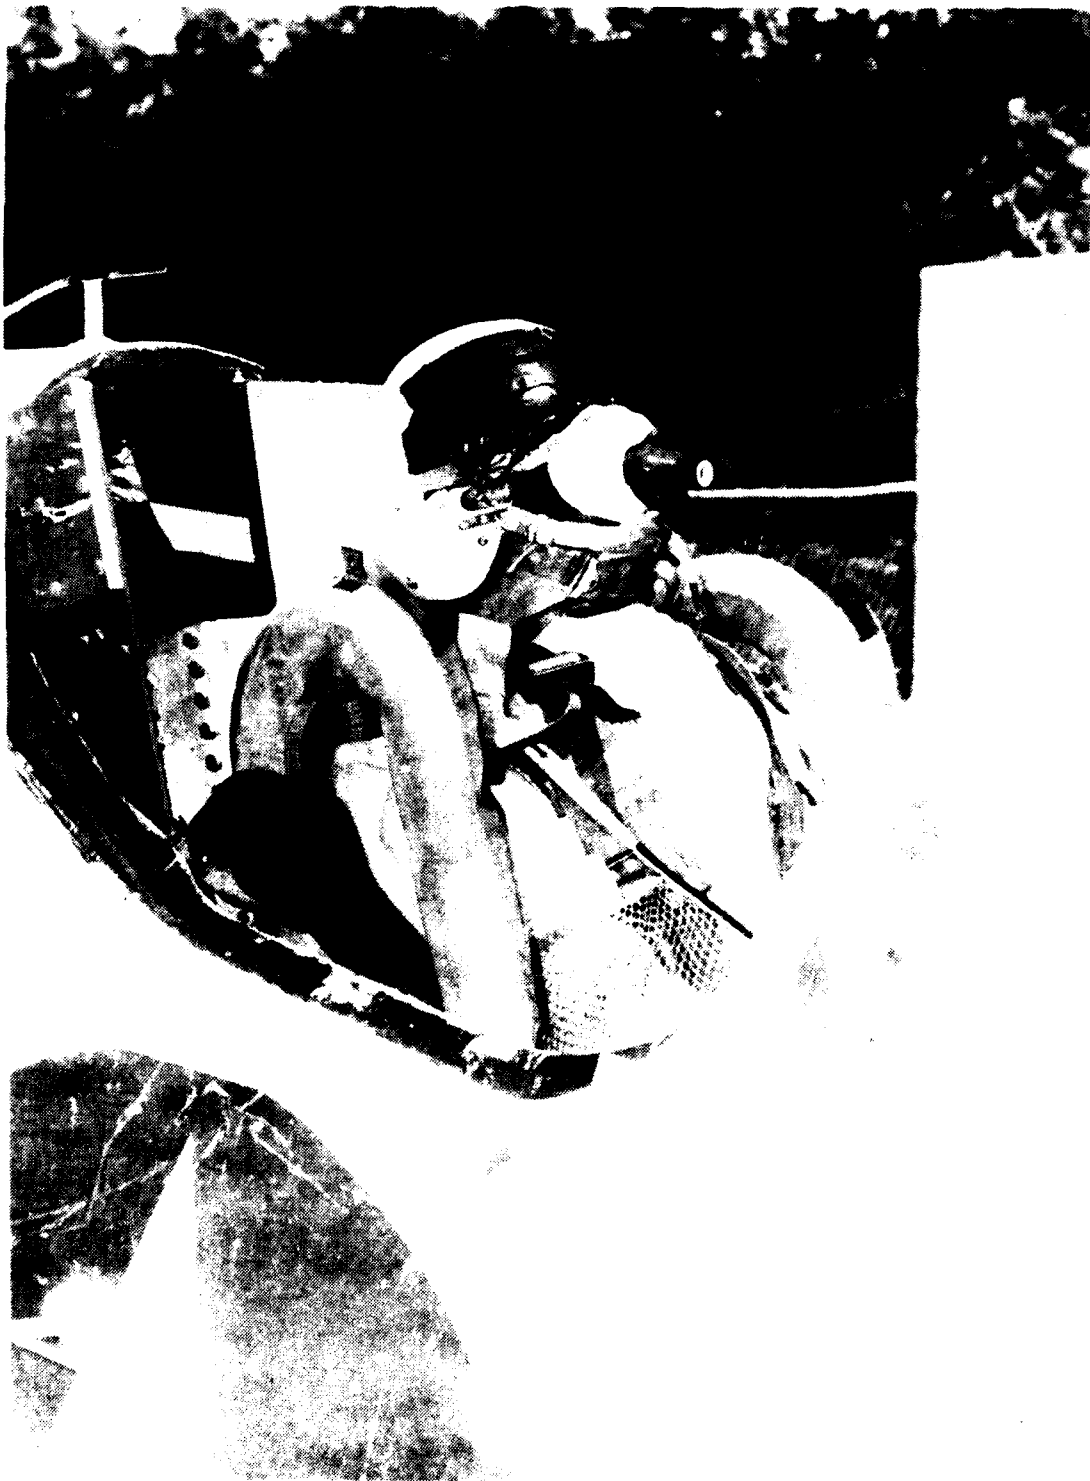
Figures 7 and 8 show the HELPS system before and after test no. 5. Although the HELPS components are in proper position after the test, proper deployment didn't occur. Film analysis showed the bladders hung-up during the still air time between HELPS initiation and airblast initiation. The airblast actually freed the bladders and allowed them to properly deploy.

Figure 7. Pretest View for Deployment During Windblast

Figure 8. Post Test View for Deployment During Windblast

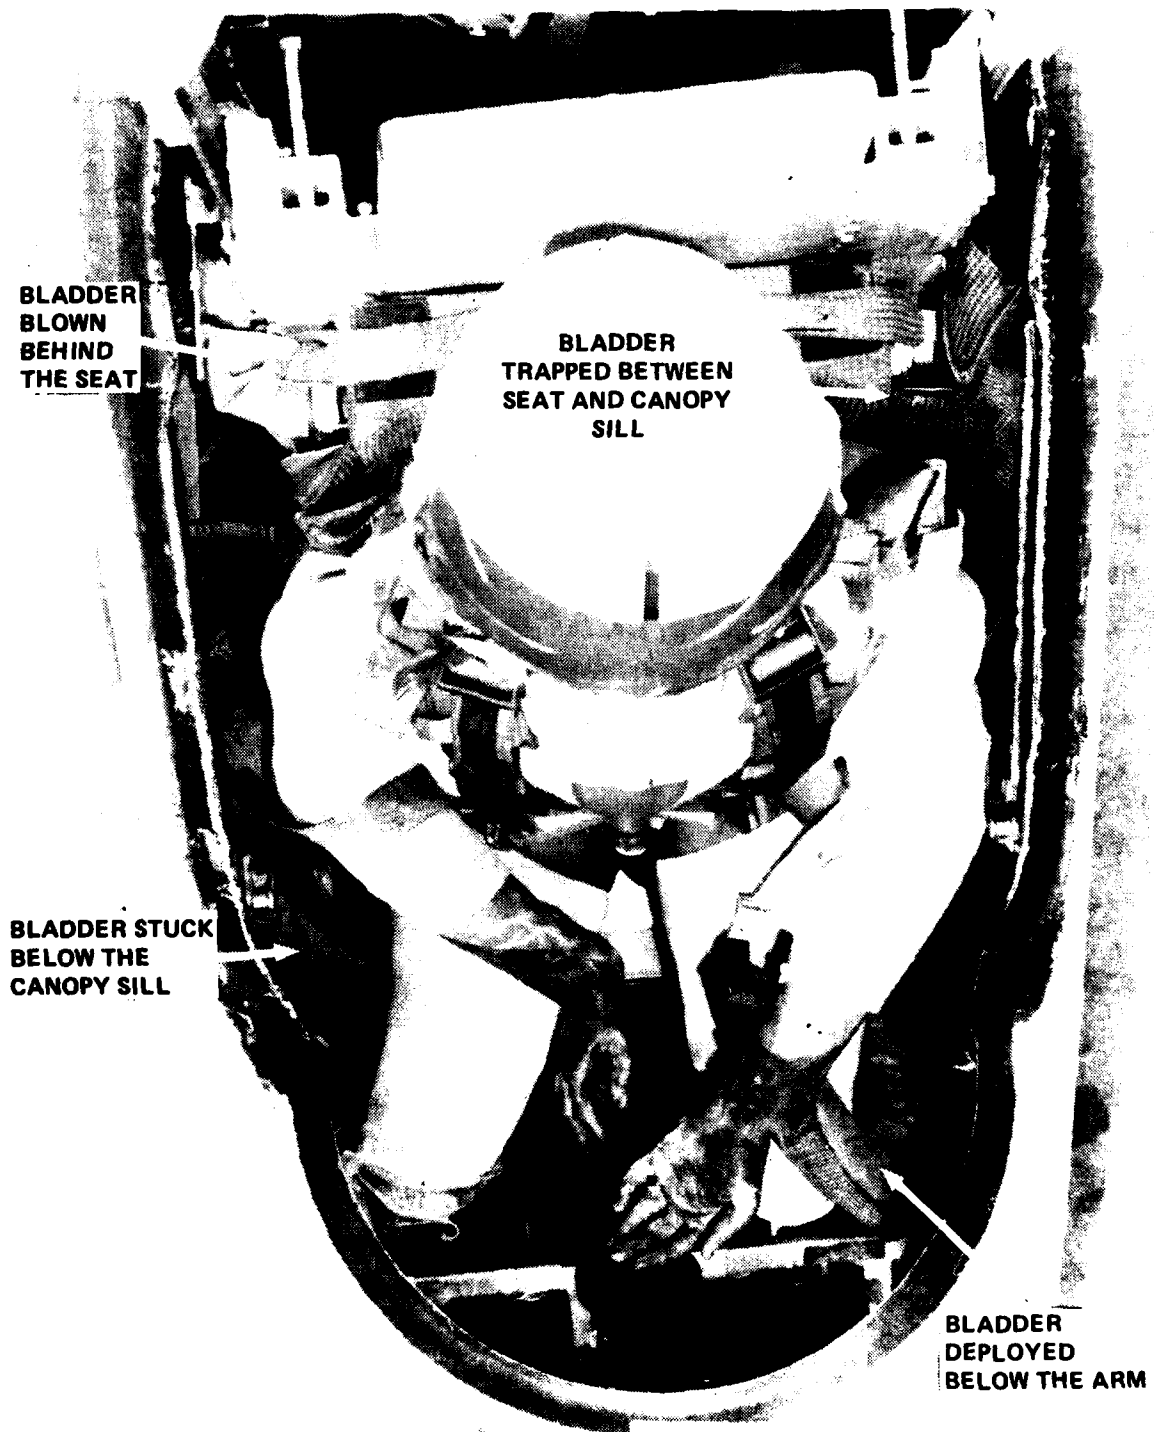
The remaining deployment tests were conducted with the HELPS initiated simultaneously with the windblast. The HELPS failed to deploy properly in these tests. Figure 9 shows four different sources of deployment failure. The wind force was greater than the forward acting force of the shoulder deployment bladders. Therefore, the bladders could not position the restraint straps above the occupants shoulders. The leg deployment bladders snagged under either the canopy sill or the dummy's arm. Before each windblast test, the dummy's hands were positioned near the location of a lower ejection handle. The windblast forced the dummy's arms back and up from this location, so the leg deployment bladder deployed underneath the dummy's arm. The inability of the shoulder bladders to properly deploy could affect the deployment of the leg bladders since they are connected by the kevlar straps.

Figure 9. Post Test 6 View for Deployment During Windblast

The current bladder deployment configuration of the HELPS is unreliable and therefore unacceptable. A redesign of this concept may provide acceptable results. Stronger bladders, higher inflation pressures, reshaped bladders, and relocated bladders could significantly improve the operating characteristics and provide the passive feature desired. Careful design on an aircraft to aircraft basis would be required to assure that cockpit components would not interfere with system deployment.

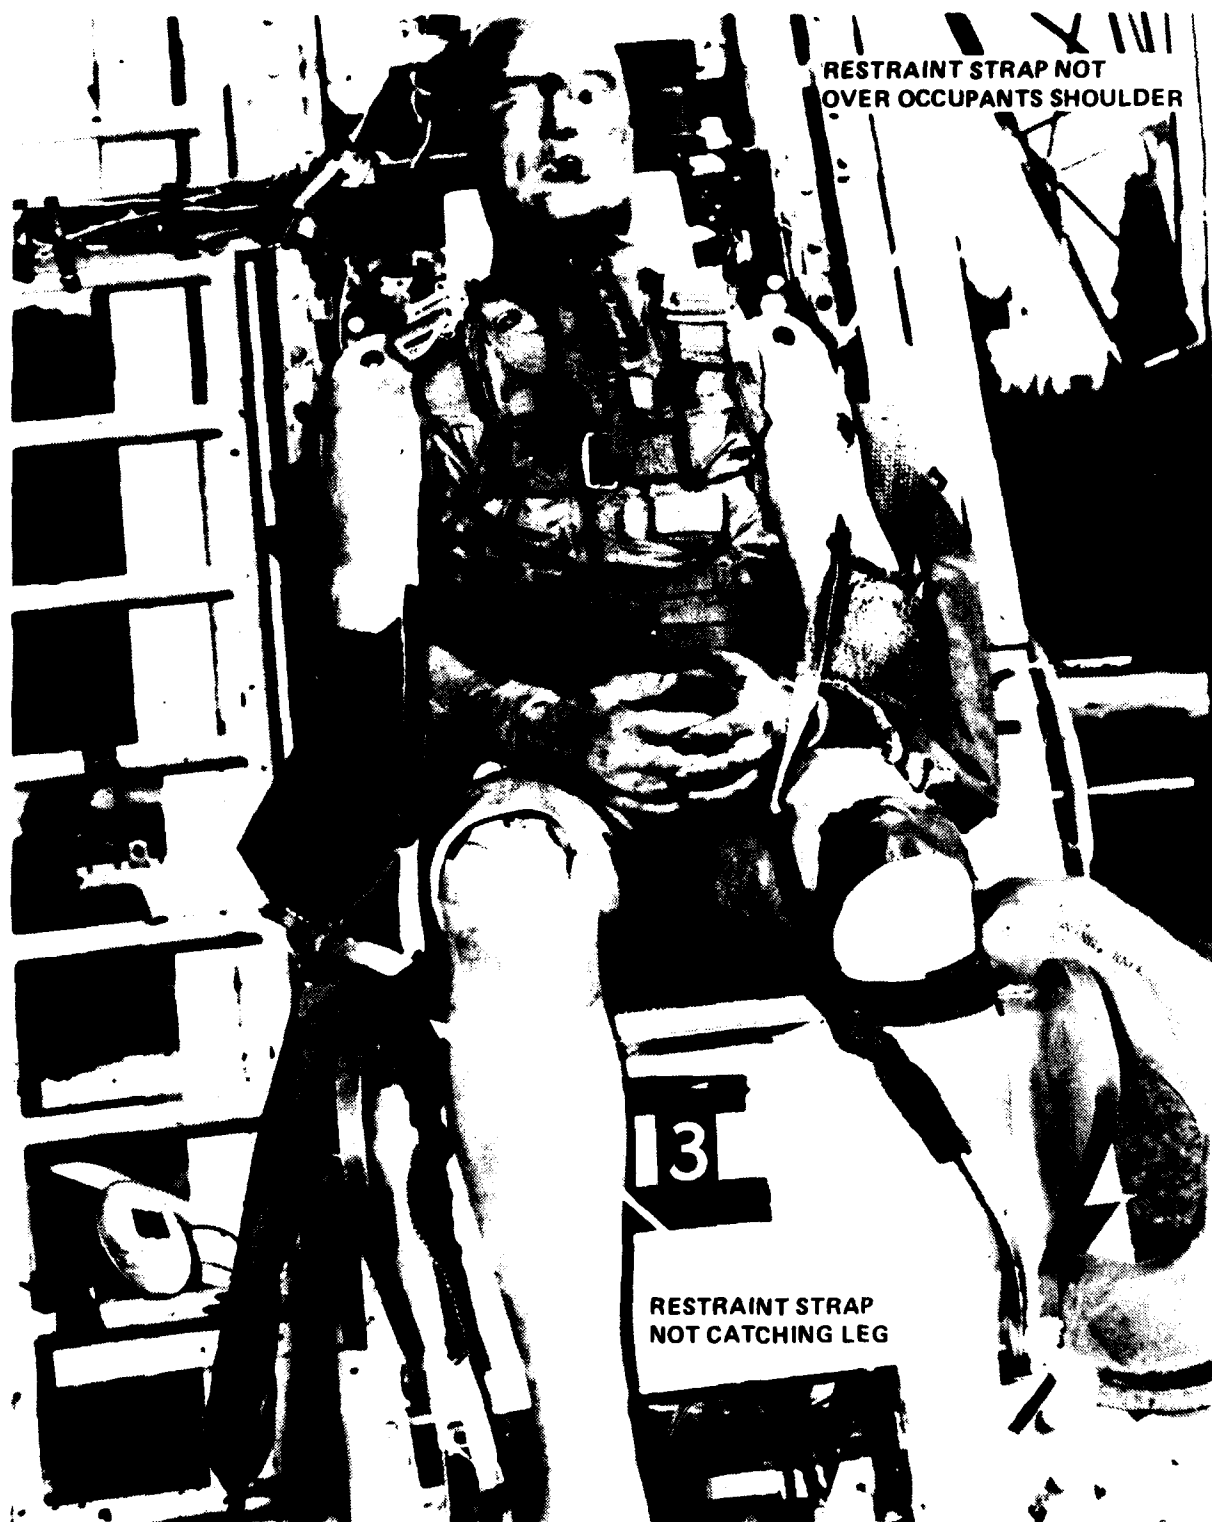
1. The shoulder restraint line did not tighten over the occupants shoulder, (figures 14 and 15). Although it would appear that the HELPS, if cinched in this manner, would restrain the arms, they actually would be more susceptible to dislodgement during an unstable ejection.

2. The leg restraint lines did not capture the legs, (figures 14 and 16). Three reasons for the failure to capture the legs were evident. These were:

- The bladders were not deployed to their proper position.
- The velcro connection of the leg restraint strap to the bladder prematurely disconnected during the deployment.
- The bladders twisted from their properly deployed position as the leg restraint straps separated from the velcro.

Figure 14. Improper Restraint

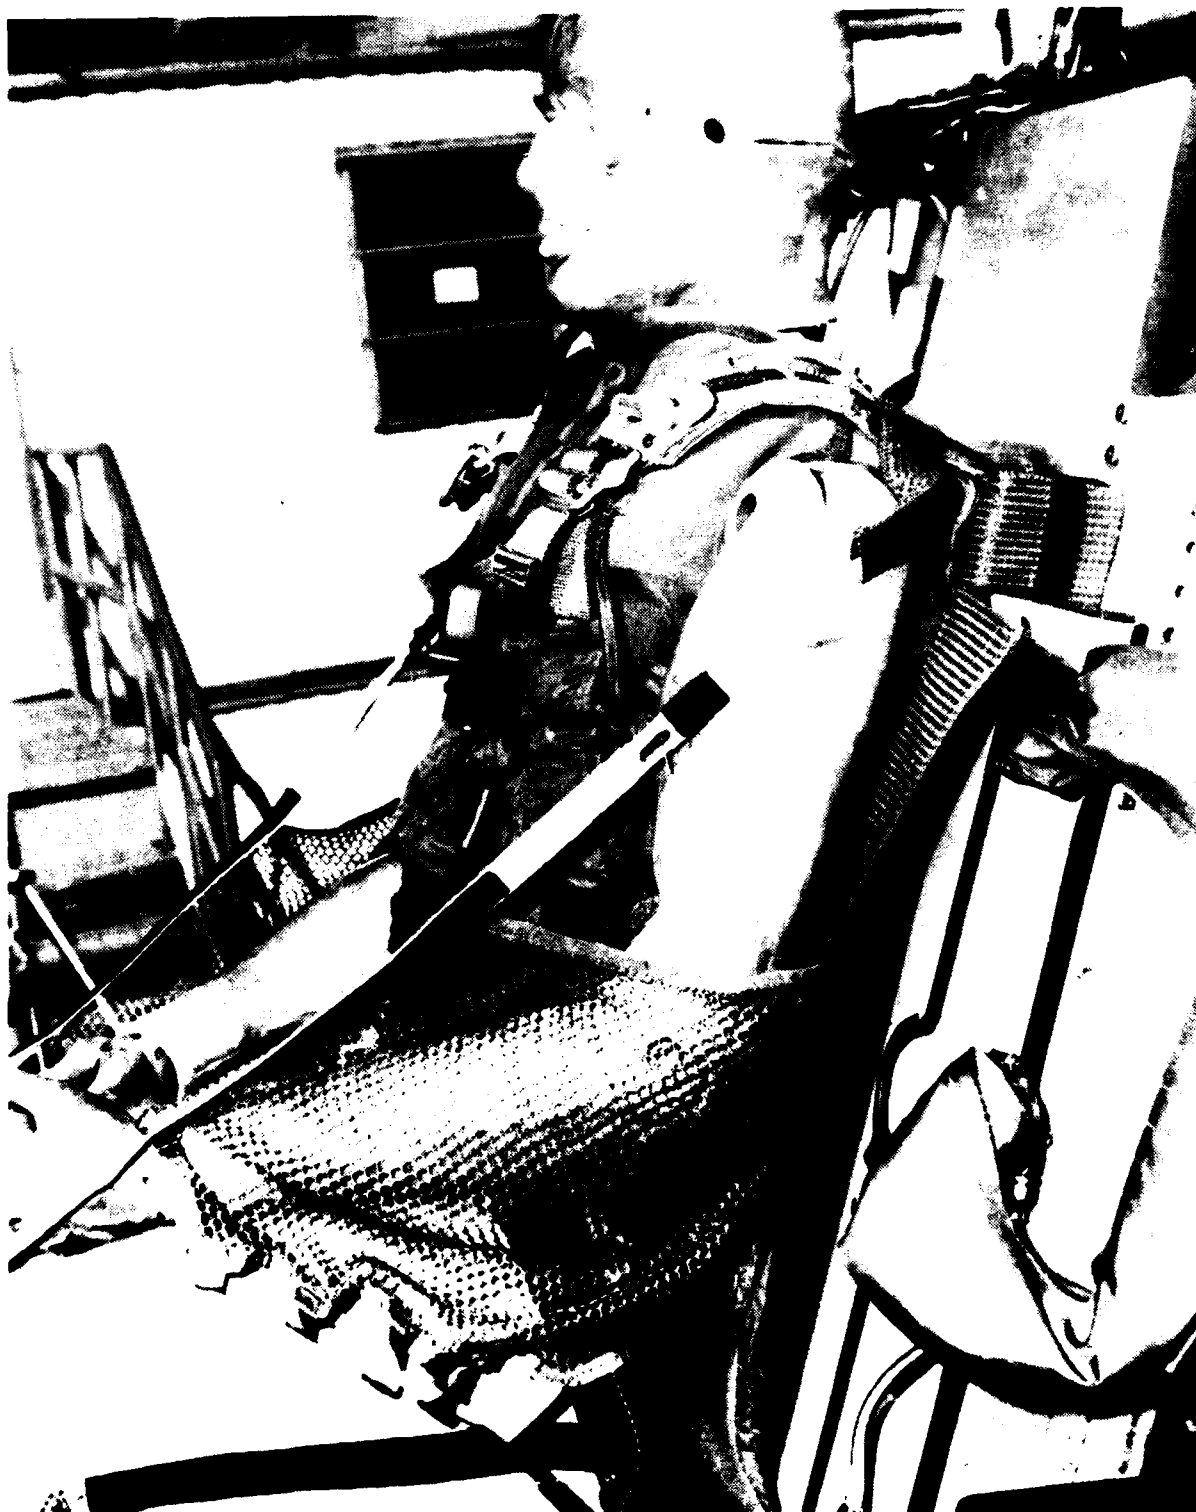
Figure 15. Close-Up of Improper Shoulder Restraint

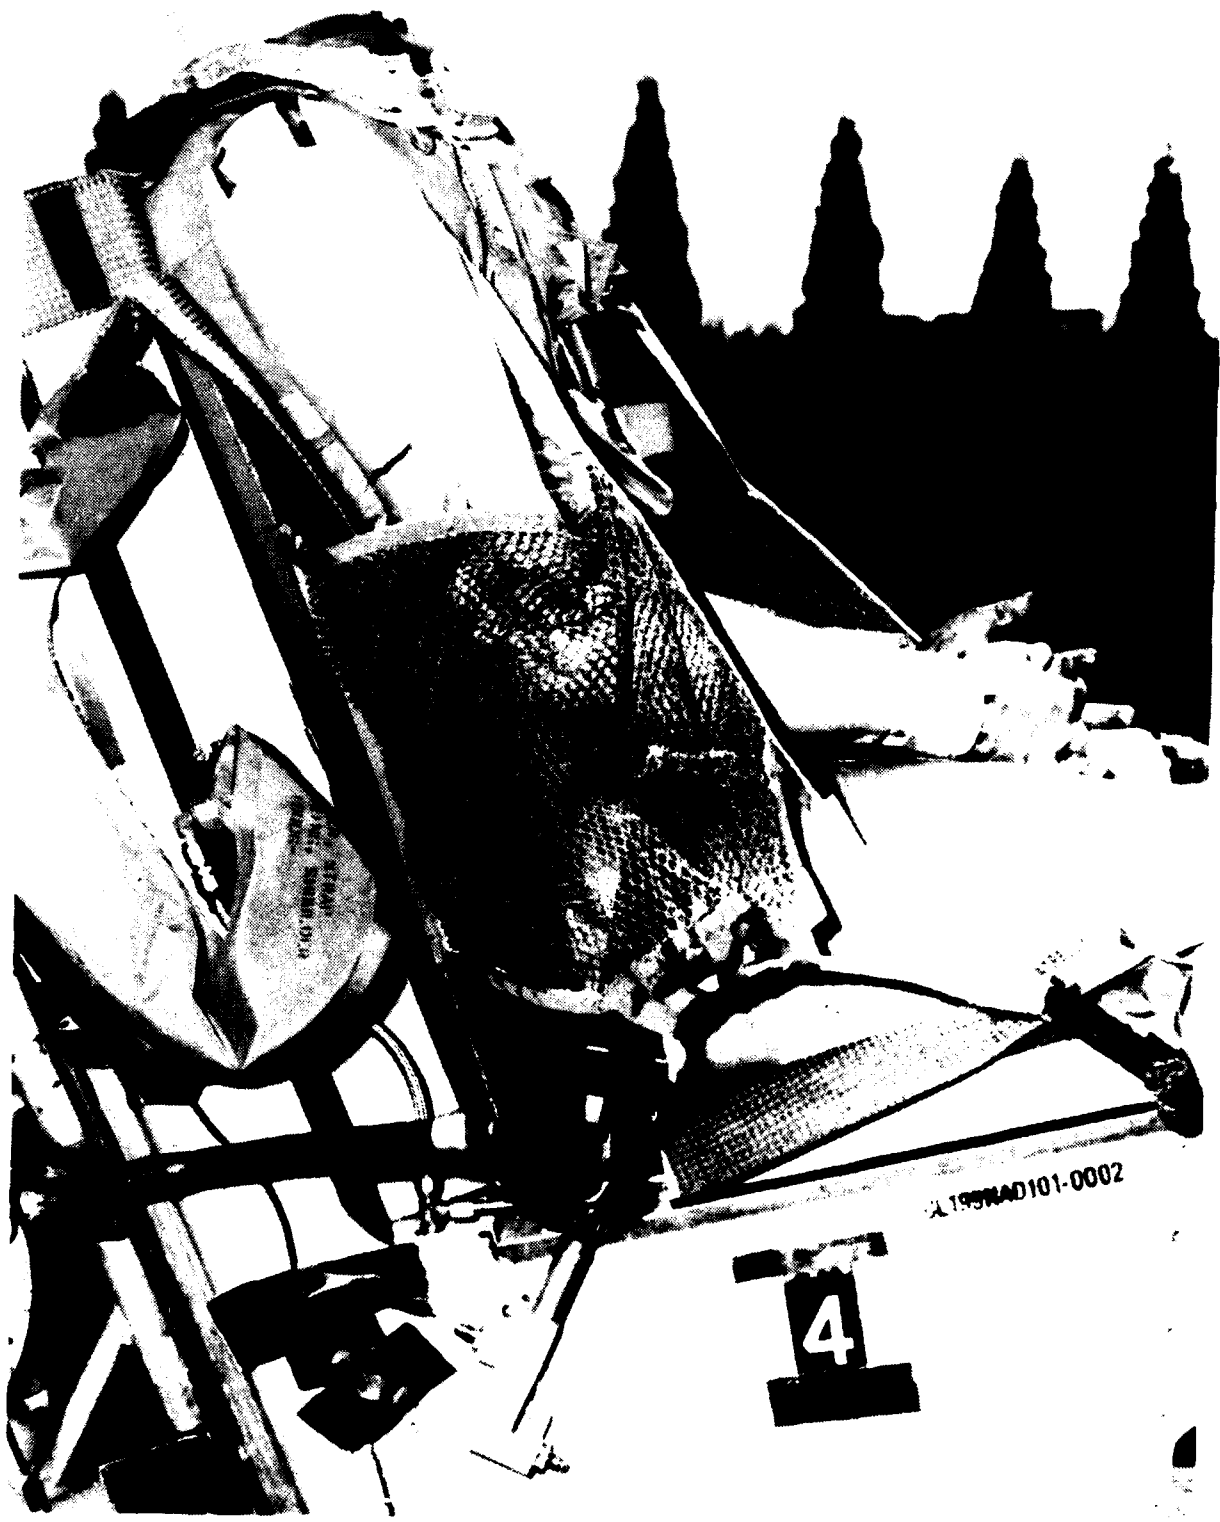
Figure 16. Close-Up of Improper Leg Restraint

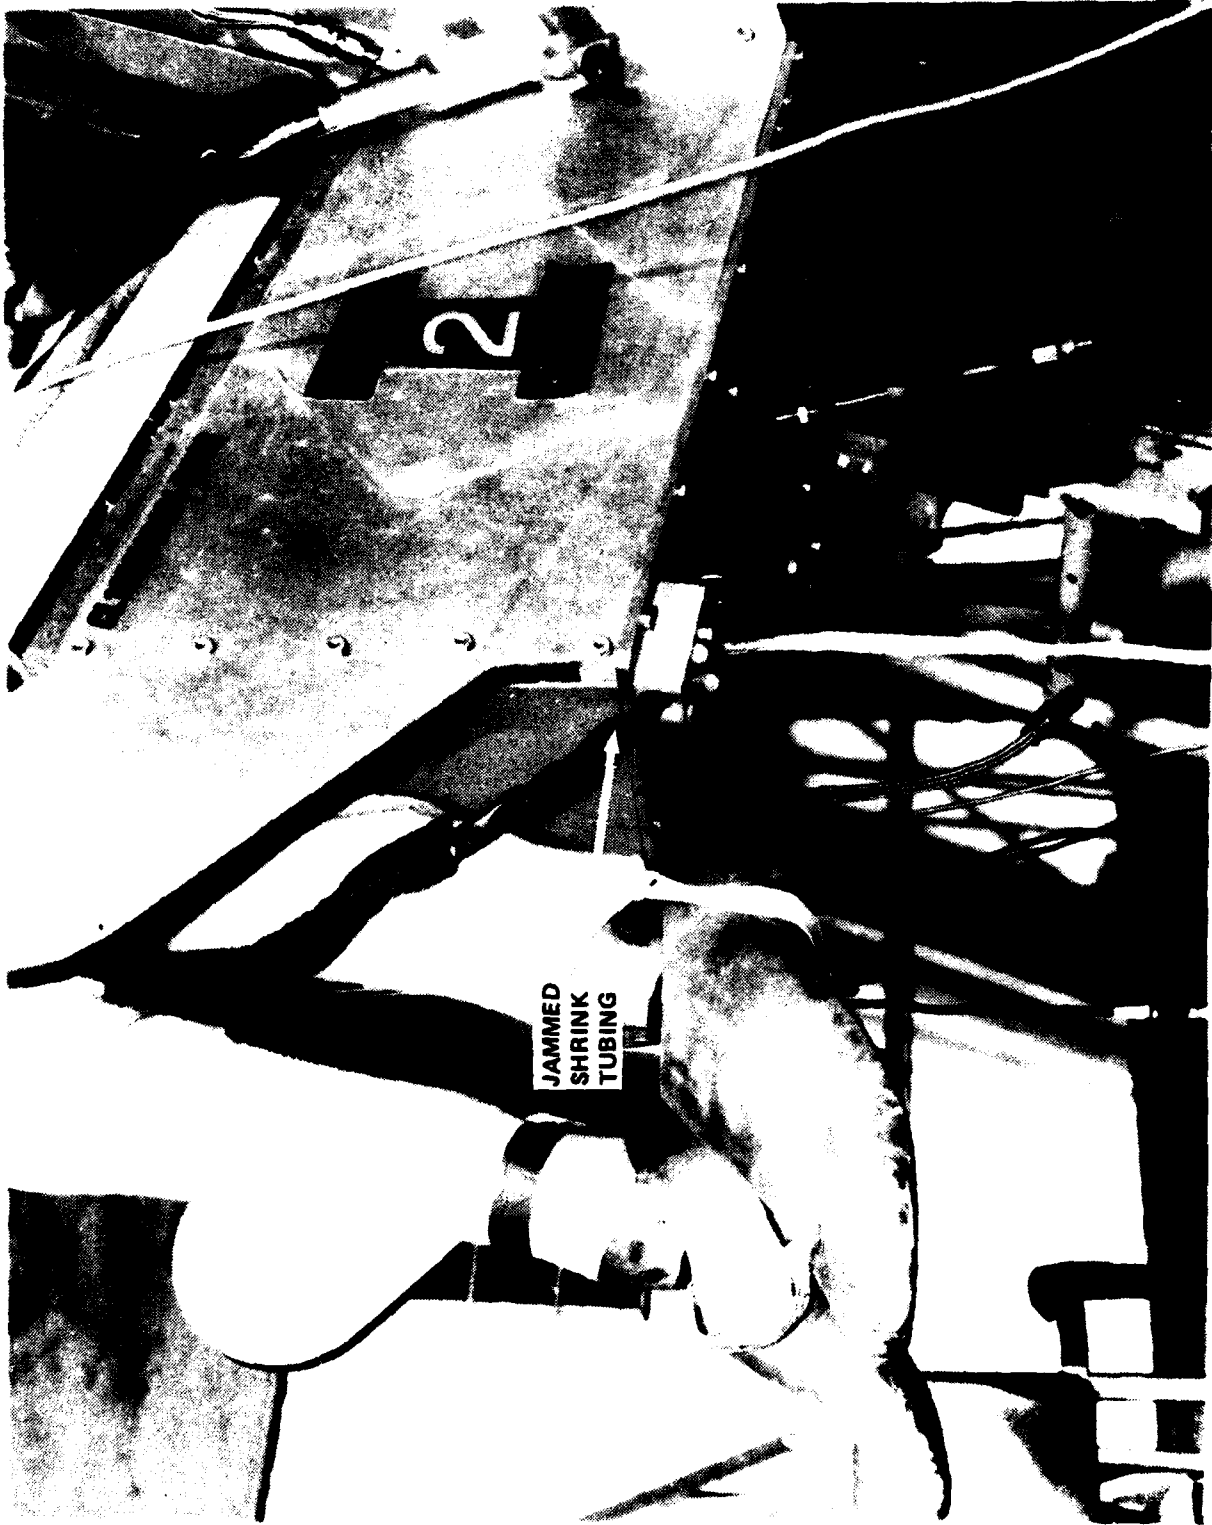
A problem with the snubbing system was also discovered during the tower evaluation. The shrink tubing jammed in the snubber blocks, as shown in figure 17. This jamming could cause the rip stitching to begin tearing before the system is completely tightened. It could also allow the kevlar line to slip back through the shrink tubing because the tubing kept the snubber pawl jammed in the unlocked position. The shrink tubing had to be removed to continue the testing.

Figure 17. Snubber Block with Jammed Shrink Tubing

The cinch-up phase of HELPS appears to be easily correctable to an acceptable configuration if the deployment problems can be corrected. When the bladders properly positioned the restraint straps, successful cinch-ups occurred. Stronger bladders would decrease the twisting motion that occurred during cinch-ups. A faster acting tensioning line can be easily developed to assure that the system is tightened over the occupant before entering the windstream. Also, a new snubber mechanism will be required to assure that no binding or jamming occurs during the cinch-up phase.

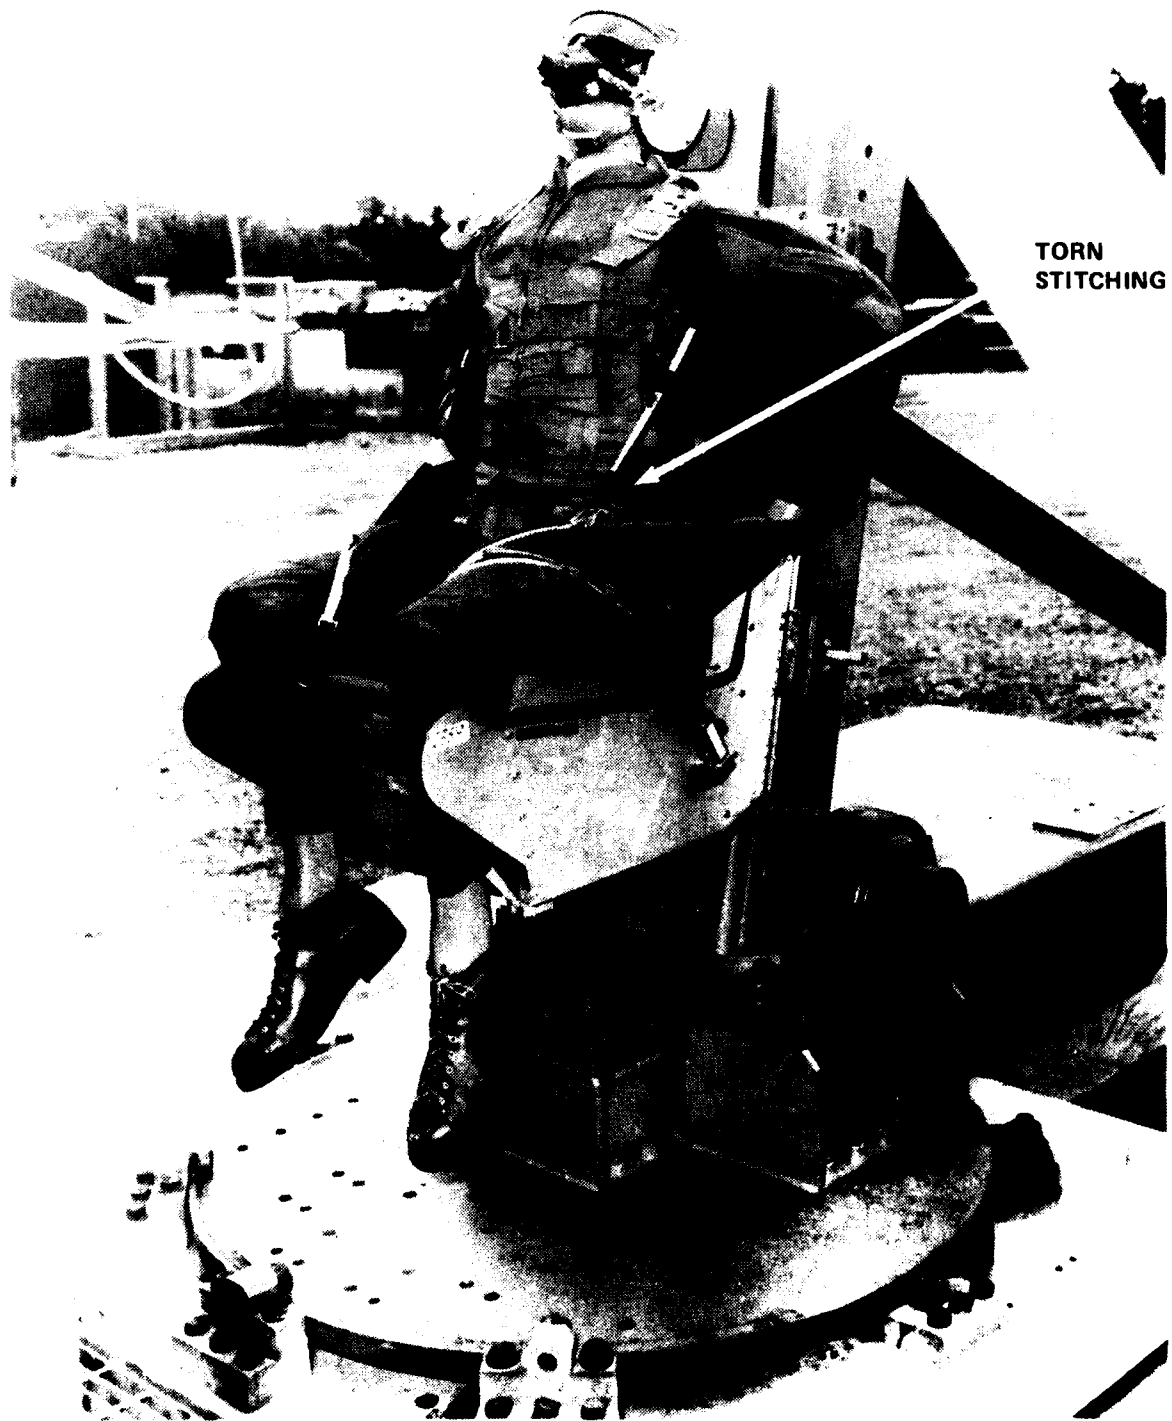
The stitching that holds the arm netting to the restraint webbing or seat side channel also failed as indicated in figure 23. The netting was re sewn with stronger thread and the system was reused.

Figure 23. Post Test View of Test 6

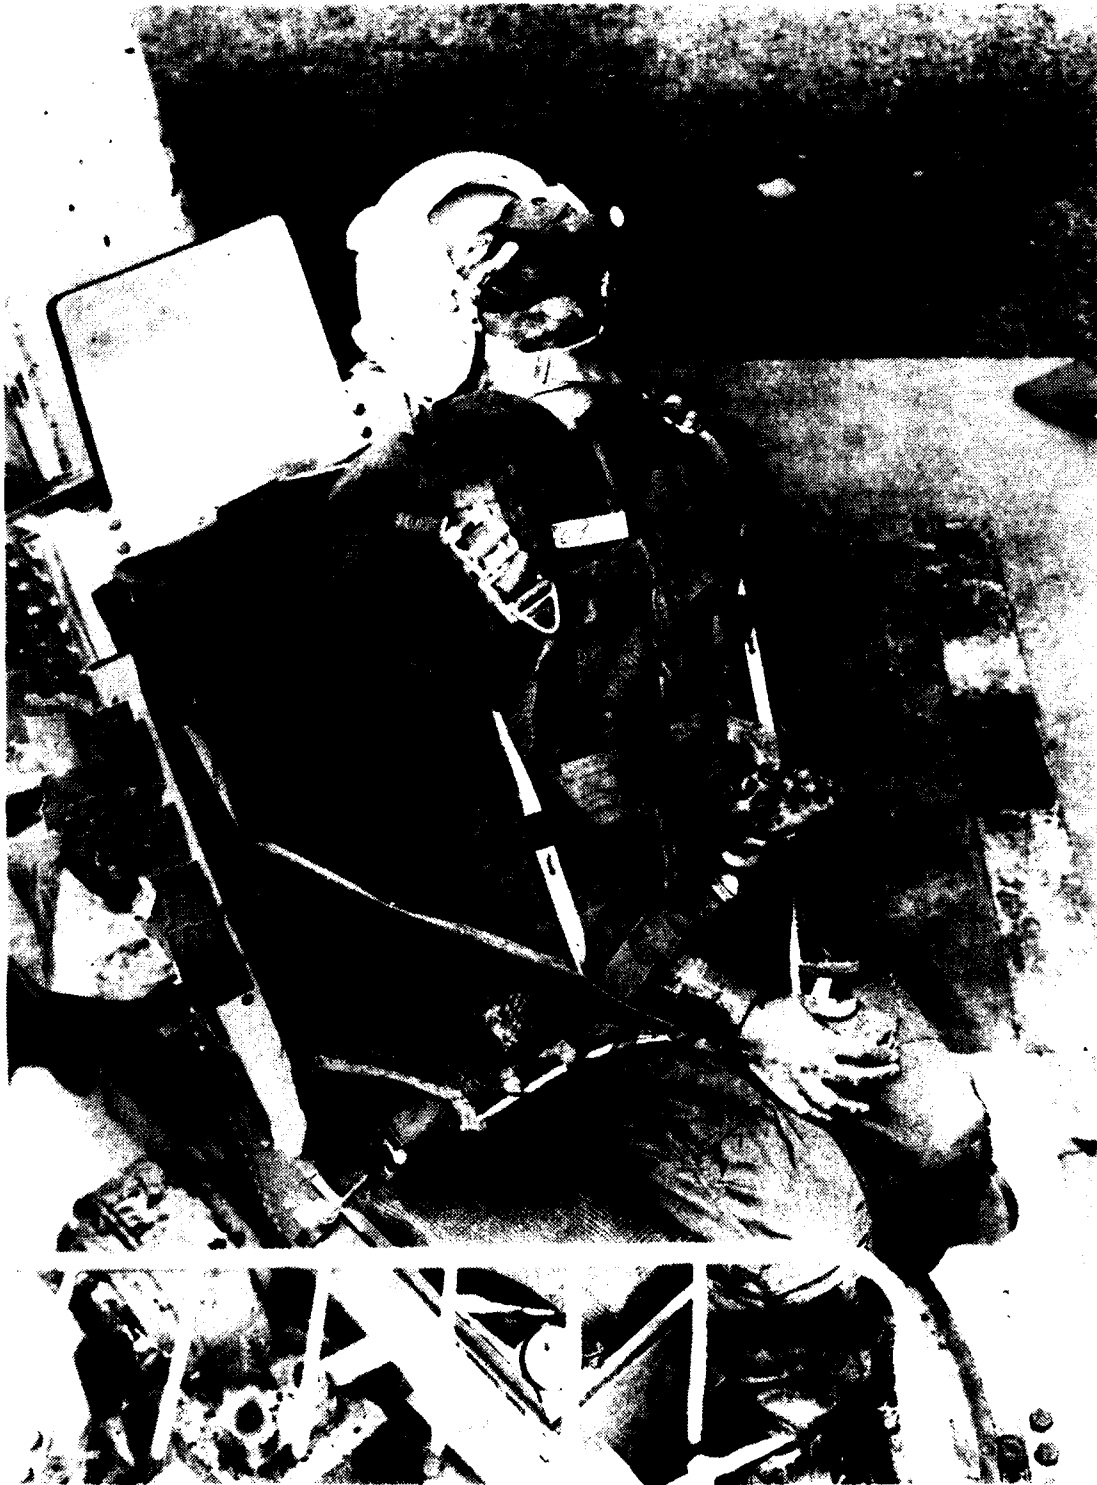
A failure of the HELPS seat attachments occurred in test 5. The left side channel was pulled from the seat back. Figures 26 and 27 show the test dummy almost blown completely off the side of the seat. A contributing factor to this failure is the poor lateral restraint provided by the MPES seat. The HELPS was being required to hold the dummy on the seat, instead of just restraining its arms. This same seat and HELPS were repaired with strengthened side channel attachments and used in all 9 tests.

Figure 26. View of HELPS After Attachment Failure

Figure 27. HELPS Attachment Failure

Recommended changes would be to provide a firmer anchor for the top of the shoulder restraint straps, a change in the length of the restraint strap, stronger seat connections, improved stitching requirements, and an improved strap snubber to maintain a tight restraint over the occupant.
