TECHNICAL REPORT HL-83-21

NAWILIWILI BREAKWATER STABILITY STUDY NAWILIWILI HARBOR, KAUAI, HAWAII

Hydraulic Model Investigation

September 1983

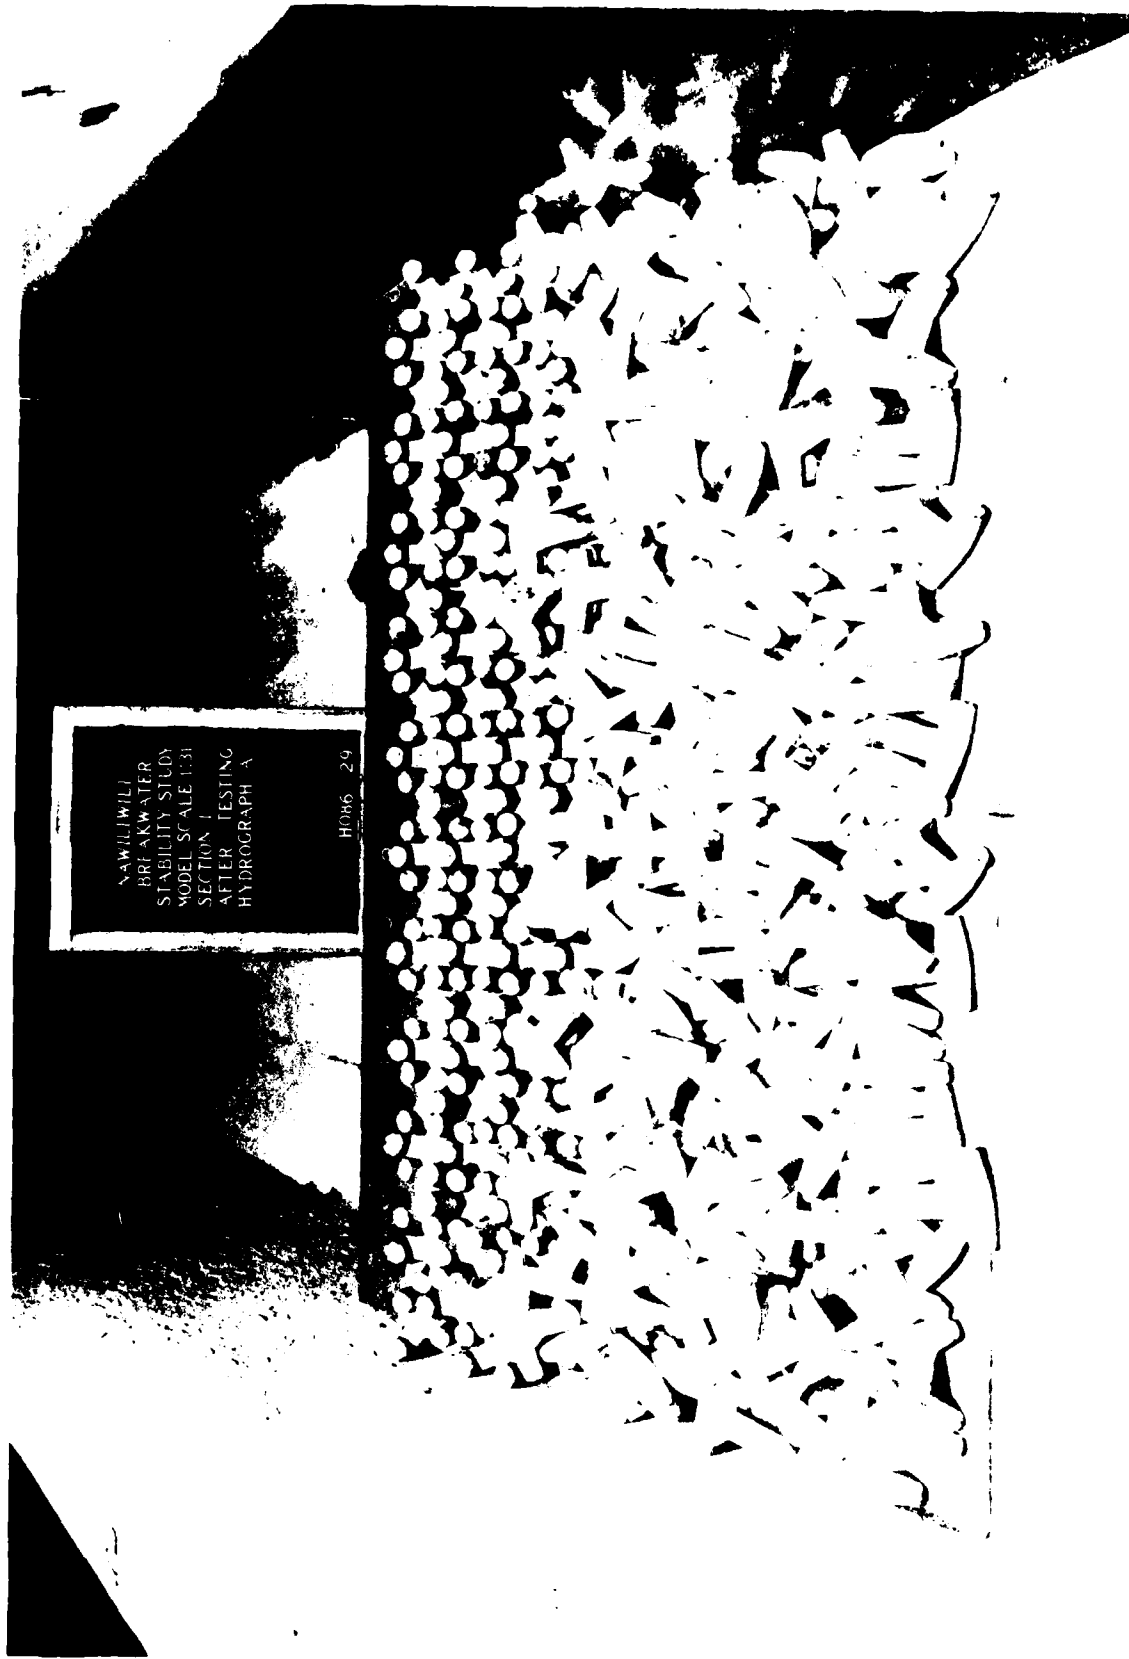
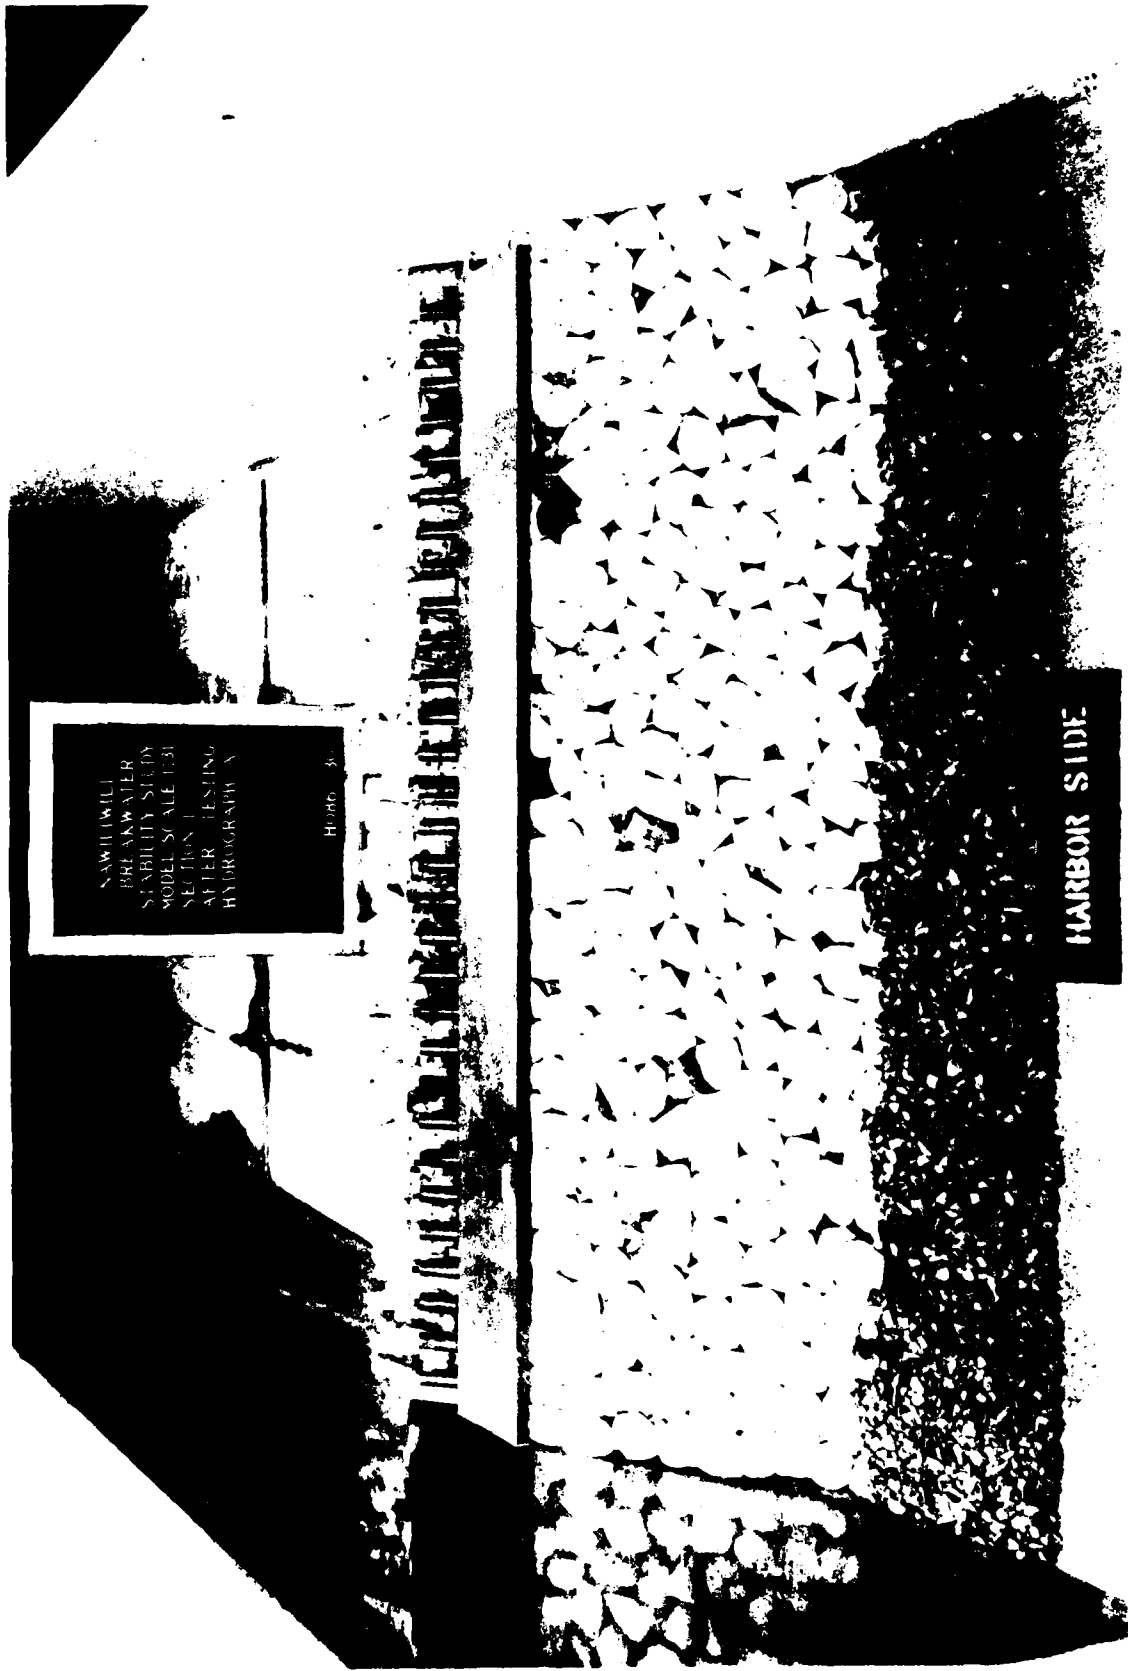
17. Section 1, Plate 4 and Photos 2-4, was constructed in the test flume at a scale of 1:31 and reproduced, as closely as possible, the existing conditions at sta 19+50 as described in the preceding paragraph. Due to the mixing of various types of prototype concrete armor units and limited range of available model armor unit weights, it was necessary to represent the existing 22,000-lb dolosse and 35,600-lb tribars as having prototype weights of 23,318 lb and 32,995 lb, respectively. The 16,000- to 20,000-lb keyed and fitted stone was represented by average individual stone weights of 18,000 lb with a linear gradation of ± 15 percent by weight. Section 1 was exposed to the wave and swl conditions of Hydrograph I and by the end of the test, the dolosse had sustained moderate to significant damage, 11 to 15 dolosse displaced upslope and 14 to 20 displaced downslope and were retained just off the dolos toe area (Photos 5-7). The dolos armor showed moderate to significant rocking in place and reorientation throughout the test. At different points during the test, it was estimated that as many as 50 dolosse showed

some type of in-place movement. Significant wave overtopping was noted throughout the hydrograph steps, but the majority of the overtopping wave energy was deflected into the harbor-side swl by the concrete cap; therefore the harbor-side armor stone was only exposed to minor amounts of overtopping wave energy. Only one armor stone was displaced off the harbor-side slope and no other movement or damage was observed. Although in-place dolos movement was noted throughout the test, no additional damage or displacement occurred during the last 45 min of Hydrograph I.

Thus it is not surprising that the 22,000-lb dolosse sustained significant damage when exposed to the severe wave conditions of Hydrograph I. Since there was only minor damage to the harbor-side armor stone of Section 1 and some instability of the sea-side dolosse should be expected for the test conditions selected in this study, POD decided not to conduct further tests at sta 19+50.

Photo 5. Side view of Section 1 after testing

Photo 6. Sea-side view of Section 1 after testing

Photo 7. Harbor-side view of Section 1 after testing

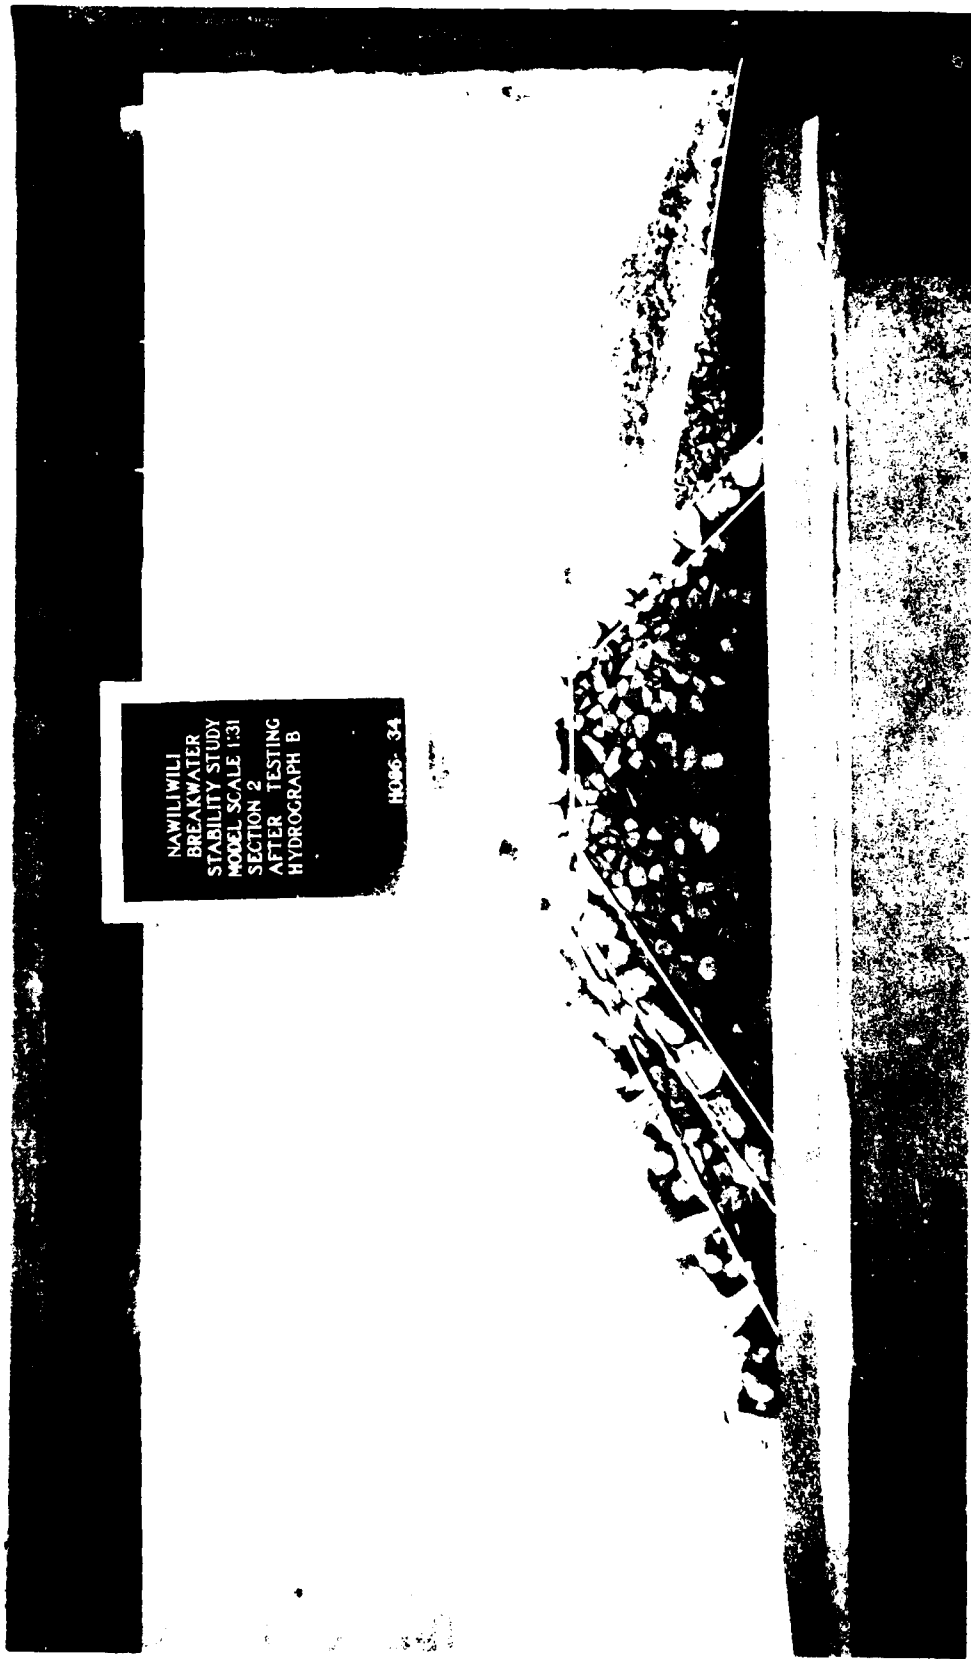
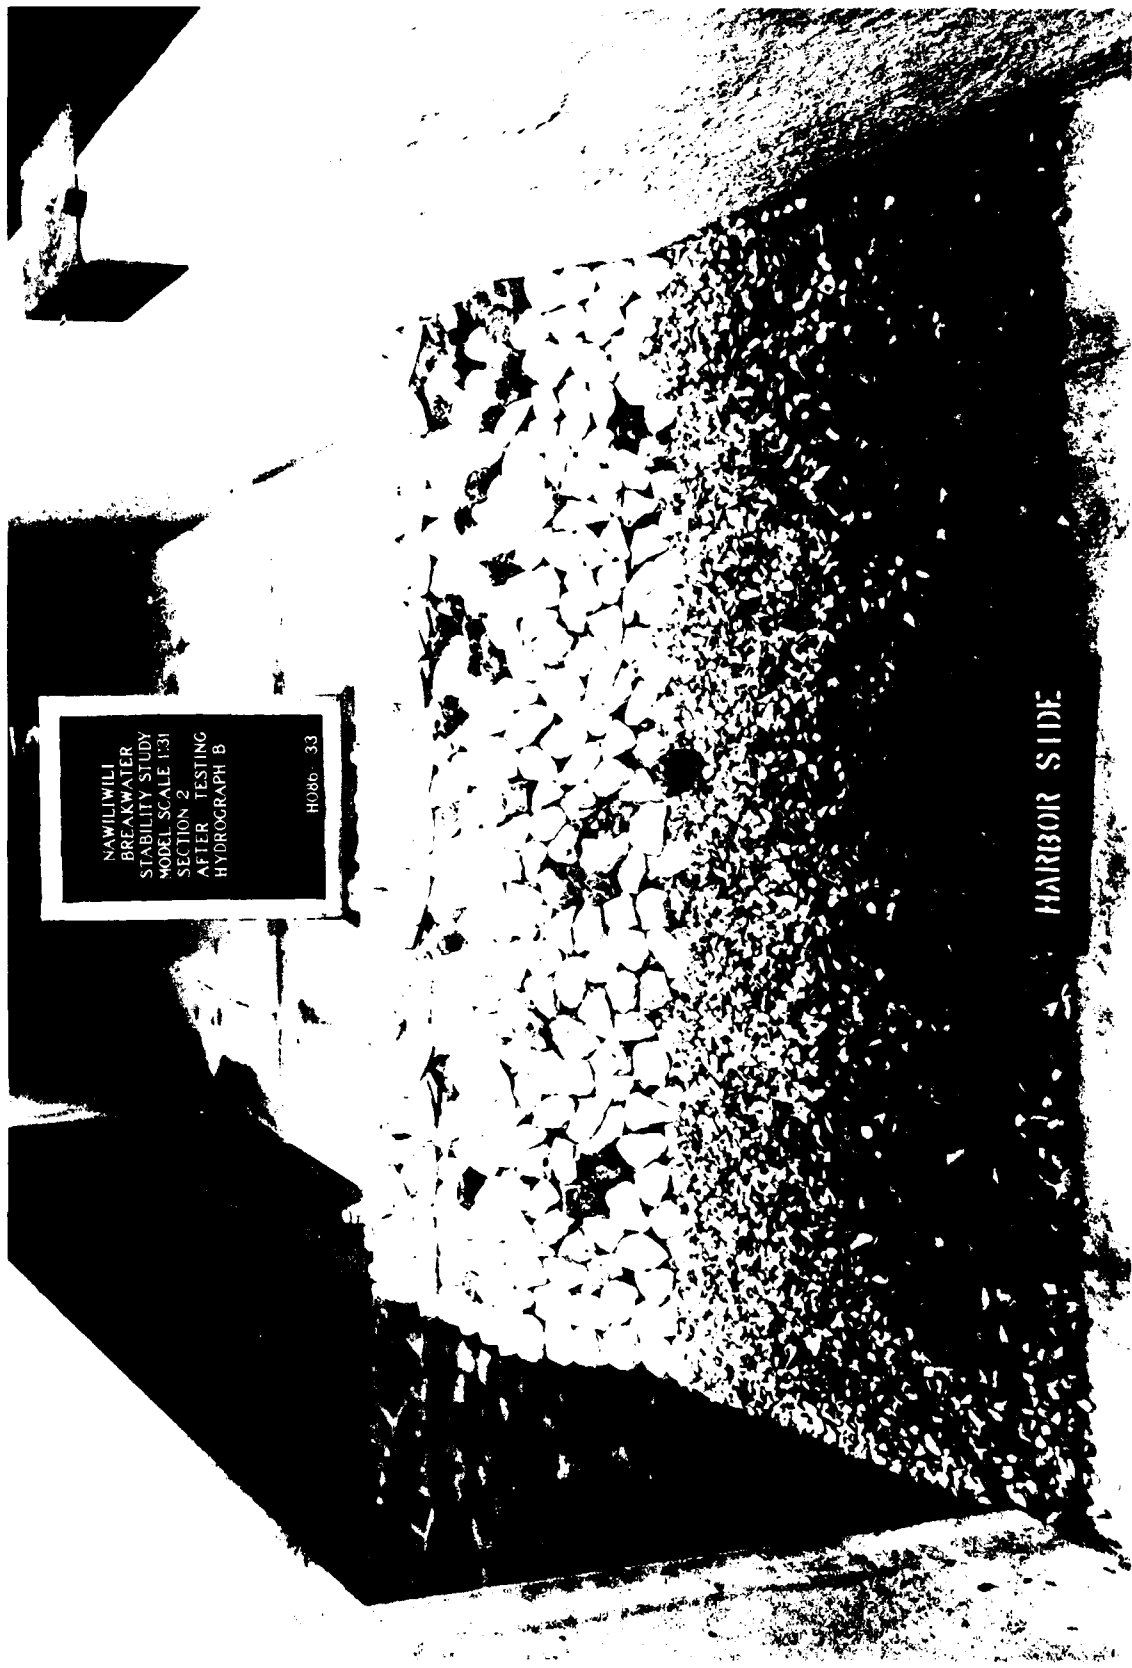
20. Section 2, Plate 5 and Photos 8-10 (before-test photographs are of the second test section; no before-test photographs were taken of the first and third test sections), was constructed in the test flume at a scale of 1:31 and reproduced, as closely as possible, the existing conditions at sta 14+00. The 22,000-lb dolosse were represented in the model as having individual prototype weights of 23,318 lb. The existing 16,000- to 20,000-lb armor stone were represented as having average individual weights of 18,000 lb with a linear gradation of ± 15 percent by weight. The test section was exposed to the wave and swl conditions of Hydrograph II. Minor to moderate in-place rocking of several dolosse on the lower sea-side slope was noted throughout the test but no displacement occurred. All three hydrograph steps produced significant overtopping, but the more severe overtopping conditions of Step 3 caused the displacement of one harbor-side slope armor stone. This displacement occurred early in Step 3 and no other damage occurred during the

remainder of the test. The overall condition of the breakwater appeared good at the end of the test (Photos 11-13).

Photo 11. Side view of Section 2 after testing, first test section

Photo 12. Sea-side view of Section 2 after testing, first test section

Photo 13. Harbor-side view of Section 2 after testing, first test section

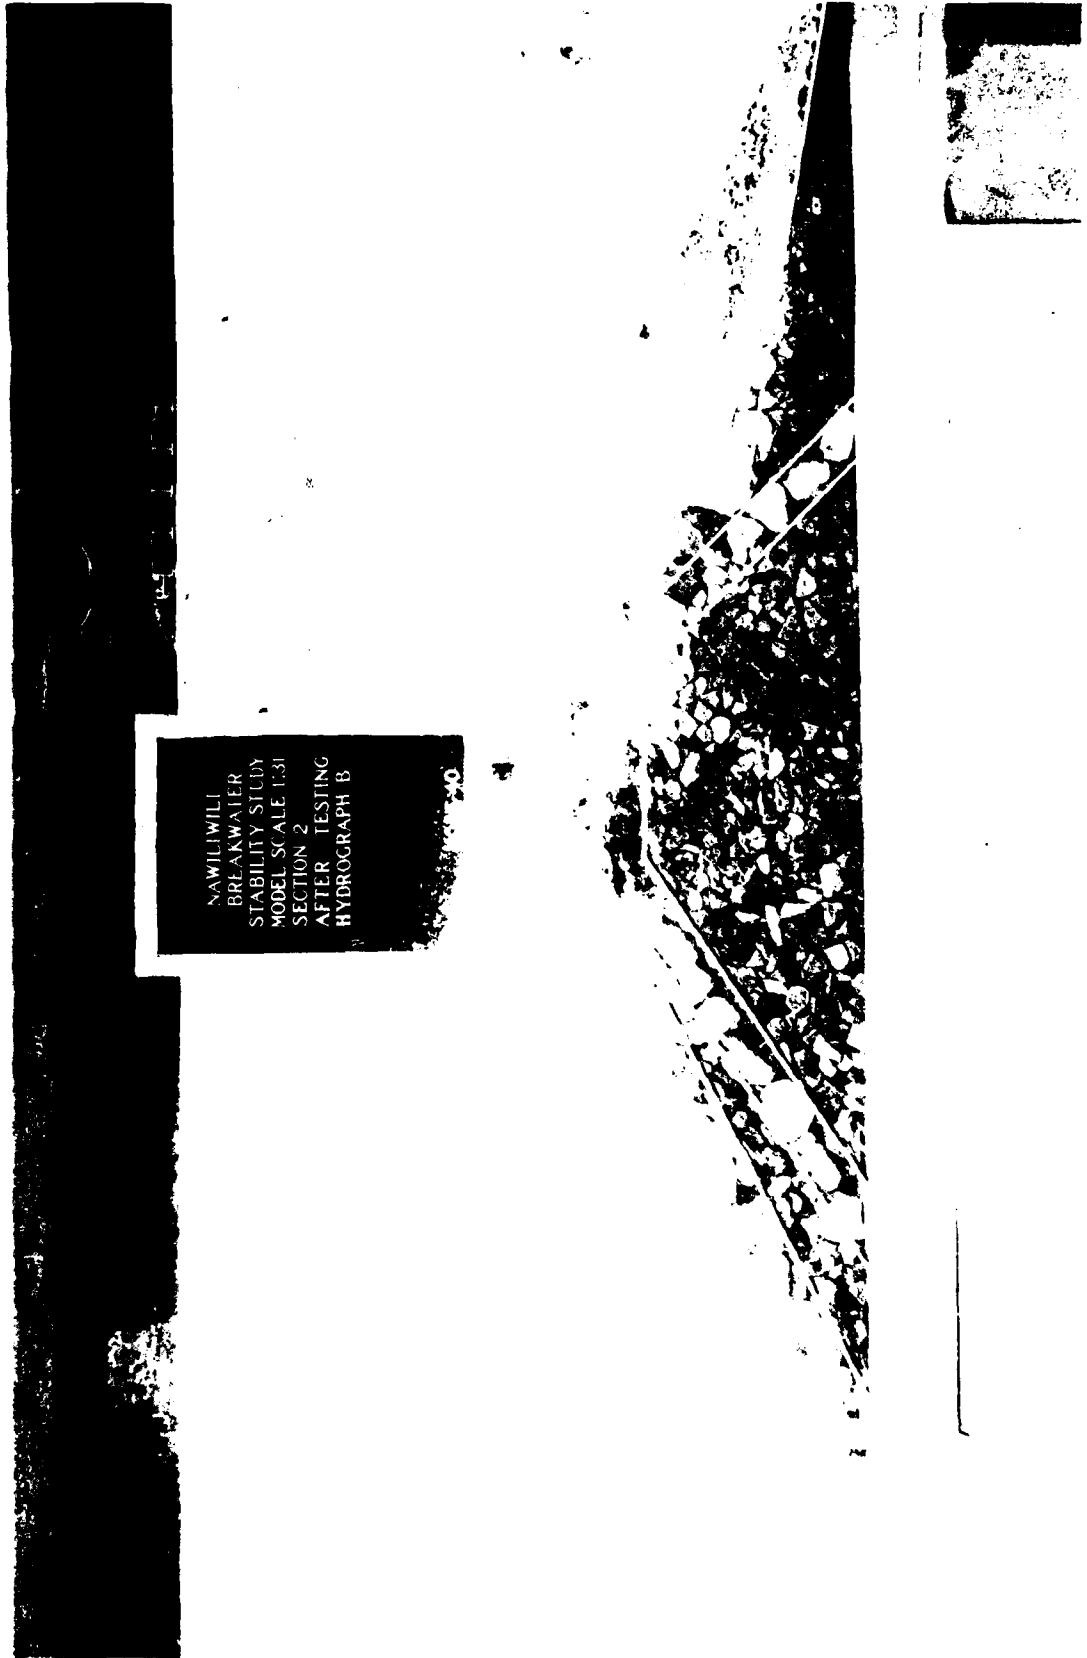
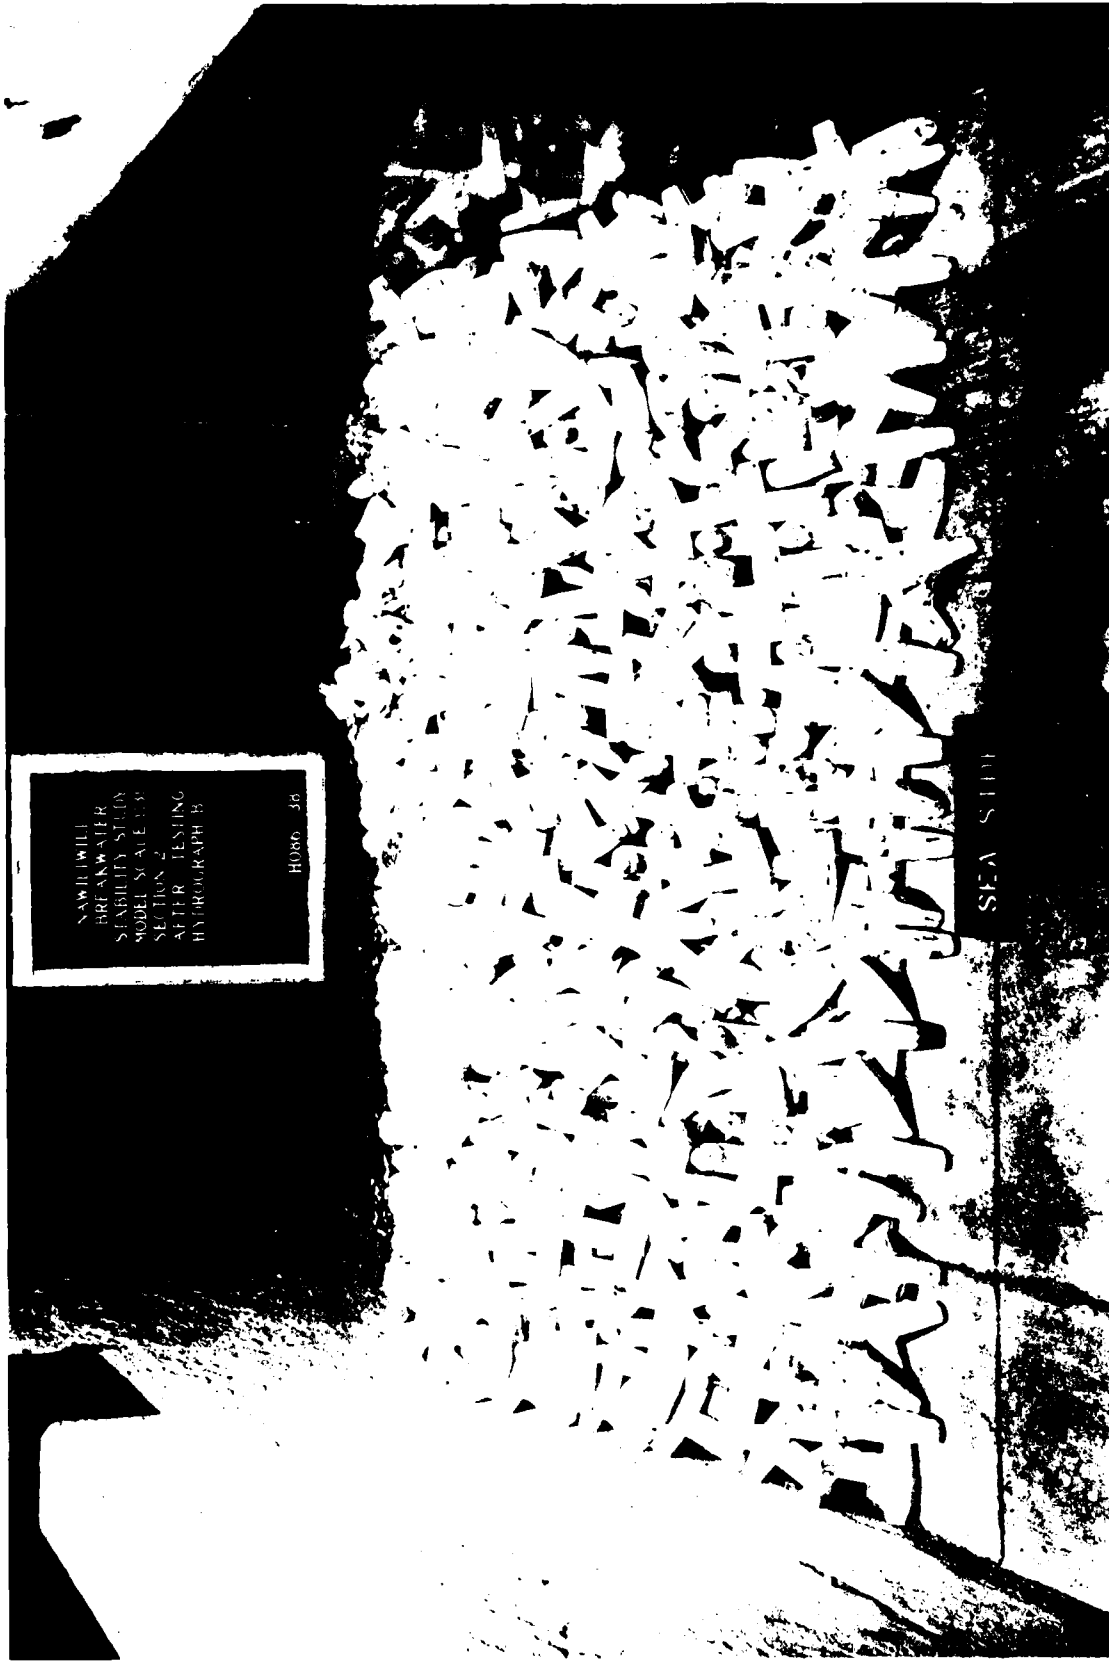
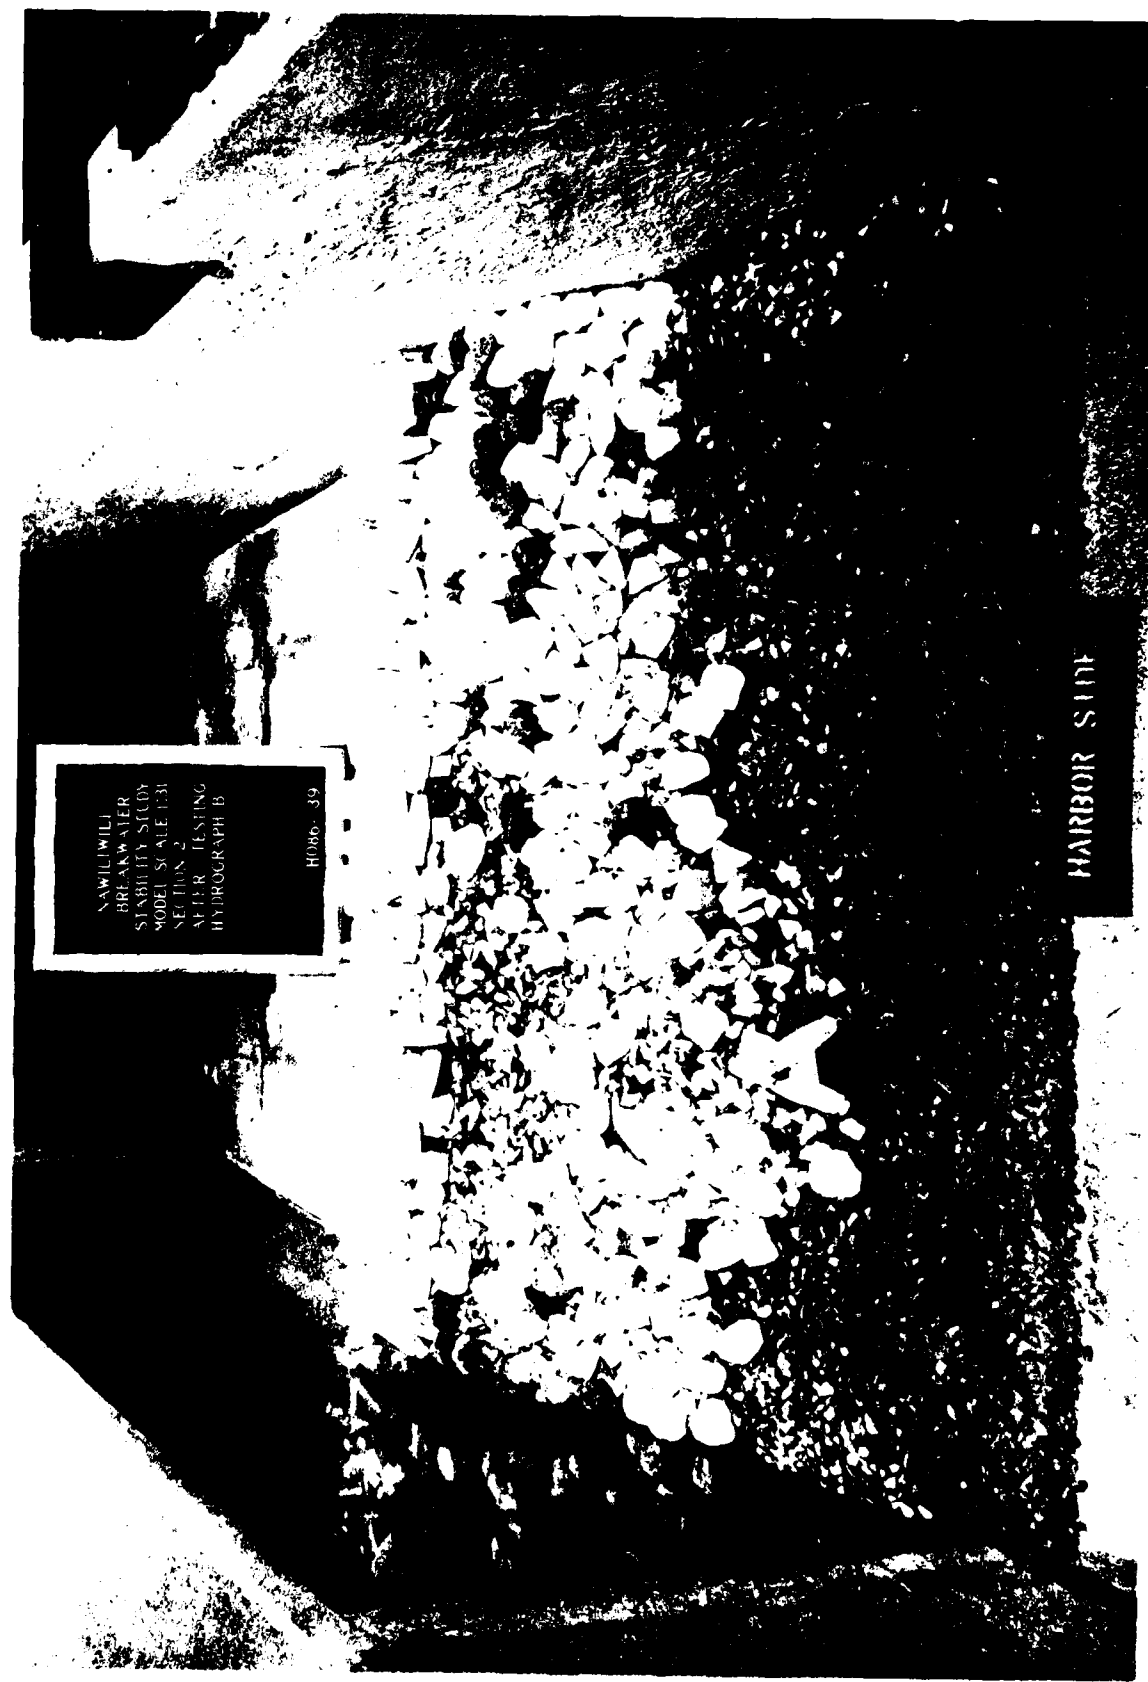
21. The test section was rebuilt and once again exposed to the test conditions of Hydrograph II. For this test, the hydrograph steps were reversed to see what effect, if any, this would have on the test results. (This hydrograph step reversal had been done during testing of Section 1 and no effects were noted on the overall test results.) Step 3 produced extensive damage on the crown and harbor-side slope. Early in Step 3, two of the keyed and fitted armor stone were displaced (one from the crown and one from just below the swl). Following this displacement, the crown and harbor-side slope began to unravel with each successive wave. One dolos was displaced from the crown onto the harbor-side rubble stone. By the end of Step 3, damage to the crown and harbor-side slope had slowed down, but the majority of the crown stone had been displaced and the overtopping waves had displaced a significant amount of core material. The armor-stone crown had failed, but this did not result in any undermining or displacement of dolosse along the sea side of the crown. Although the crown and harbor-side slope were considered failed, the structure was exposed to Steps 2 and 1 to see if these conditions would displace any of the crown dolosse or cause any other additional damage. These conditions caused no additional damage, but some moderate in-place rocking of dolosse on the lower sea-side slope and a slight shift toward the harbor-side were noted on a few of the crown dolosse. By the end of the test, all damage had stopped. The sea-side dolosse were in good condition and the armor-stone crown and harbor-side slope were in need of total rehabilitation (Photos 14-16).

22. It was noted during the construction of the second test section that the keyed and fitted construction achieved was not as tight as had been reproduced on the first test section. This may very well have been the reason for the failure of the second test section. Not knowing exactly how tight the existing prototype keyed and fitted armor stone actually are, it was decided to rebuild the test section. During this building, an effort was made to achieve the same tightness of construction as had been accomplished on the first test section. The test section was once again exposed to Hydrograph II. The hydrograph steps were run in reverse to see if the tighter crown and harbor-side slope construction would prove stable for the selected test conditions. One armor stone was displaced from the upper harbor-side slope

Photo 14. Side view of Section 2 after testing, second test section

Photo 15. Sea-side view of Section 2 after testing, second test section

Photo 16. Harbor-side view of Section 2 after testing, second test section

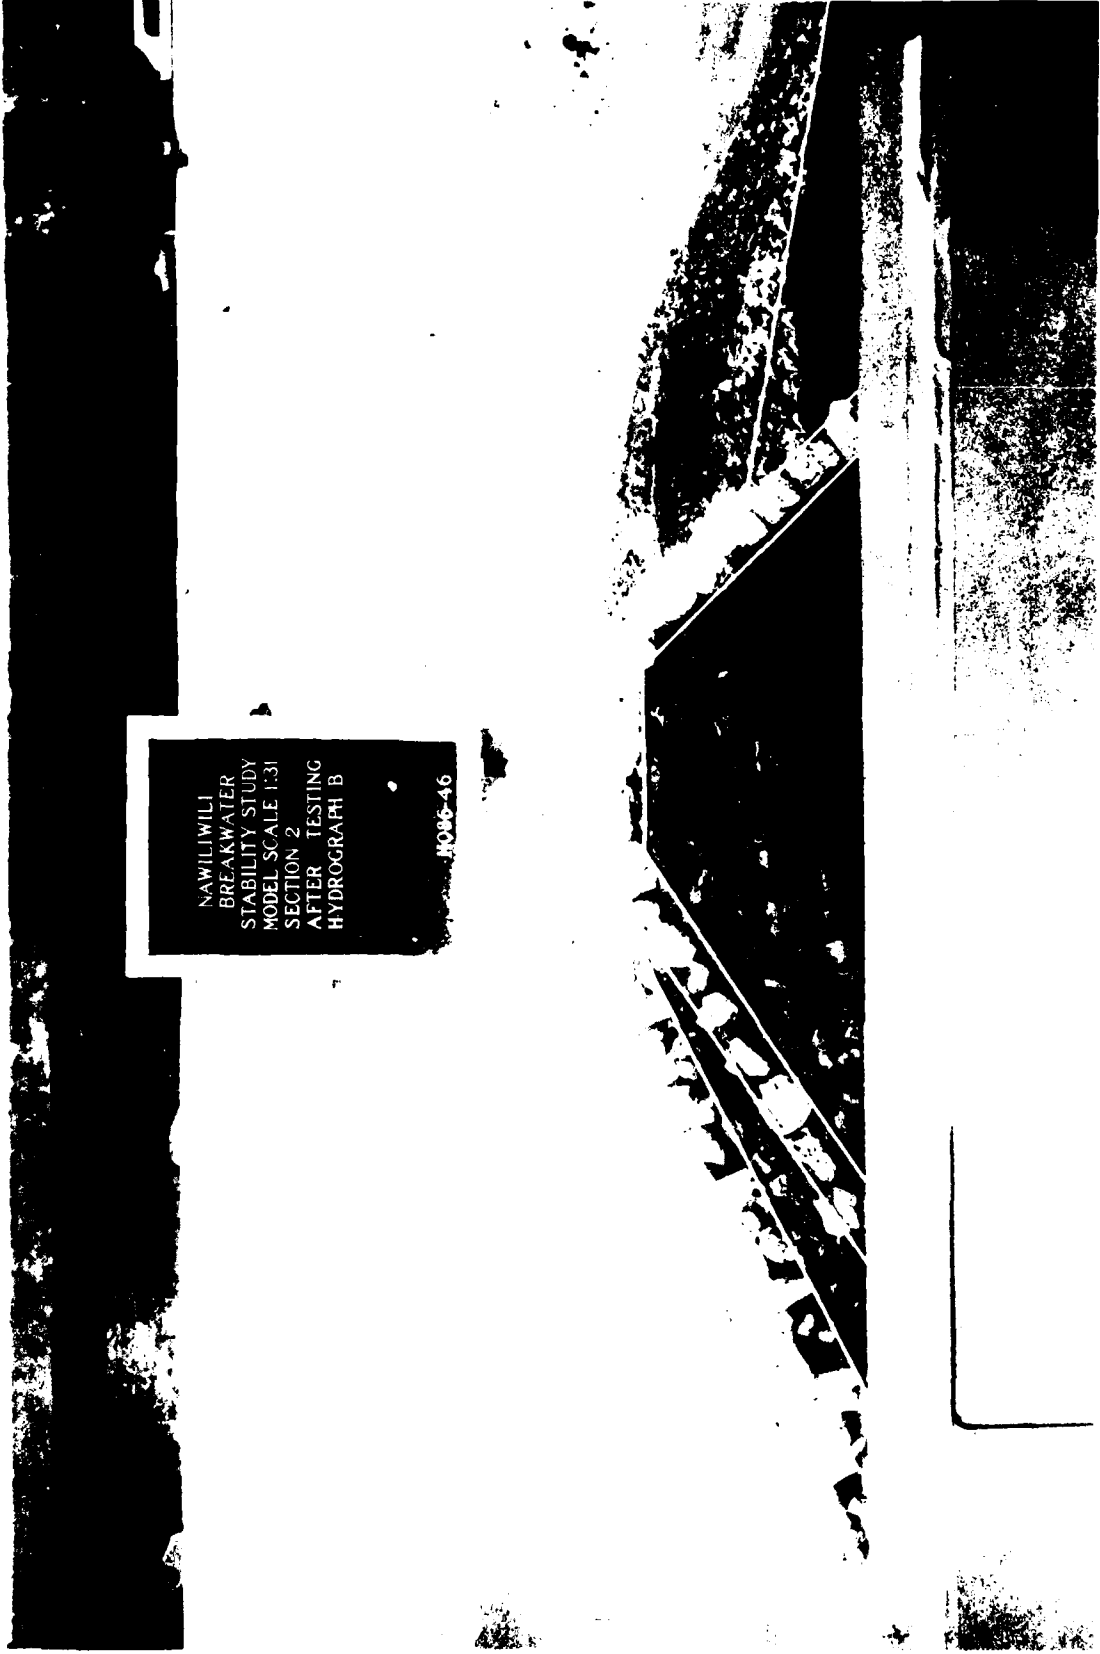
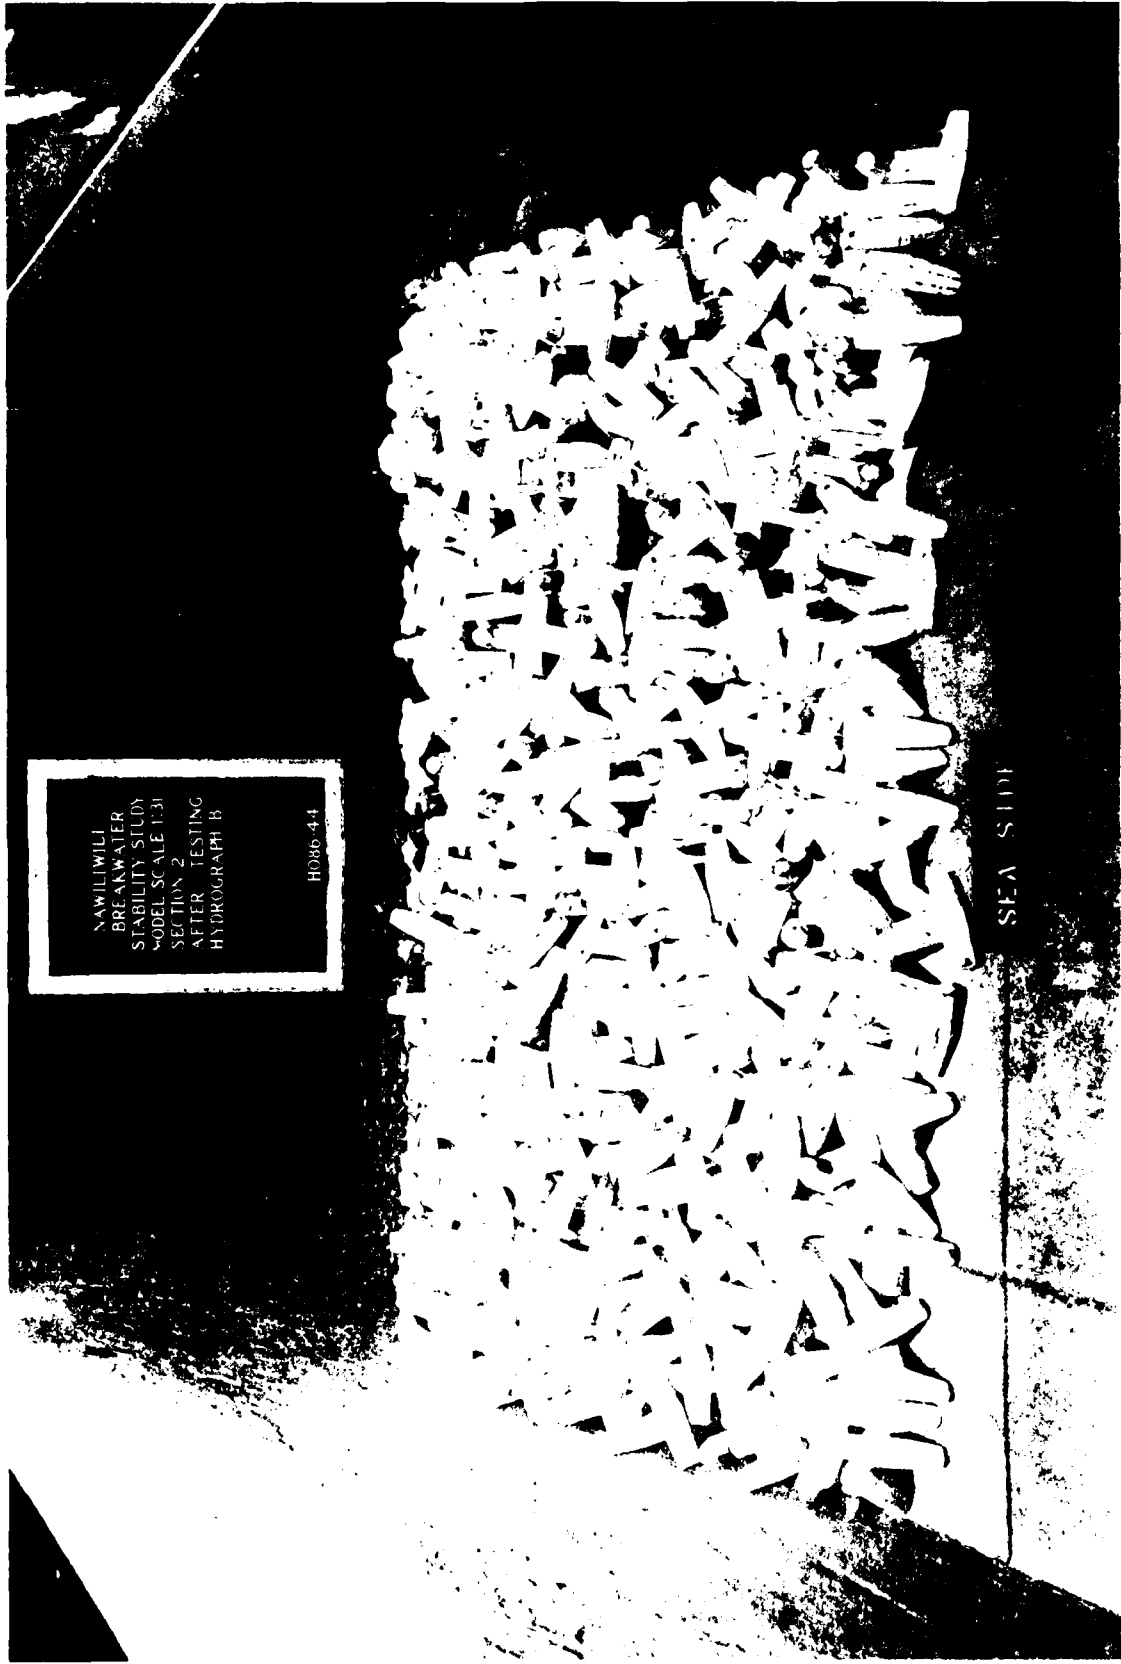
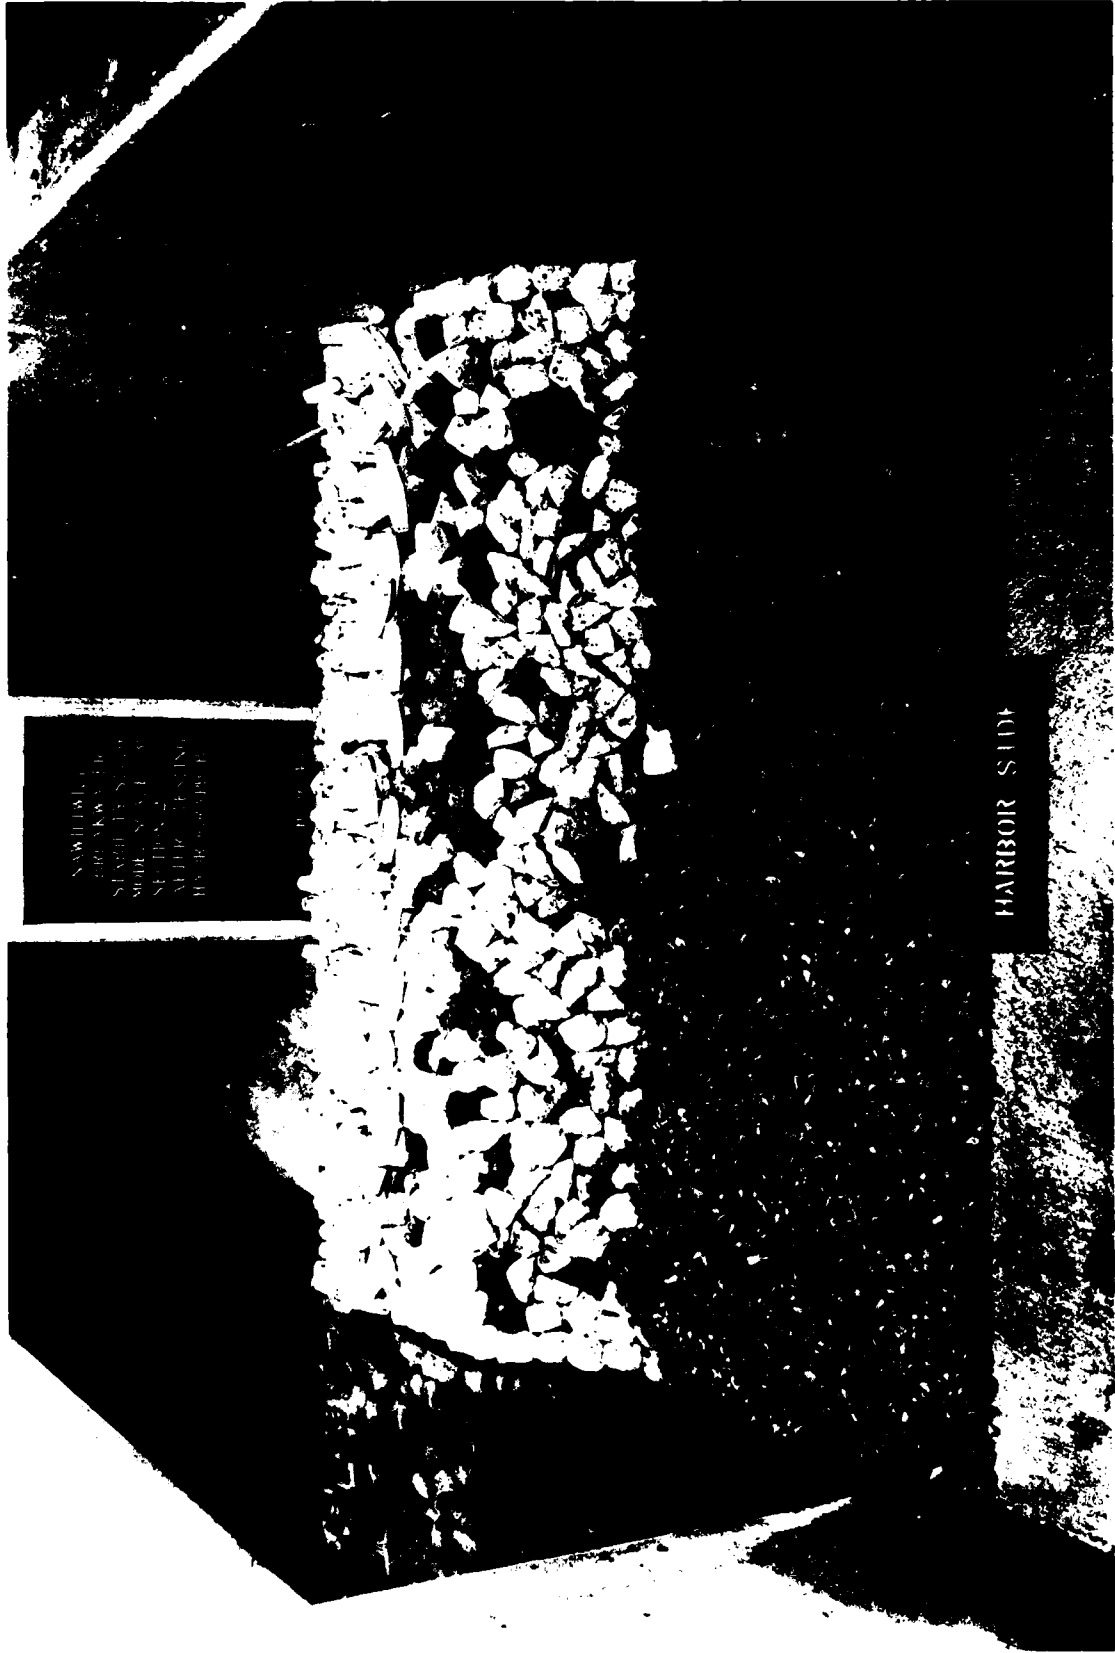
during Step 3 and minor to moderate in-place rocking of 10 to 12 dolosse was noted throughout the hydrograph. No other movement or damage occurred and the structure was in good condition at the end of the test (Photos 17-19).

Photo 17. Side view of Section 2 after testing, third test section

Photo 18. Inboard view of Section 2 after testing, third test section

Photo 19. Harbor-side view of Section 2 after testing, third test section
