TECHNICAL REPORT HL-83-21

NAWILIWILI BREAKWATER STABILITY STUDY NAWILIWILI HARBOR, KAUAI, HAWAII

Hydraulic Model Investigation

September 1983

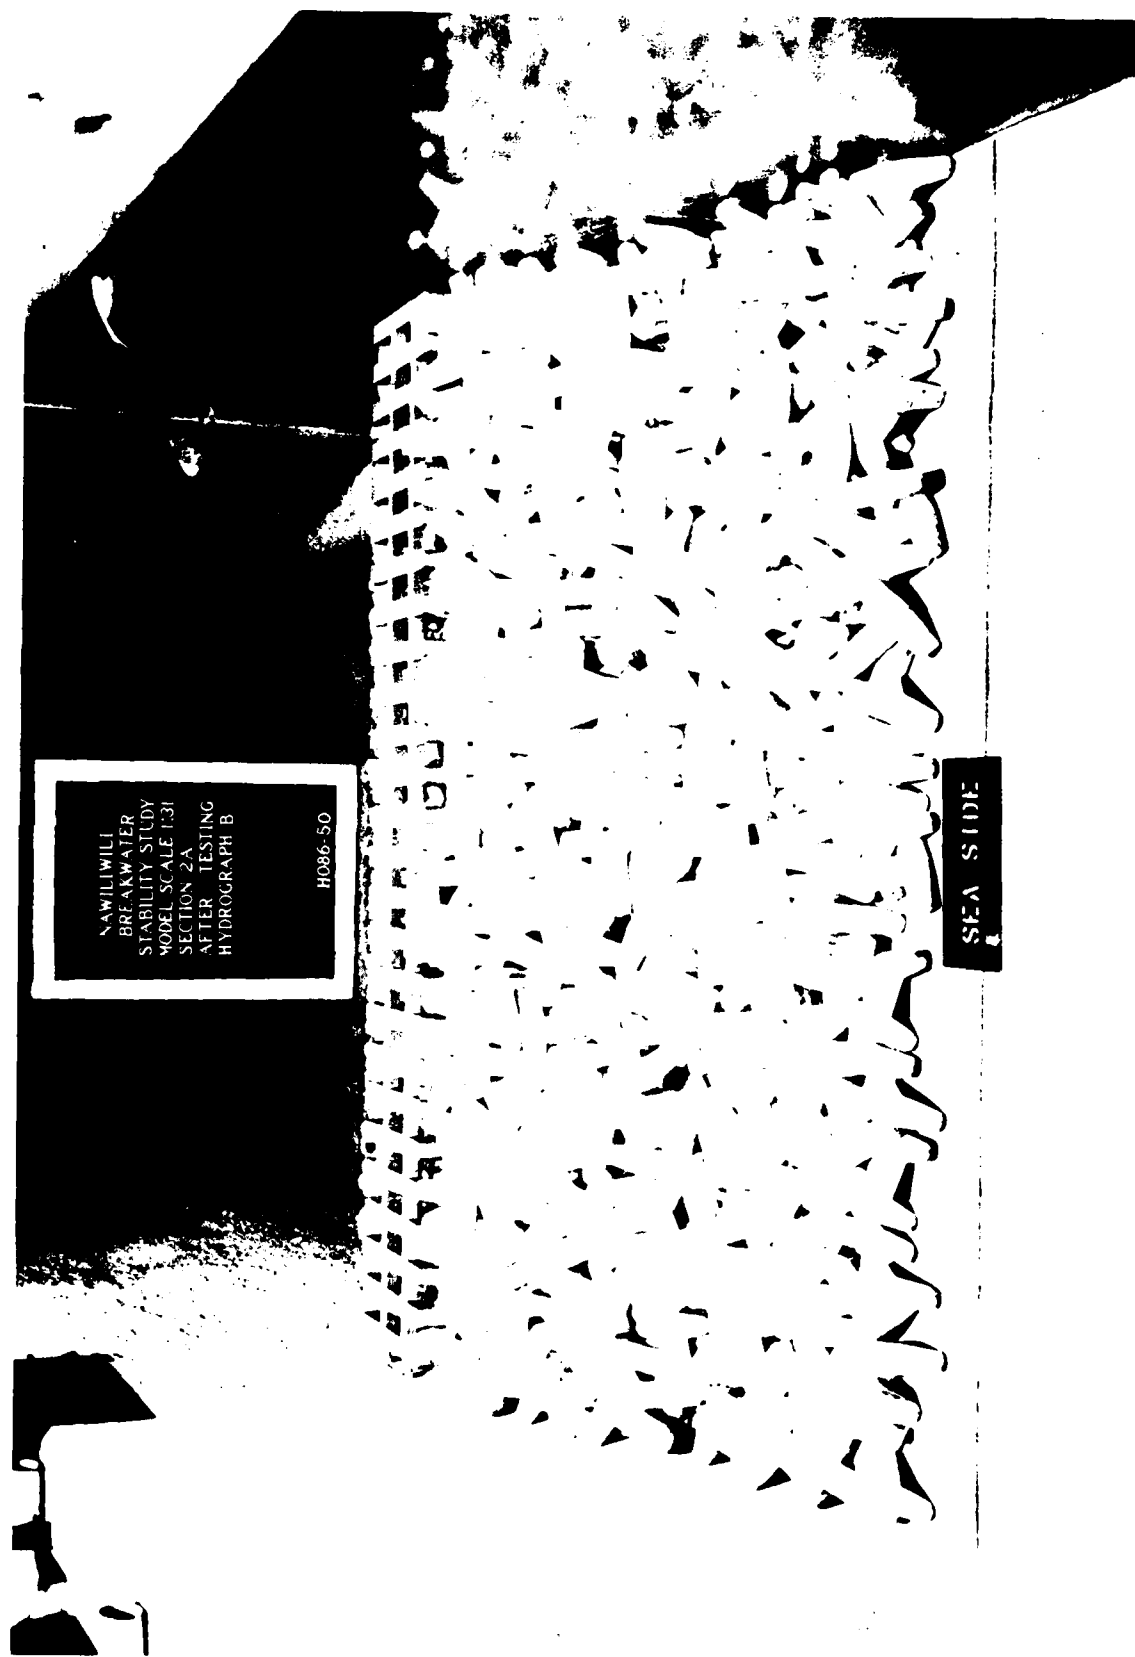
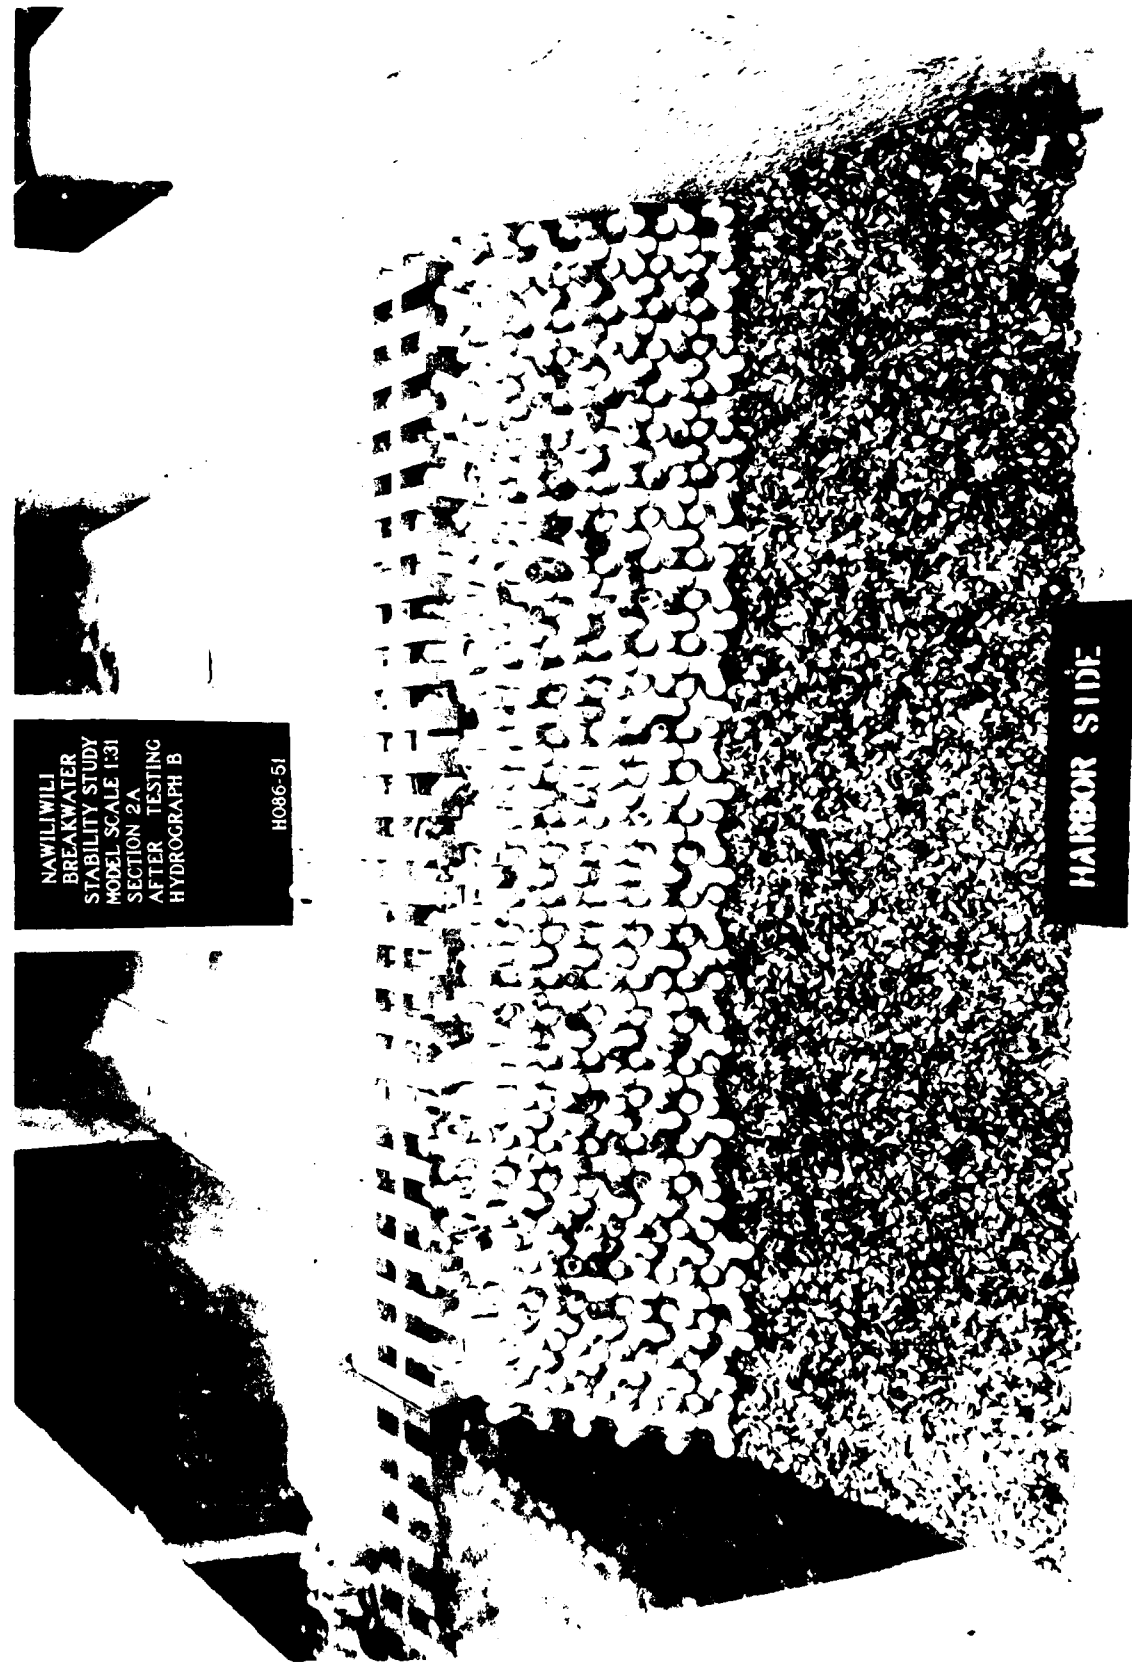
Plexiglas, was geometrically similar to the proposed prototype rib cap and was held in place in the model, thus ensuring proper transmission, reflection, and dissipation of wave energy and the assumed stability of the prototype rib cap. Due to model scale selection and availability of model tribar unit weights, the 13,000-lb tribars were represented in the model as having individual weights of 12,827 lb. The test section was exposed to wave and swl conditions of Hydrograph II. Minor to moderate degrees of rocking in place of several dolosse on the lower sea-side slope were observed throughout the test, but no dolos displacement occurred. The rib cap reduced the amount of overtopping wave energy, but all three hydrograph steps still produced moderate to significant amounts of overtopping. The majority of the overtopping wave energy was deflected away from the harbor-side slope by the rib cap. Some very minor in-place rocking of a couple of tribars next to the rib cap was noted during Step 3. No other movement was observed and the structure was in very good condition at the end of the test (Photos 23-25).

- (4) The proposed concrete rib cap for the crown and 13,000-lb tribars for the harbor-side slope of Section 2A are very adequate designs for the wave and swl conditions of Hydrograph II.

Photo 23. Side view of Section 2A after testing

Photo 24. Sea-side view of Section 2A after testing

Photo 25. Harbor-side view of Section 2A after testing

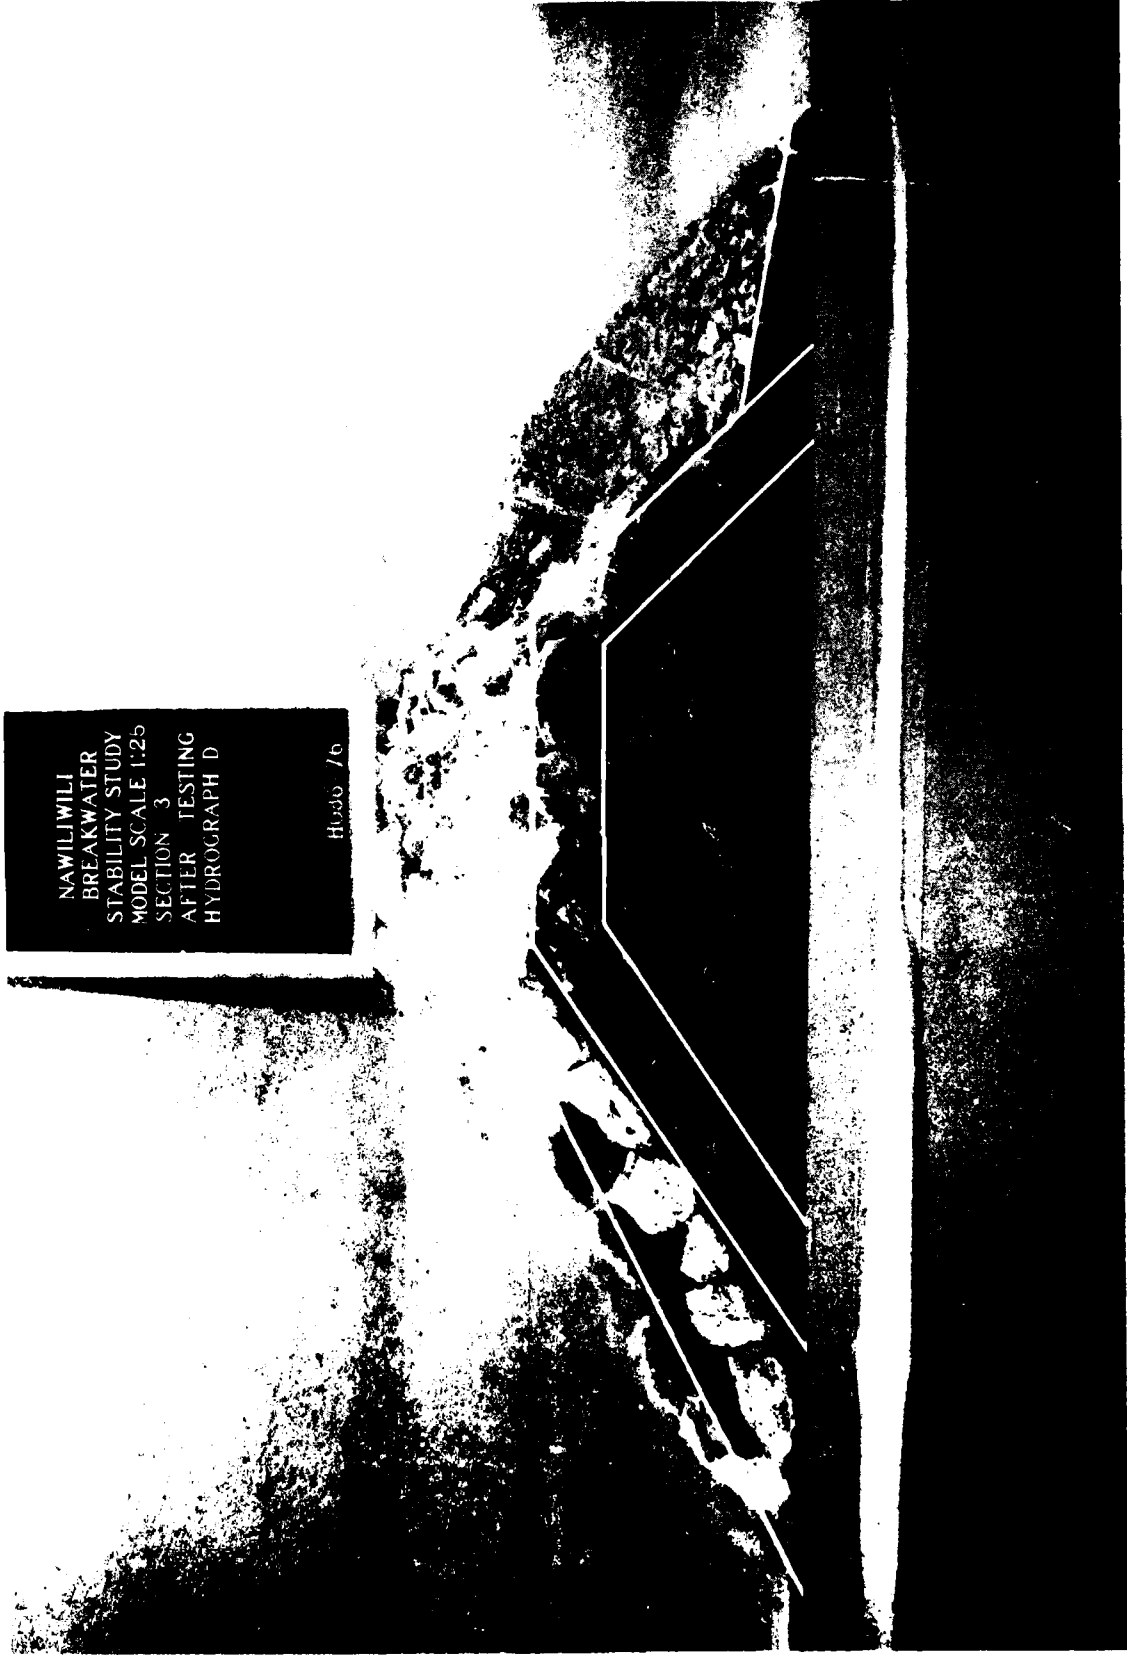
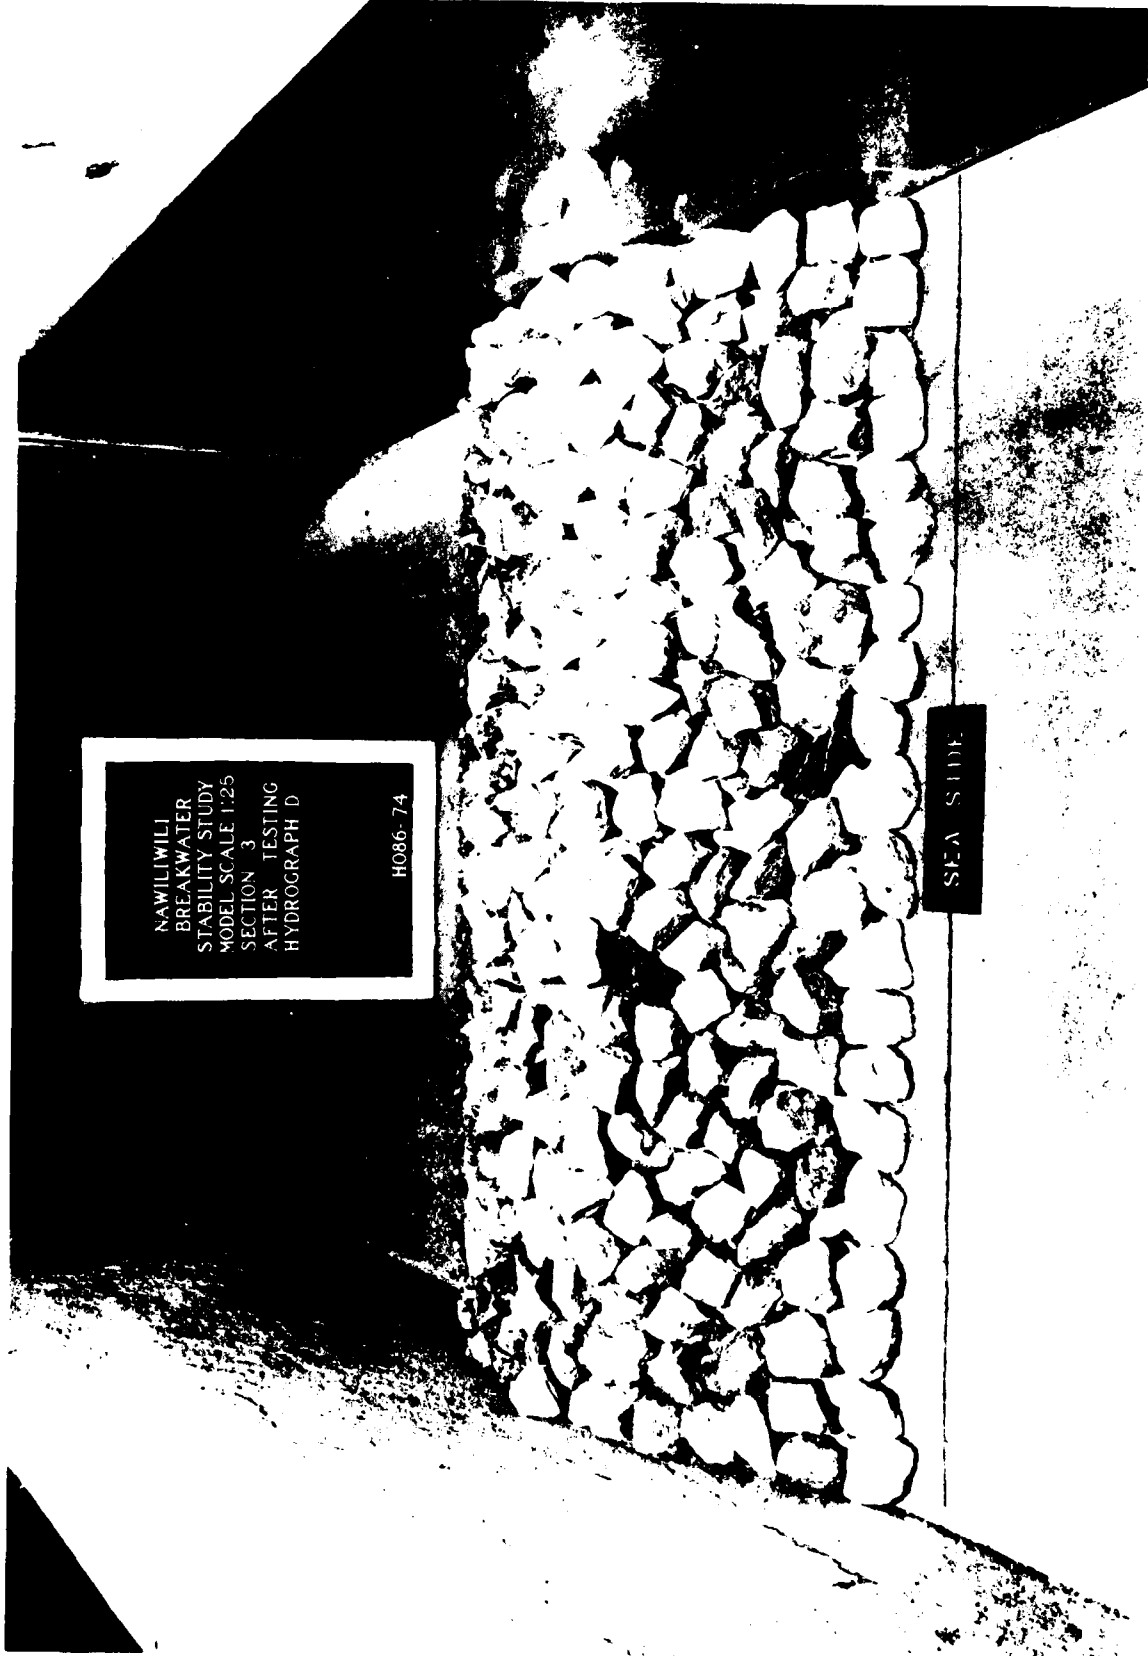
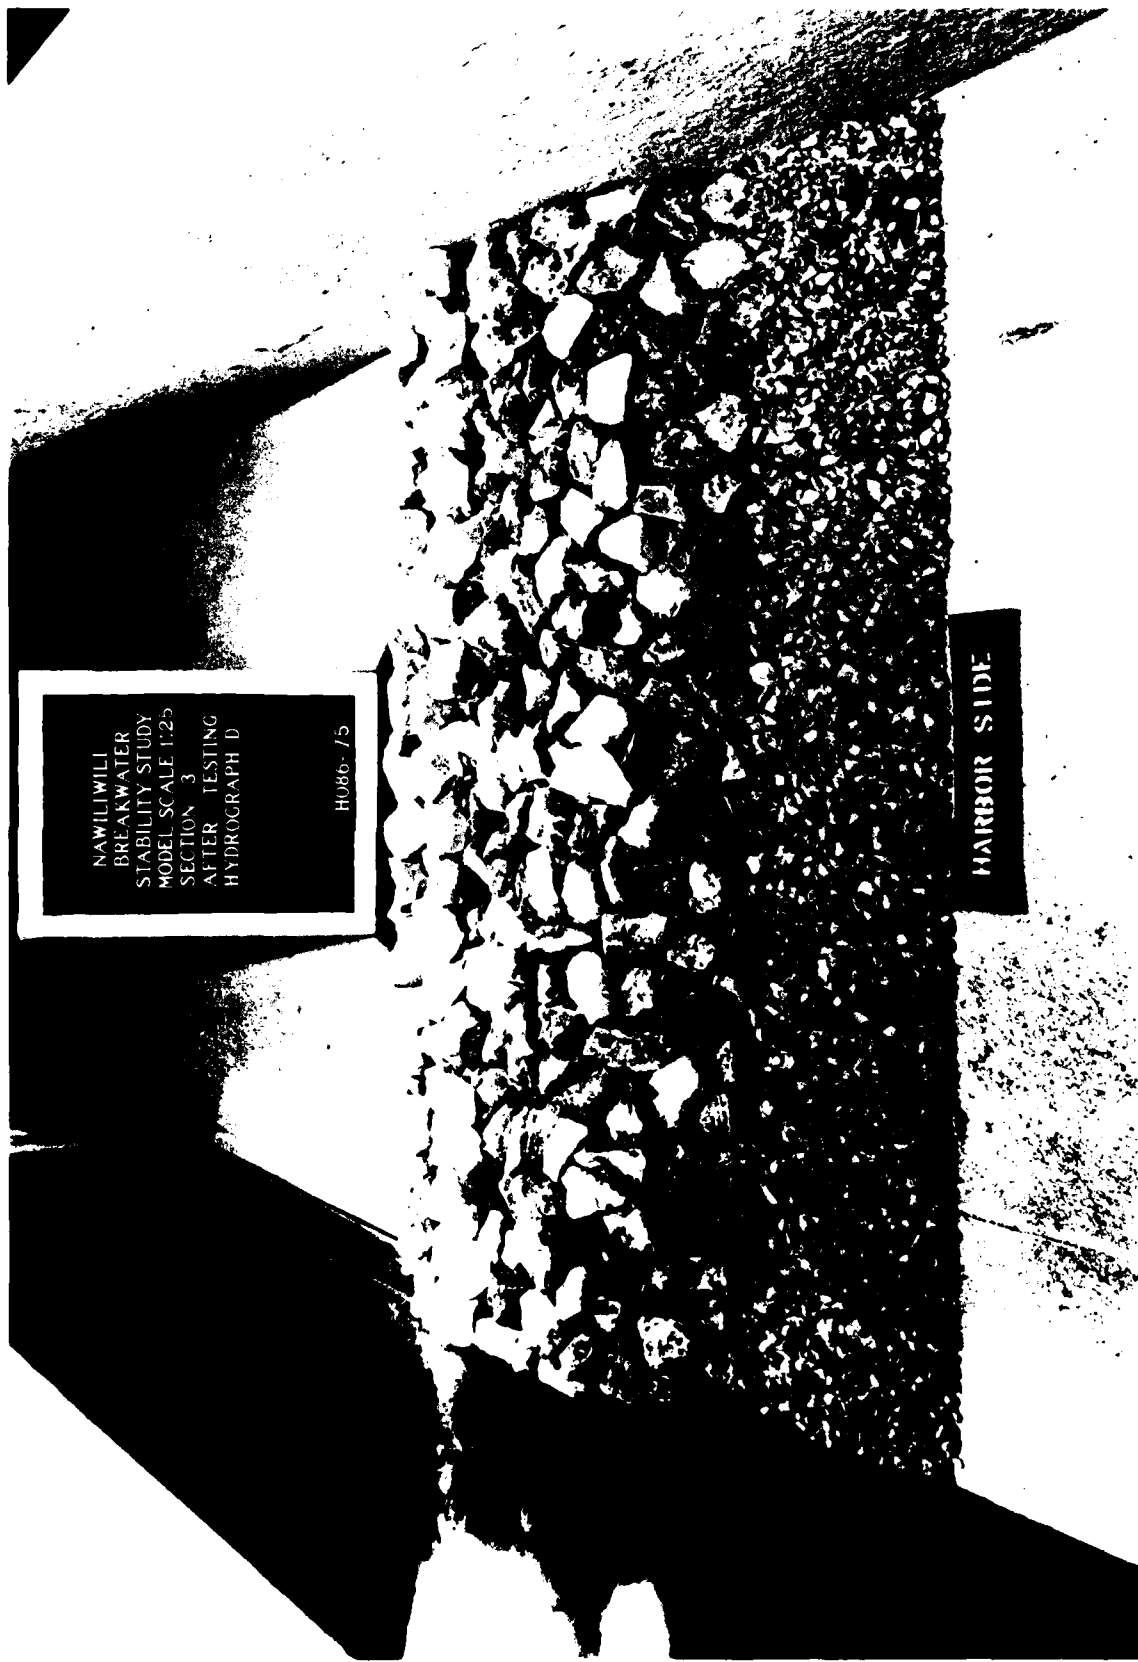
27. Section 3, Plate 7 and Photos 26-28, was constructed at a scale of 1:25 and reproduced, as closely as possible, the existing conditions at sta 10+00. The 16,000- to 20,000-lb keyed and fitted armor stone and the 14,000- to 24,000-lb random-placed armor stone were represented as having average individual stone weights of 18,000 lb and 19,000 lb, respectively, with linear gradations of ± 15 percent by weight. Section 3 sustained no

damage during its exposure to Hydrograph III (Photos 29-31). The only movement observed was minor in-place rocking of four to six armor stone on the lower sea-side slope. Steps 1 and 2 of Hydrograph III produced minor to moderate amounts of splash over the structure crown, while Step 3 produced very minor amounts of solid water overtopping.

Photo 29. Side view of Section 3 after testing

Photo 30. Sea-side view of Section 3 after testing

Photo 31. Harbor-side view of Section 3 after testing
