# MARINE CASUALTY REPORT

## SS OGDEN WILLAMETTE: MAJOR ENGINE ROOM FLOODING

MARINE BOARD OF INVESTIGATION REPORT

REPORT NO. USCG 16732/0210

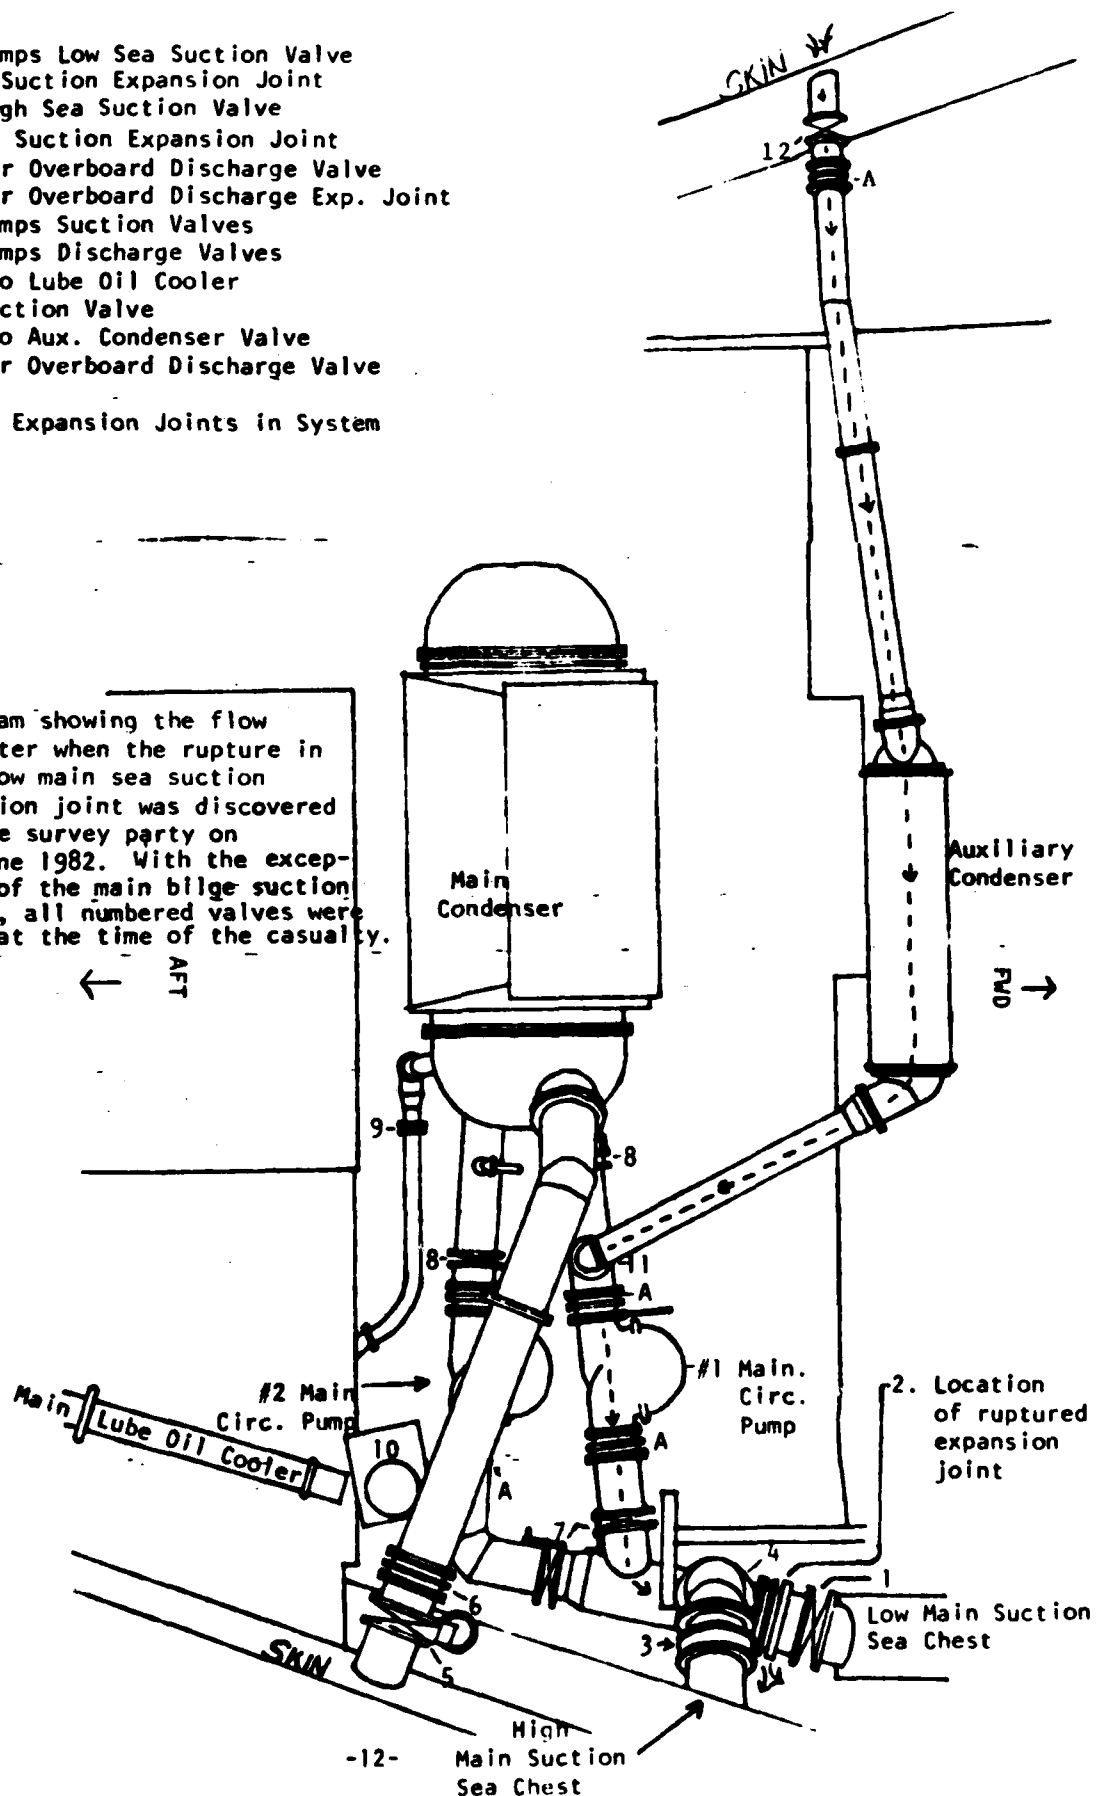
Figure 1. Diagram showing the flow of water when the rupture in the low main sea suction expansion joint was discovered by the survey party on 29 June 1982. With the exception of the main bilge suction valve, all numbered valves were open at the time of the casualty.
