# GRANGER LAKE

## FINAL FOUNDATION REPORT

## EMBANKMENT-OUTLET WORKS-SPILLWAY

VOLUME-1  
AUGUST 1983

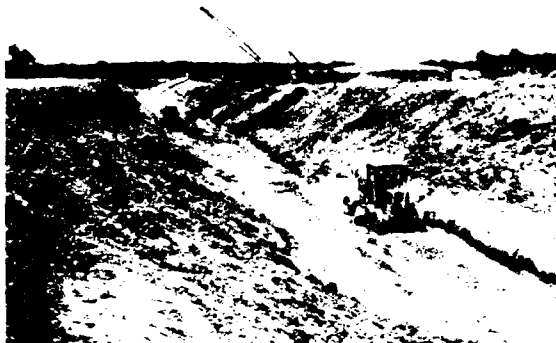
*Figure 1.* Cutoff trench, 1st contract: Looking north toward San Gat River from vicinity of station 41+00, upstream.

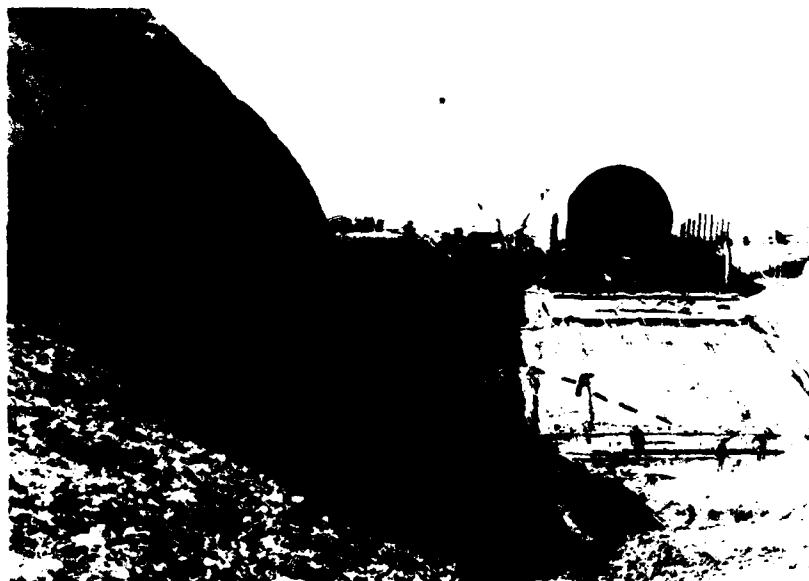
*Figure 38.* Outlet works, 2nd contract: View of one fault of Balcones system and two faults of local system in the right stilling basin sideslope.

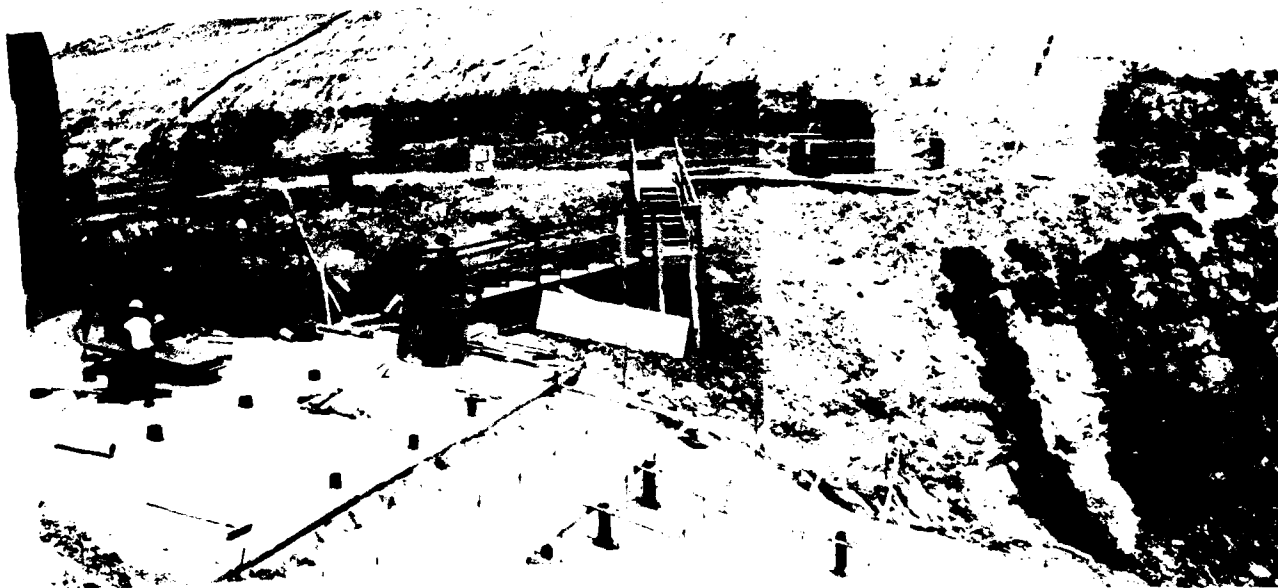
Figure 42. Outlet Works, 2nd contract: Left (north) sideslope of chute and stilling basin showing faults and the lower depositional seam.

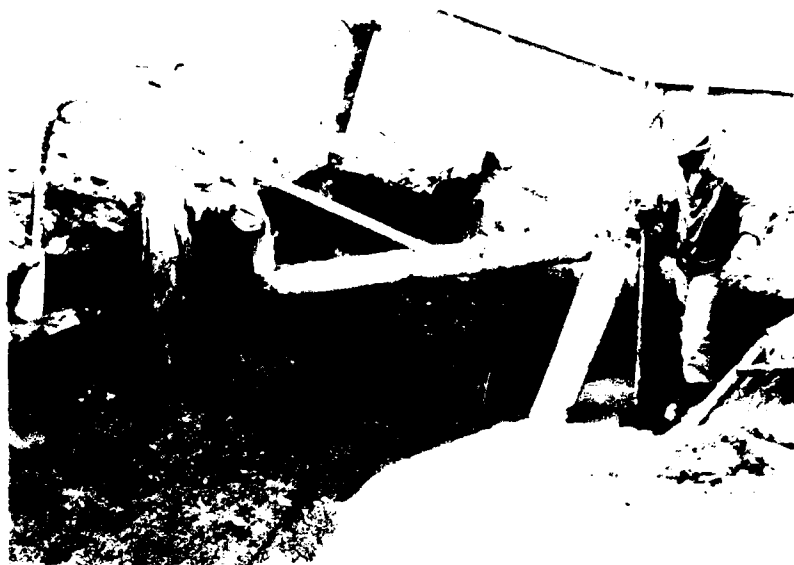
*Figure 82.* Spillway, 3d contract: View of slumped drainage blanket sand and resulting void under the work slab. Note: Water leaking from water-charged cross drainpipe. Site is next to left wall at foot of chute.

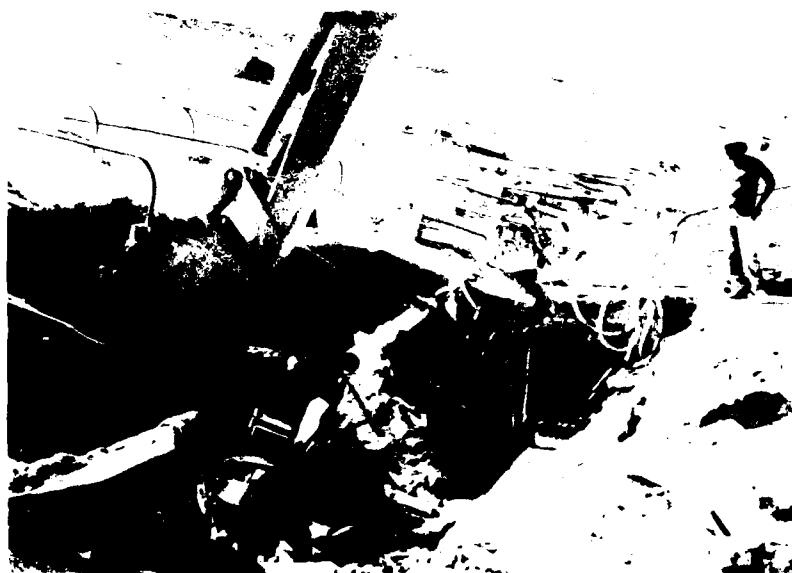
*Figure 83.* Spillway, 3d contract: Excavating manhole at offset 207.5 feet left at the base of the chute. Note void under the work slab both upstream and downstream from key concrete. Also key concrete reaching cross drainpipe.
