CONNECTICUT RIVER BASIN  
WEST HARTFORD, CONNECTICUT

**HARTFORD RESERVOIR NO.2 DAM  
CT 00003**

**PHASE I INSPECTION REPORT  
NATIONAL DAM INSPECTION PROGRAM**

DECEMBER 1980

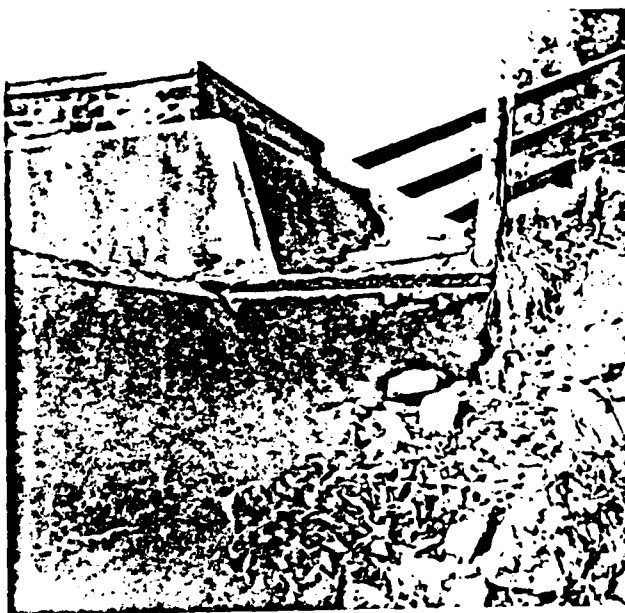
#3 Walkway slab at spillway is undermined

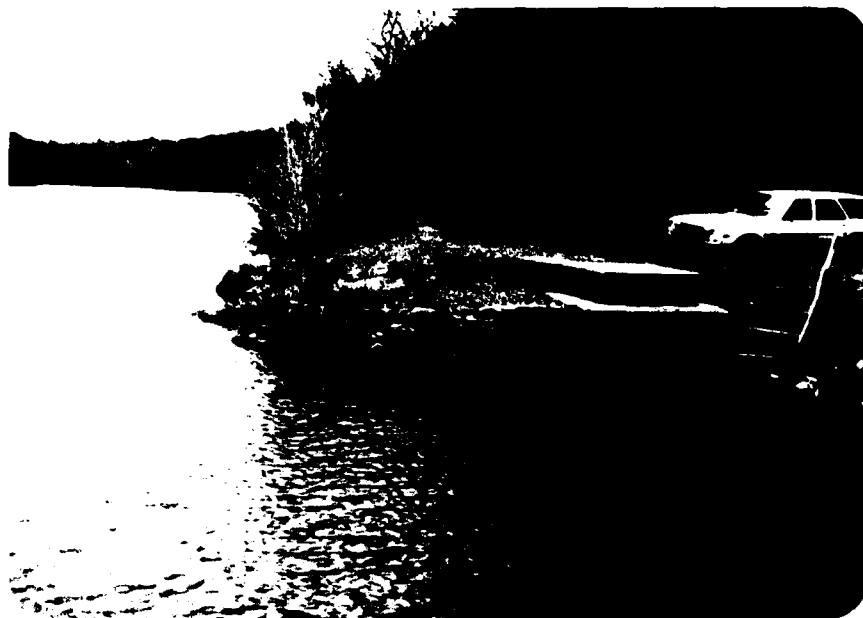
PHOTO NO. 12

LEFT TRAINING WALL
