NATIONAL DAM INSPECTION PROGRAM ULBRICH RESERVOIR DAM
(CT 00038) CONNECTI..(U) CORPS OF ENGINEERS WALTHAM MA
NEW ENGLAND DIV APR 81

4. TITLE (and Subtitle) Conn. Coastal Wallingford, Conn. Ulbrich Reservoir Dam NATIONAL PROGRAM FOR INSPECTION OF NON-FEDERAL DAMS	5. TYPE OF REPORT & PERIOD COVERED INSPECTION REPORT

OVERVIEW PHOTO
DECEMBER, 1980
ULBRICH RESERVOIR DAM
SPRING BROOK
WALLINGFORD, CONNECTICUT

U.S. ARMY ENGINEER DIV. NEW ENGLAND CORPS OF ENGINEERS WALTHAM, MASS.	NATIONAL PROGRAM OF INSPECTION OF NON-FED DAMS	PHOTO LOCATION PLAN ULBRICH RESERVOIR DAM SPRING BROOK WALLINGFORD, CONNECTICUT
PHILIP W. GENOVESE AND ASSOCIATES, INC. ENGINEERS - HAMDEN, CT.

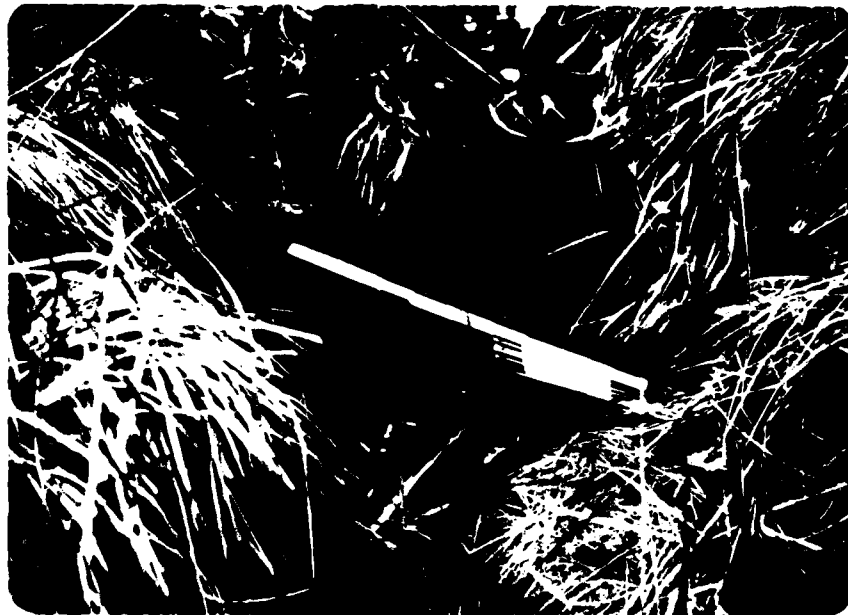
No flow was observed from the 10-inch toe drains, which extend from Sta 16+45 to Sta 20+45 and from Sta 7+45 to Sta 11+45 (Photos Nos. 4, 5, and 12), and no flowing seepage was observed on the downstream slope or toe of the dam. At the time of inspection the reservoir elevation was 5 feet below the spillway crest, 2 feet above the toe drain elevation between Sta 16+45 and Sta 20+45, and about 8 feet above the toe drain elevation between Sta 7+45 and Sta 11+45.

4. 10-inch-diameter concrete pipe in toe drain outlet on left side of spillway discharge channel.
