HOUSATONIC RIVER BASIN  
DANBURY CONNECTICUT

# MERCERS POND DAM CT 00068

## PHASE I INSPECTION REPORT NATIONAL DAM INSPECTION PROGRAM

JULY 1980

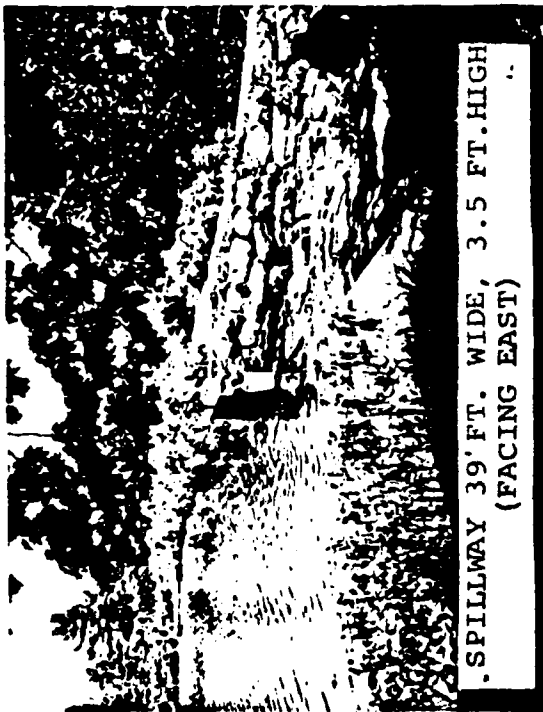
SPILLWAY 39' FT. WIDE, 3.5 FT. HIGH  
(FACING EAST)
