HOUSATONIC RIVER BASIN
DANBURY CONNECTICUT

PADANARAM RESERVOIR DAM
CT 00067

PHASE I INSPECTION REPORT
NATIONAL DAM INSPECTION PROGRAM

JULY 1980

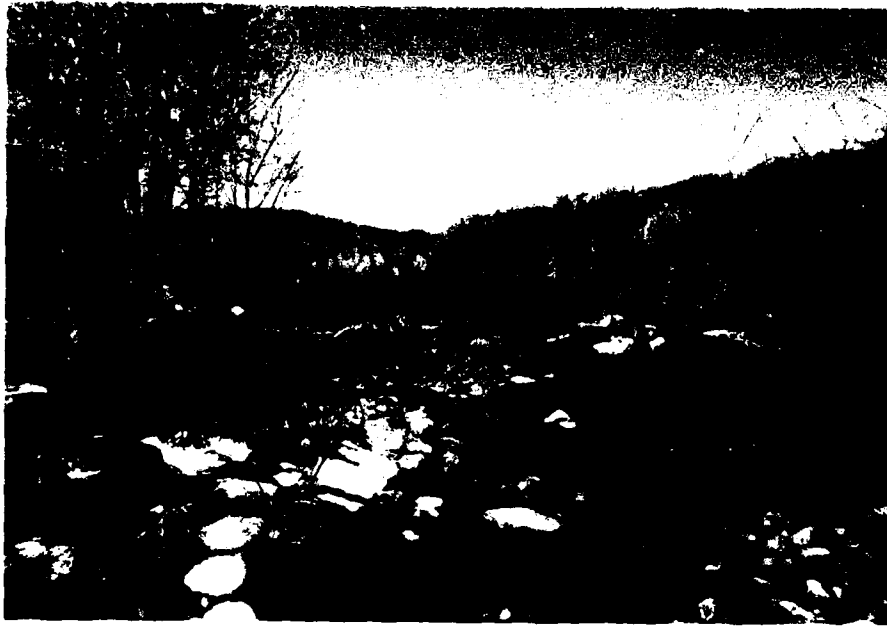
The spillway is a stone weir that is in fair condition (Photo 3). The approach channel is not well defined and is the natural slope of the bottom of the pond. The training walls of the spillway are also stone masonry and are in fair condition. The downstream channel is a natural channel with riprap in some areas. It is 24 feet wide with steep side slopes (Photo 4). The condition is good except for areas of the channel where debris is cluttered.

PHOTO 3
SPILLWAY-UPSTREAM
