JOHN D. MILNE DAM  
CT 00058

PHASE I INSPECTION REPORT  
NATIONAL DAM INSPECTION PROGRAM

AUGUST 1978

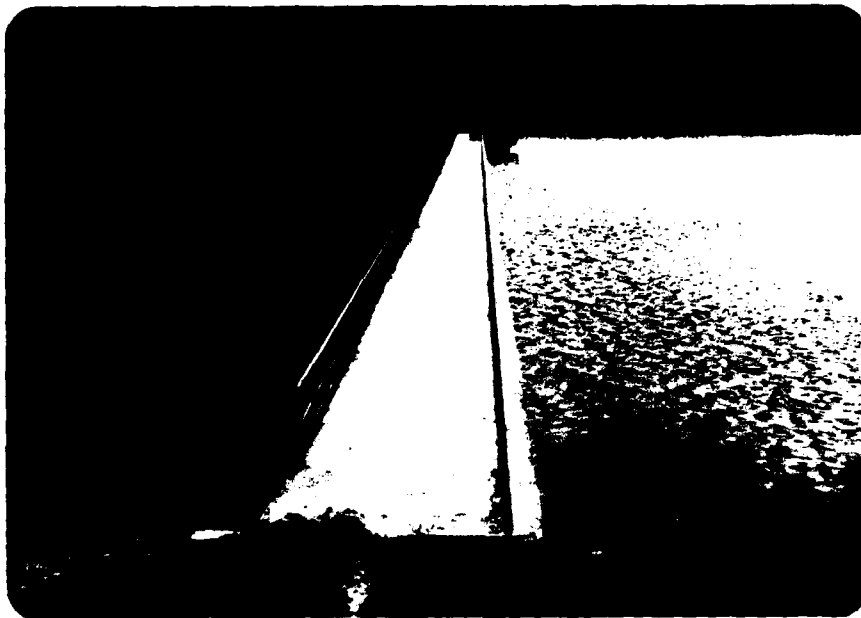
PHOTO #1: Crest of Dam looking West.

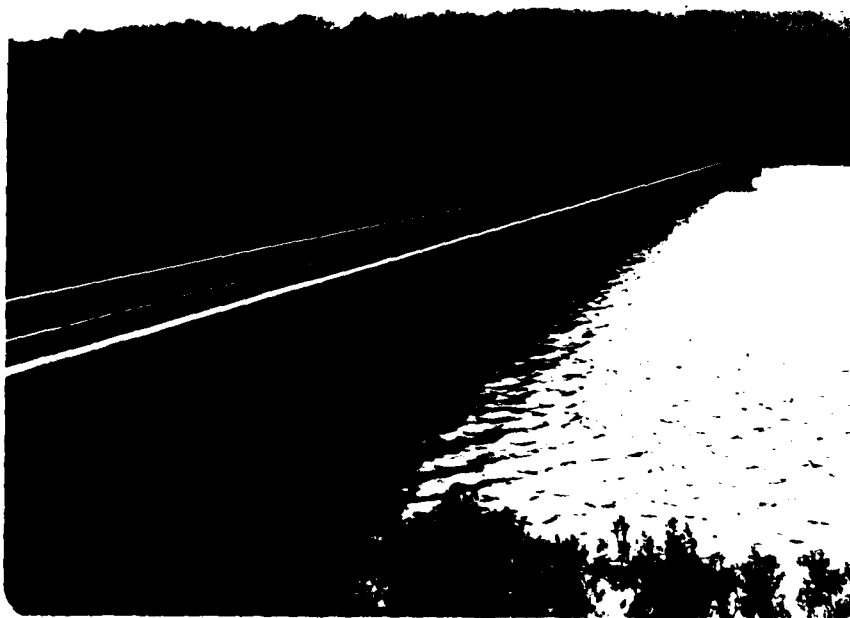
1) Upstream Face - At or above the water line, spalling was evident. At construction joints on the east side of dam, considerable spalling just above the water line was noted. The intake chamber also had surface spalling.

PHOTO #2: Upstream Face of Dam looking West.

1) Finish preparing and patching deteriorated concrete surfaces on upstream face, principally at construction joints and the downstream sloping face.
