CONNECTICUT COASTAL BASIN  
WALLINGFORD, CONNECTICUT

# MAC KENZIE RESERVOIR DAM CT 00037

## PHASE I INSPECTION REPORT NATIONAL DAM INSPECTION PROGRAM

AUGUST, 1979

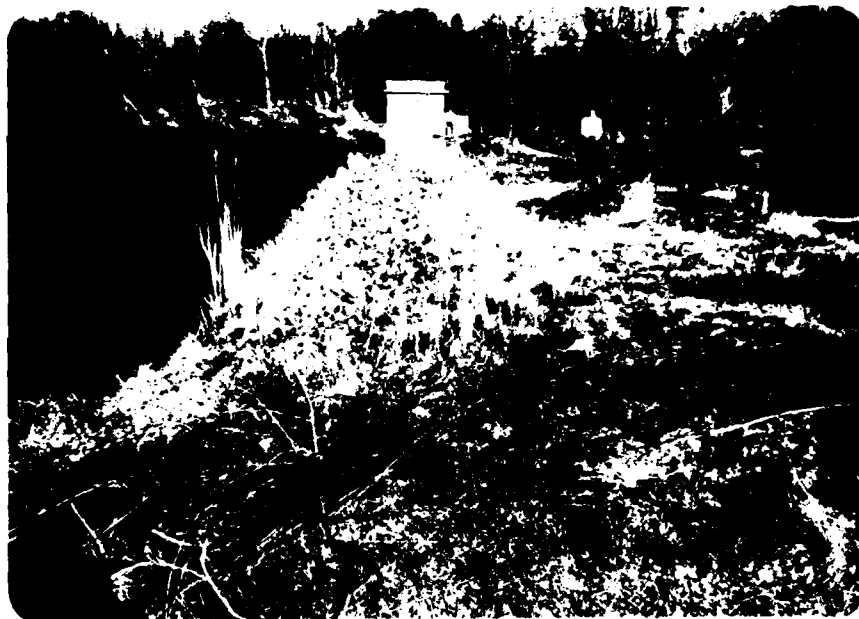
Crest - The 10 foot wide crest is grass covered (Photo 1). The crest is generally uniform except for two depressions at either end of the main embankment. One is located adjacent to the gatehouse slab and is approximately 10 feet long and 6 inches deep. Some undermining of the gatehouse slab in this area was also noted. The other depression is at the right abutment and is 10 feet long and 6 inches deep. The soil was evidently pushed to the left, leaving a small mound, so as to allow easier access to other parts of the reservoir by maintenance vehicles (Photo 2).

Upstream Slope - The upstream slope has hand placed riprap about 2 feet below the crest with a maximum size of approximately 18 inches. Riprap was missing in several places, exposing areas approximately 3 ft. by 4 ft. in size. Grass and weeds were observed between the riprap (Photo 1).

PHOTO 1 - Crest of dam and upstream slope riprap (May, 1979).

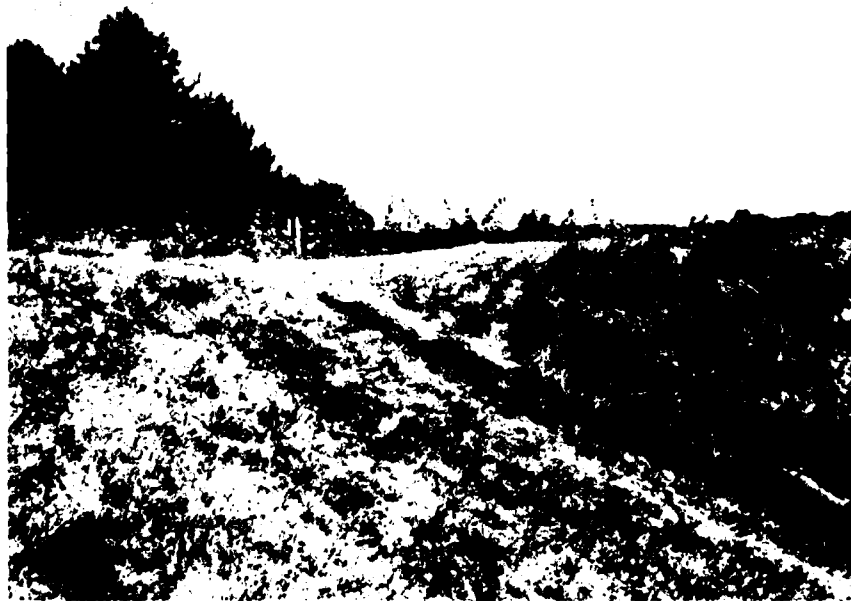
PHOTO 2 - Crest of dam at right abutment. Note low area on the left side of photo and mound of dirt at center (August, 1979).

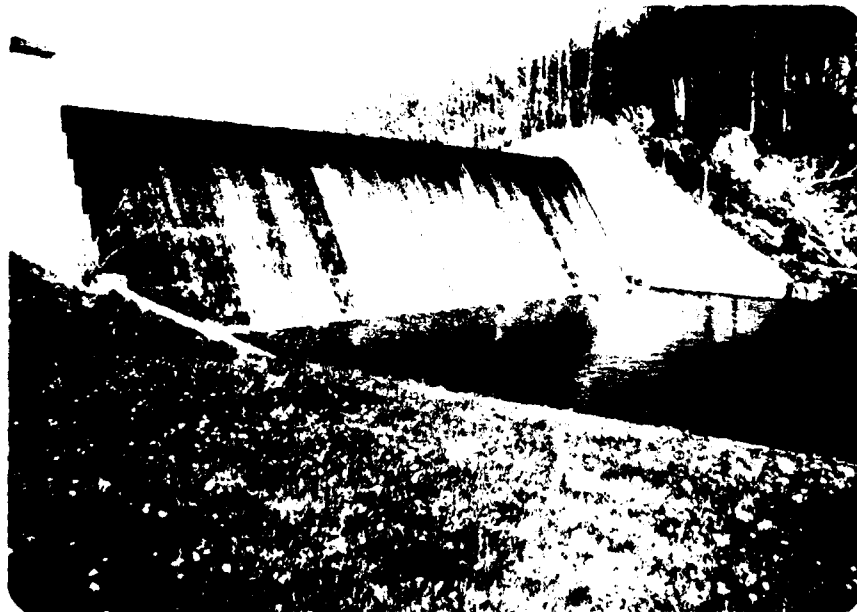
Trees with a maximum diameter of 12+ inches and heavy brush were noted on the slope of the left embankment (Photo 4). Seepage was discovered on the lower portion of the slope and toe adjacent to the left spillway training wall (Photo 5). The seepage and wet area extends along this wall approximately 60 feet with a width of up to 10 feet. A visual assessment of the rate of seepage discharge is 5 to 8 gallons per minute (gpm). In an upper zone of this area, at a distance of 2+ feet downstream from the toe of the weir training wall and 1- foot from the inside edge of the spillway channel retaining wall, a seep was discovered with a measured flow rate of 4 gpm (Photo 6). Water emanating from this area was clear, however the

PHOTO 4 - Spillway and spillway training wall. Section at far right of photograph (May, 1979).

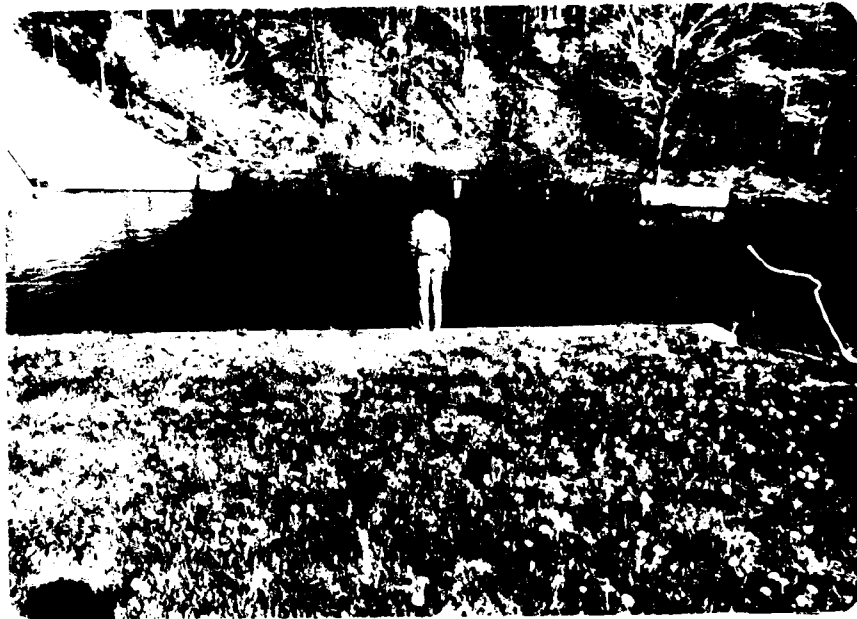
area around the seepage was covered with clayey silt deposits of a bright red and brown color (Photo 5 and 6). The origin of the seepage seems to be through the body of the left embankment in an area adjacent to the concrete spillway wall. The operator noted that there is significant icing in this area during winter months.

PHOTO 5 - Seepage at left spillway retaining wall and tree growth on downstream slope of left embankment. Note brown color of seepage spot (May, 1974).

Further studies should be conducted for immediate identification of the origin and effect of considerable seepage at the toe of the left embankment and downstream area, and also to restore damaged riprap on the upstream slope of the embankment and restore concrete at the spillway and gate house.
