NATIONAL PROGRAM FOR INSPECTION OF NON-FEDERAL DAMS  
SUCCESS LAKE DAM (CT.) (U) CORPS OF ENGINEERS WALTHAM MA  
NEW ENGLAND DIV MAY 81

| REPORT DOCUMENTATION PAGE | | READ INSTRUCTIONS<br>BEFORE COMPLETING FORM |
|---|---|---|
| 4. TITLE (and Subtitle)<br>Success Lake Dam<br>Conn. Coastal Basin, Bridgeport, Conn.<br>NATIONAL PROGRAM FOR INSPECTION OF NON-FEDERAL DAMS | | 5. TYPE OF REPORT & PERIOD COVERED<br>INSPECTION REPORT |

The inspection of Success Lake Dam and subsequent hydrologic-hydraulic investigation revealed that the dam should be classified as having a low hazard potential. The following is an abbreviated Phase I Inspection report to substantiate this classification.

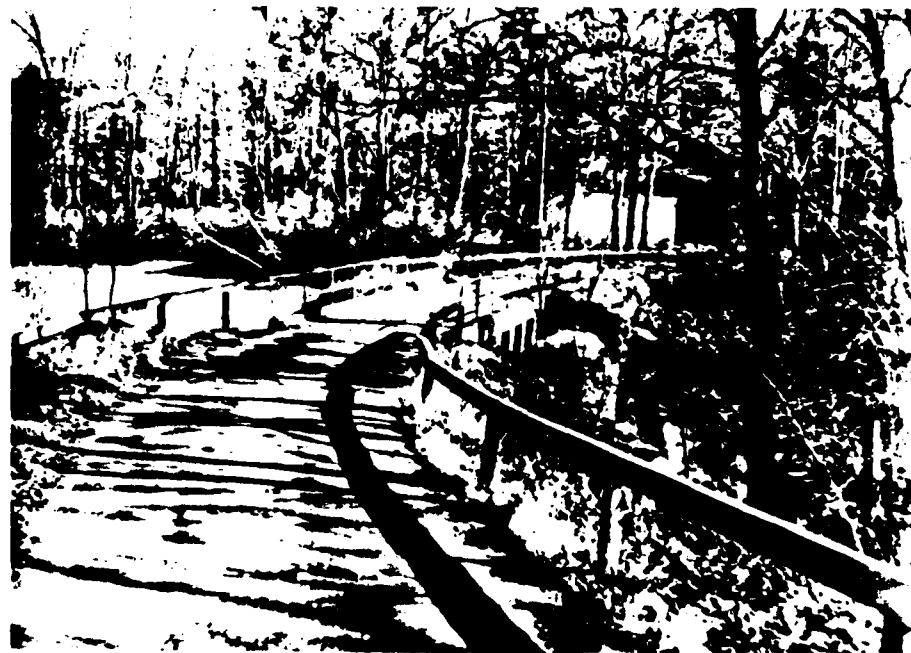
Photo 1 Top of dam and single lane road.

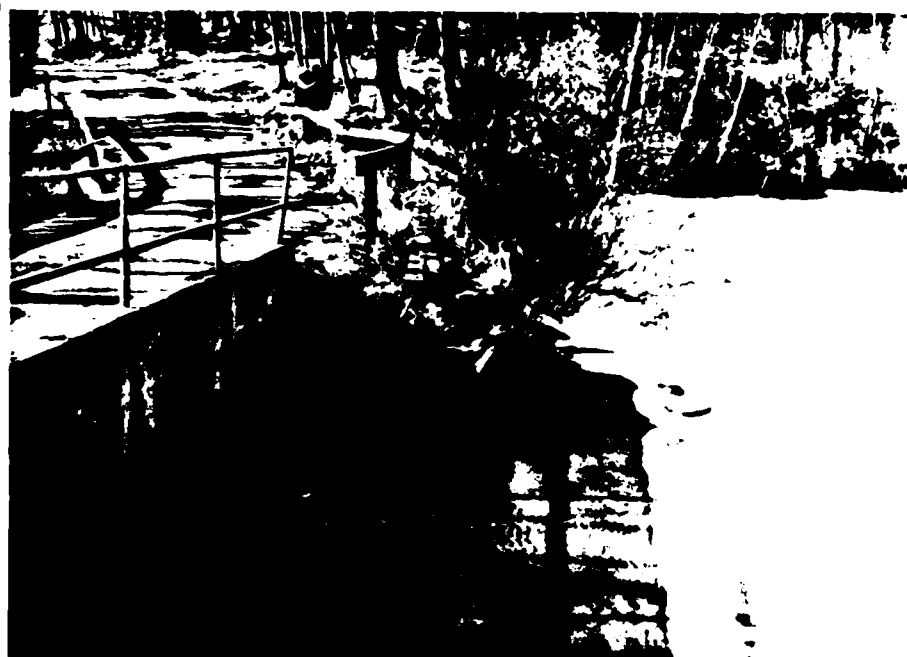
Photo 2 Upstream face of dam, spillway crest and right dam embankment.

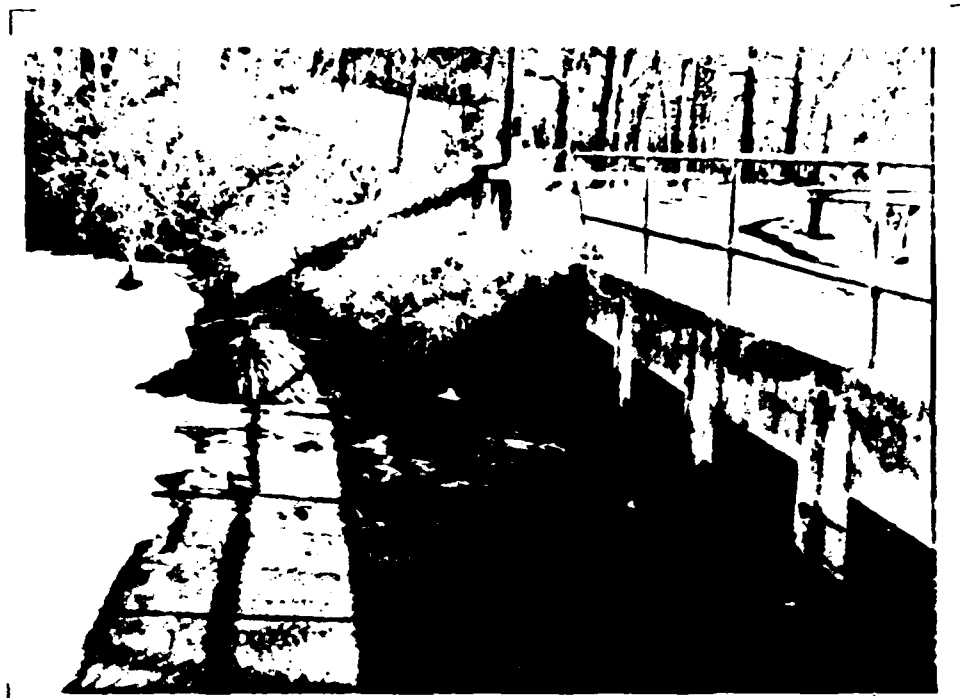
Photo 3 Upstream face of dam, spillway crest and left dam embankment.

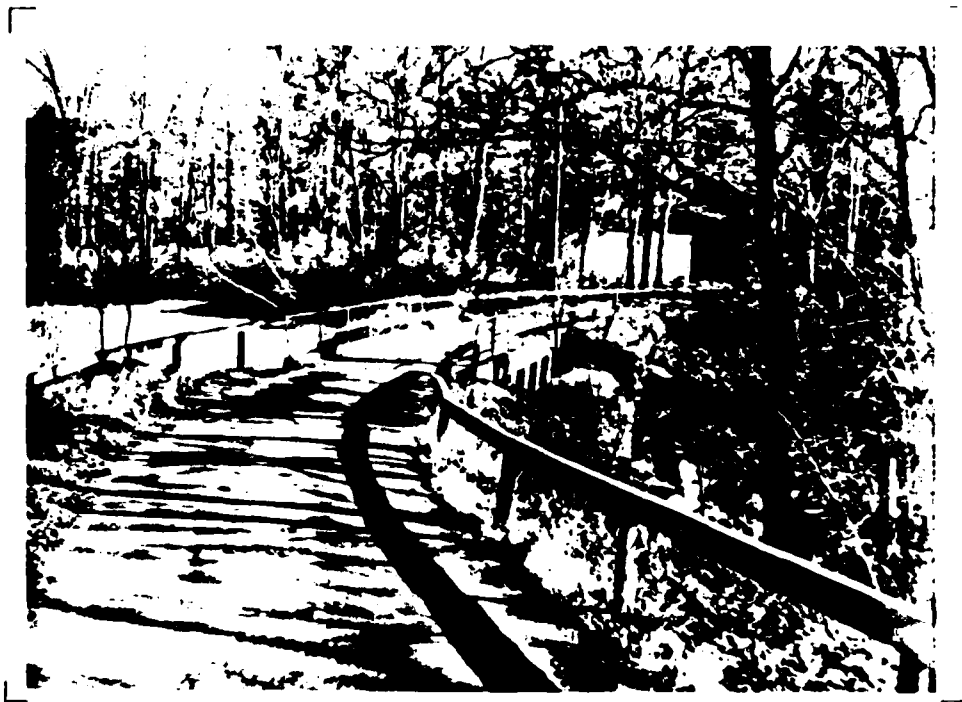
Photo 1 Top of dam and single lane road.

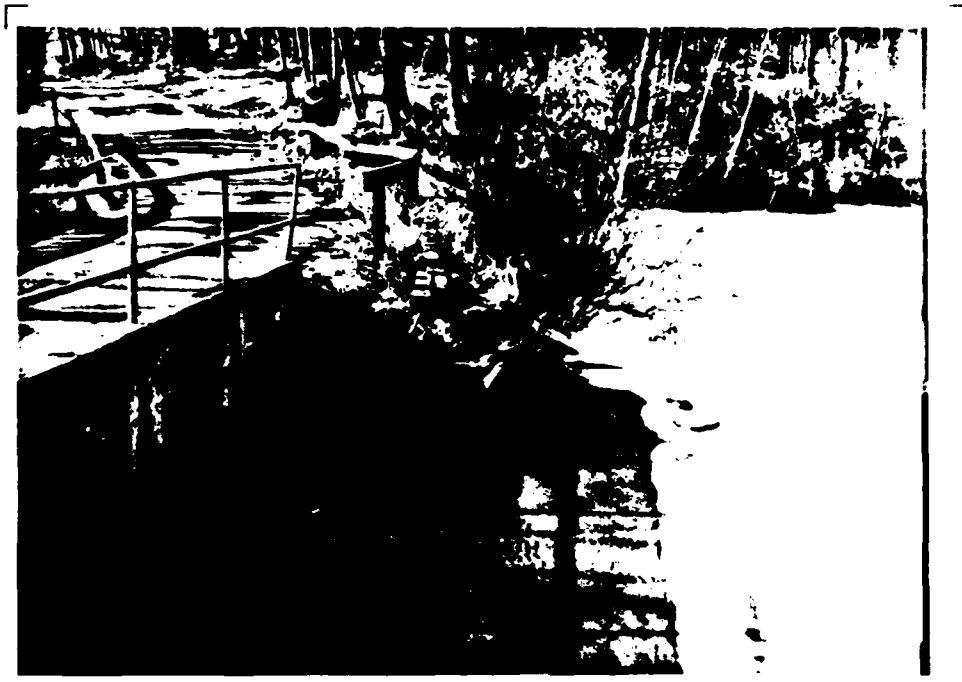
Photo 2 Upstream face of dam, spillway crest and right dam embankment.

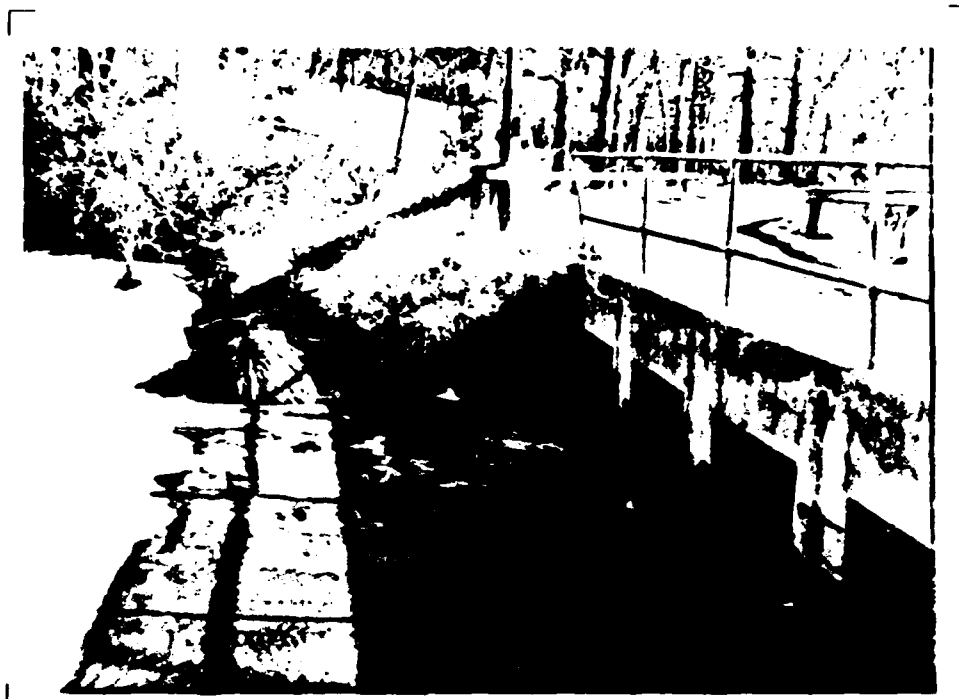
Photo 3 Upstream face of dam, spillway crest and left dam embankment.
