NATIONAL PROGRAM FOR INSPECTION OF NON-FEDERAL DAMS
BIRGE POND DAM (CT 00..10) CORPS OF ENGINEERS WALTHAM
MA NEW ENGLAND DIV JUL 80

BIRGE POND DAM
CT 00007

CONNECTICUT RIVER BASIN
BRISTOL, CONNECTICUT

PHASE I INSPECTION REPORT
NATIONAL DAM INSPECTION PROGRAM

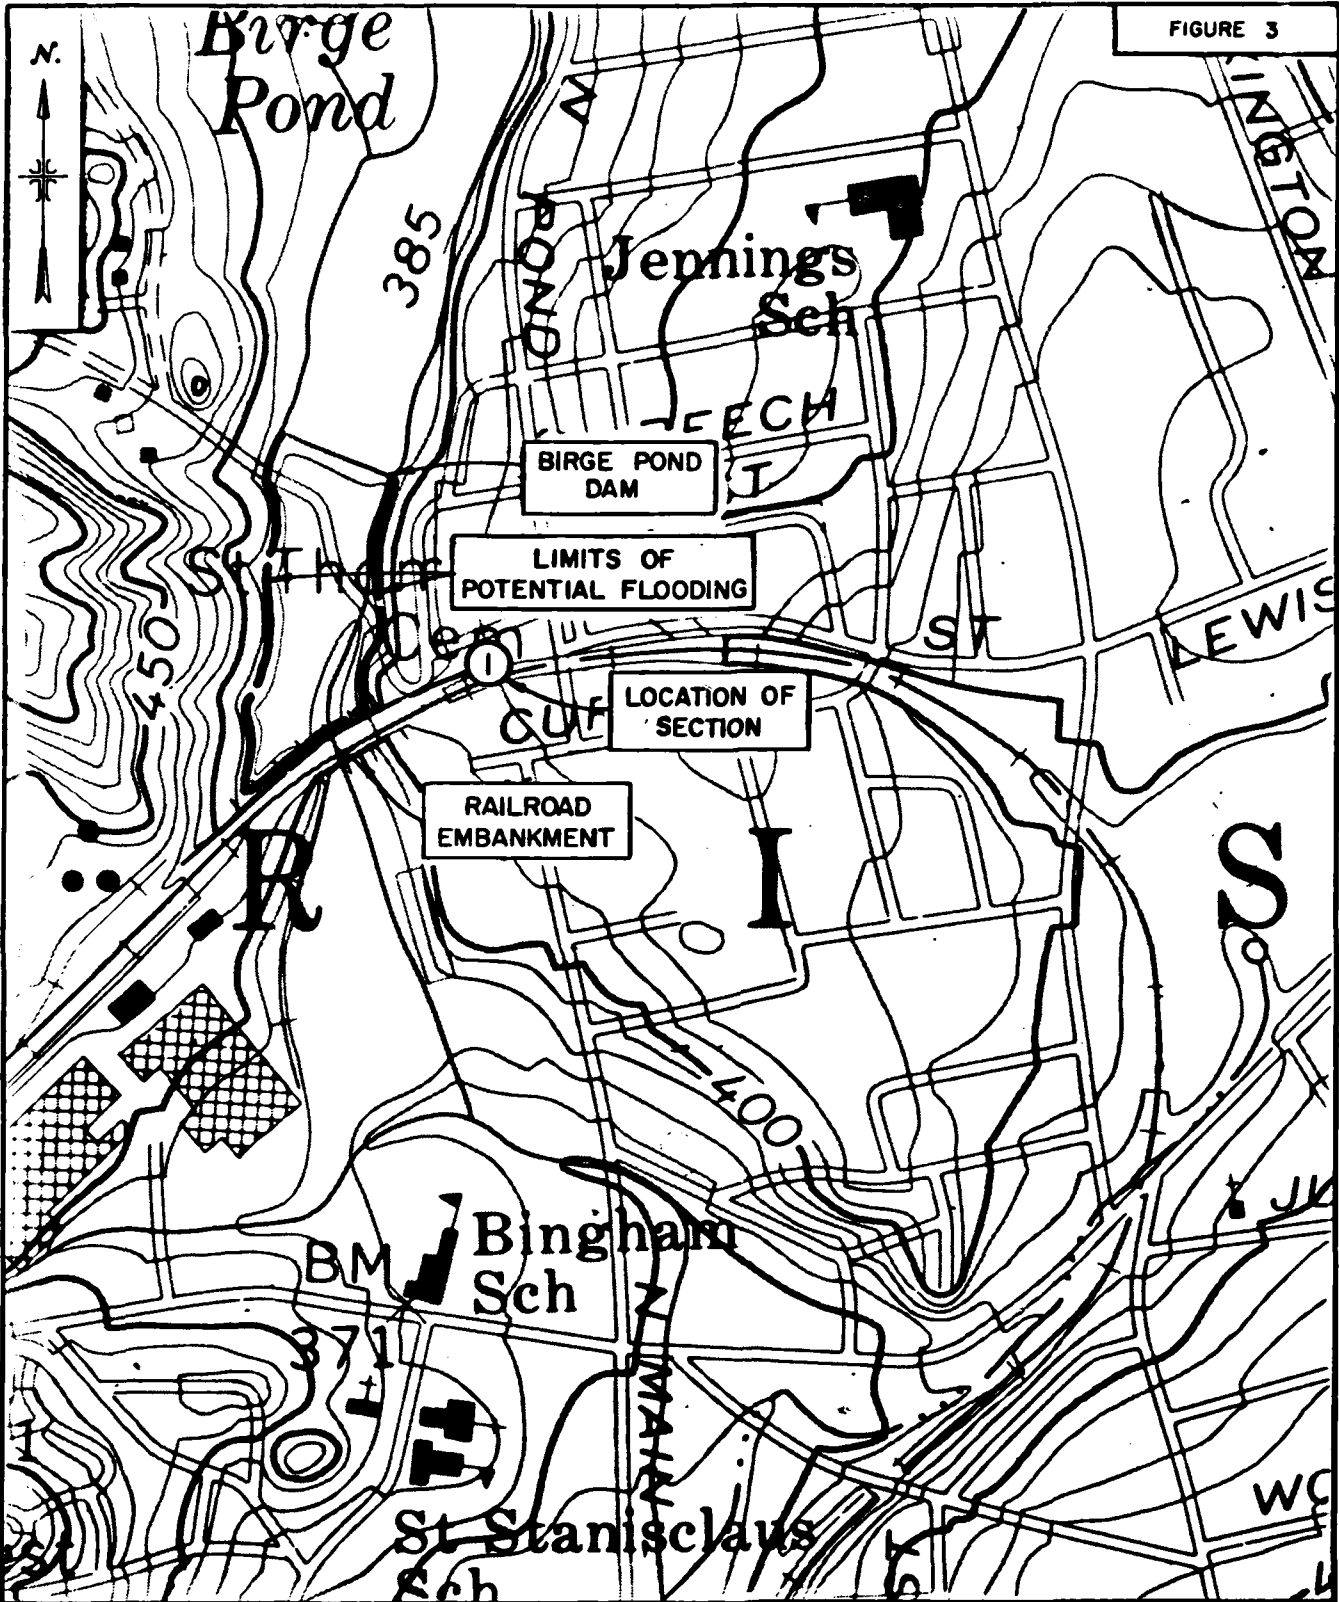
FIGURE 3

Downstream culverts have a capacity of 1080 cfs according to the Bristol City Engineer. The roadway approximately 200 feet downstream of the dam would be inundated by 15 feet of water and possibly washed out. It is doubtful the railroad embankment would be damaged as a result of the dam breach.

No homes are located within the potential limits of a dam breach flood, therefore, the loss of any lives is unlikely. The dam is classified as "Low" Hazard Potential in accordance with the Corps of Engineers' Recommended Guidelines for Safety Inspection of Dams.

LIMITS OF POTENTIAL FLOODING
