**BRANFORD SUPPLY PONDS DAM
CT 00116**

**PHASE 1 INSPECTION REPORT
NATIONAL DAM INSPECTION PROGRAM**

APRIL 1981

PHILIP W. GENOVESE AND
ASSOCIATES, INC.
ENGINEERS - HAMDEN, CT.

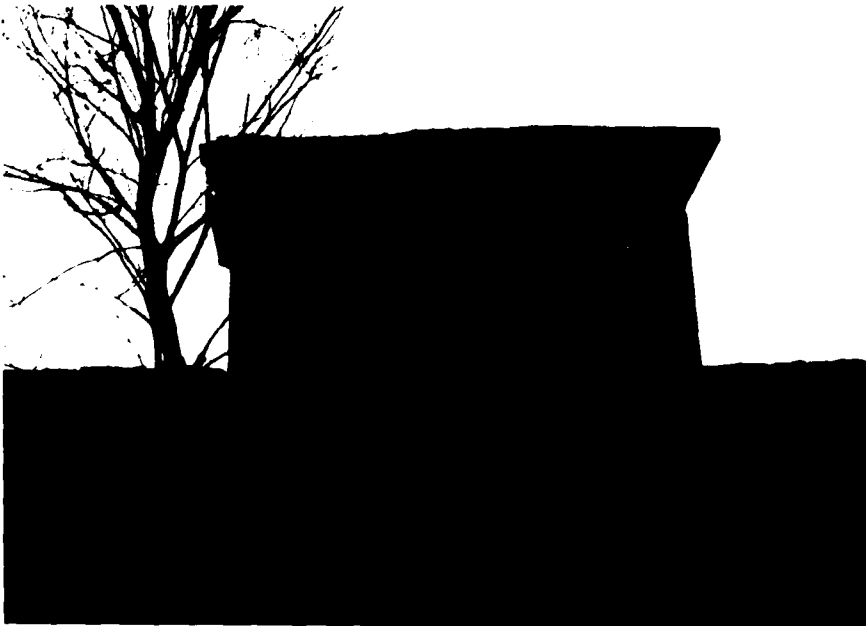
There is a gatehouse and outlet works located on the dam. The outlet works are in poor condition. There is no lock on the gatehouse door and there is evidence of trespass. There are a number of significant cracks (maximum size 1/32 of an inch) in the walls of the gatehouse. A horizontal crack runs along the perimeter 5 feet above the floor. There are three vertical cracks - two at corners of north wall and one midway in south wall - starting at the floor to a distance of 5 feet. The gate valves are unpainted, ungreased and rusty, but are still operable. The gate chamber is flooded and therefore, inaccessible by the rusting ladder leading down to it. The outside of the gatehouse is cracking in a number of places and the roof slab has visible reinforcing. The vent pipe consists of a 6 inch pipe through the downstream gatehouse wall.

8. Looking upstream at gatehouse. Note cracks and spalling of concrete on roof and at base.

5. Perform a detailed hydrologic and hydraulic analysis to assess further the potential of overtopping the dam and the need for and the means to increase project discharge capacity.
6. Repair cracking and spalling observed at the gatehouse..
7. Repair spalling and cracking of dam cap and left downstream training wall of spillway.
8. The existing tree growth within an area of 10 feet from the downstream toe of the dam should be removed by uprooting and the root zones backfilled with carefully selected soil, placed as directed by the Engineer.
