QUINNIPIAC RIVER BASIN  
HAMDEN, CONNECTICUT

LAKE WHITNEY DAM  
CT 00119

PHASE I INSPECTION REPORT  
NATIONAL DAM INSPECTION PROGRAM

AUGUST 1978

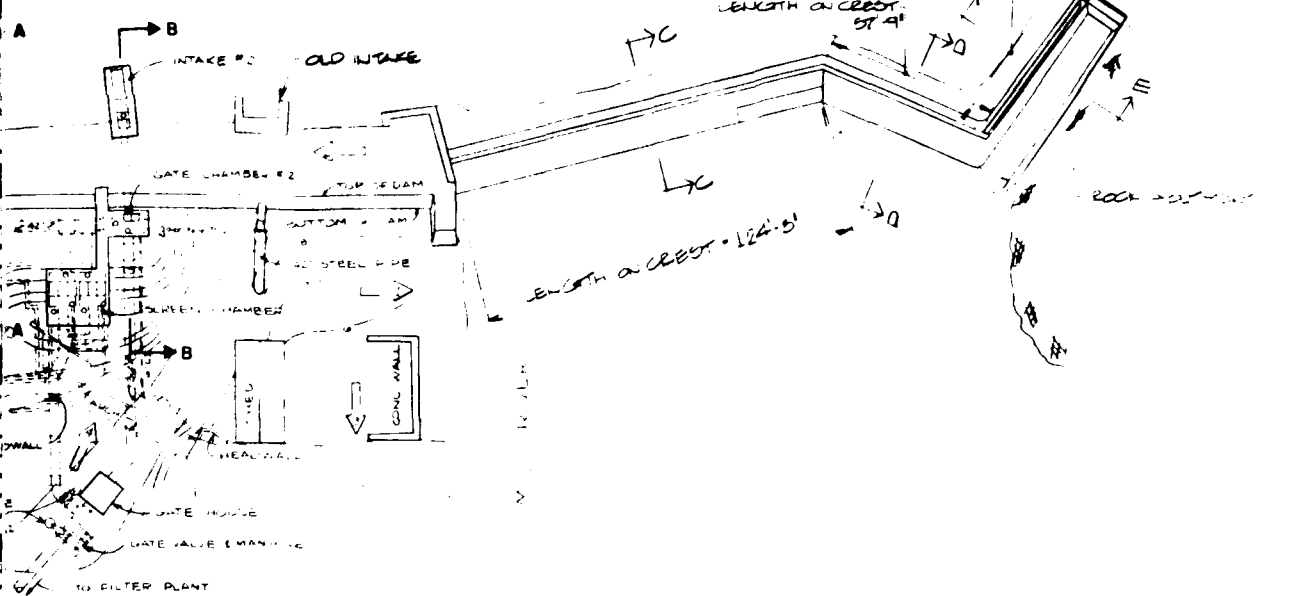
PLAN

| AREA EVALUATED | BY | CONDITION |
|---|---|---|
| | GC | Depressions noted D.S. of dam as noted in plan. Largest depression is about 8 ft. in diameter and 2 ft. deep. They correspond to location of existing arch conduit and could be due to loss of ground into the conduit. |
