CONNECTICUT COASTAL BASIN  
HAMDEN, CONNECTICUT  
**BUTTERWORTH DAM**  
**CT 00122**

PHASE I INSPECTION REPORT  
NATIONAL DAM INSPECTION PROGRAM

JUNE 1981

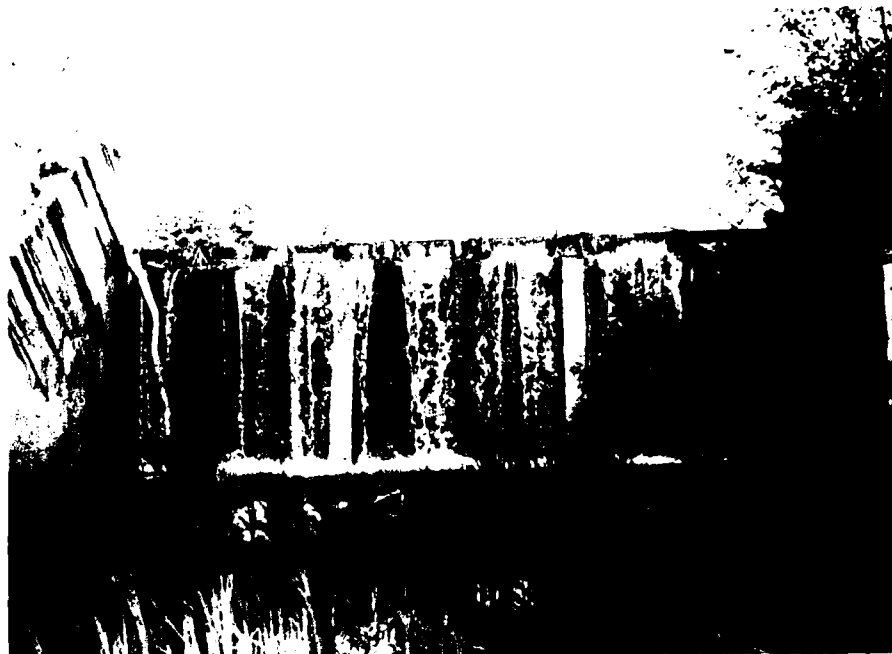
Photo 3 - Principal spillway from discharge channel  
(April, 1981).
