NAUGATUCK RIVER BASIN  
WATERTOWN, CONNECTICUT

ECHO LAKE DAM  
CT 00124

PHASE I INSPECTION REPORT  
NATIONAL DAM INSPECTION PROGRAM

JUNE 1980

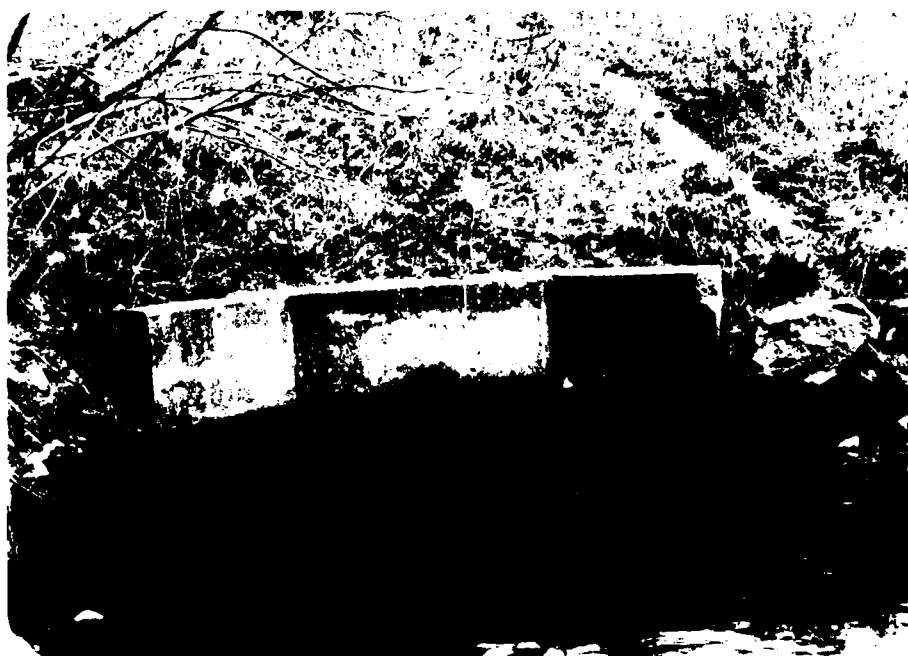
PHOTO NO. 4

concrete endwall for the outlet pipe, Photo 4. A small hole, approximately 7 inches in diameter and 12 inches deep, was observed just upstream of the concrete endwall, Photo 5. Seepage was observed exiting from the toe of the downstream slope near the right end of the concrete endwall, Photo 6. The area was rust-colored and flow was free of sediments at the time of inspection.

CONCRETE ENDWALL AT OUTLET OF 24-INCH RCP.  
NOTE SLUMPING AT ENDS OF WALL.
