NAUGATUCK RIVER BASIN  
TORRINGTON - GOSHEN, CONNECTICUT

**WHIST POND DAM  
CT 00102**

**PHASE I INSPECTION REPORT  
NATIONAL DAM INSPECTION PROGRAM**

DECEMBER 1980

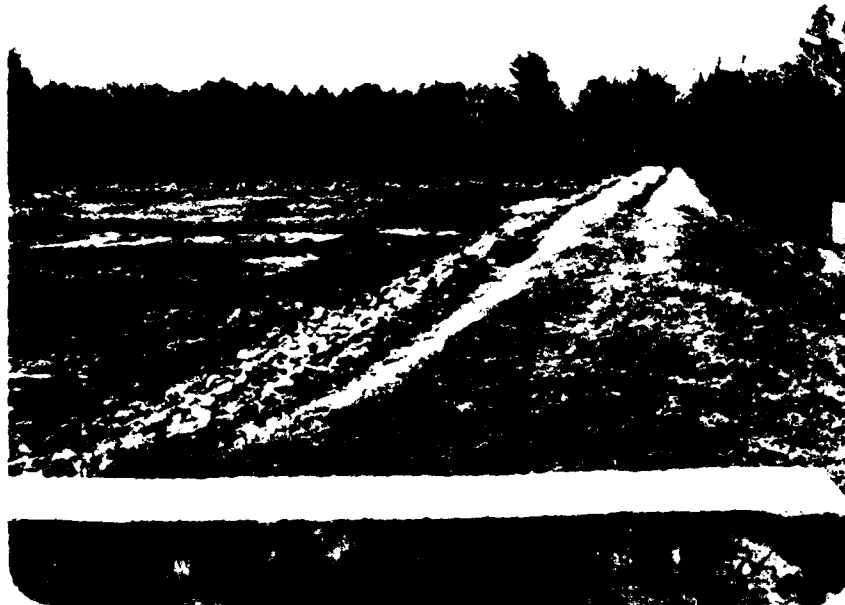
PHOTO NO. 1

The crest of the dam is generally level and covered with grass, Photos 1 and 4. There is a foot path at approximately the center line of the crest along the entire length of the dam. Tree roots were observed at several locations along the crest of the dam, Photo 5, and appear to originate from trees located downstream of the embankment, Photo 4.

The downstream slope of the dam is grass-covered, Photos 1 and 4. Several rats due to mowing equipment were observed on the downstream slope.

VIEW OF DAM FROM  
RIGHT END OF SPILLWAY

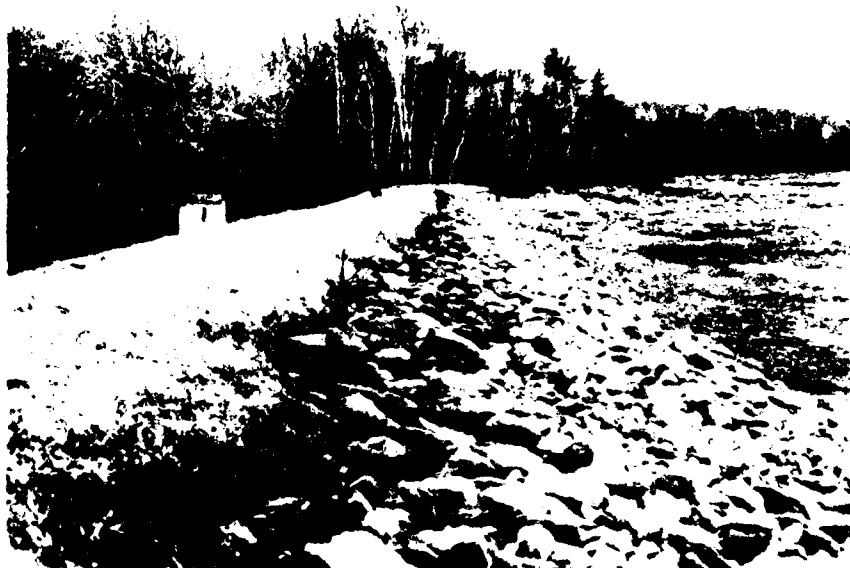
PHOTO NO. 2

| AREA ELEVATION | CONDITIONS |
|---|---|
| ROCK SLOPE PROTECTION -<br>RIPRAP FAILURES | Riprap appears to be settling, possibly<br>due to lack of filter. |

RIPRAP ON UPSTREAM SLOPE

1. Investigate the slumping of the riprap slope protection, and design remedial measures as required.
2. Investigate the condition of the spillway weir and training walls, and design required repairs.
3. Clear trees from the area downstream of the dam to within 20 feet of the toe.
4. Design an upstream gate for the low level diversion outlet in order to relieve full reservoir water pressure in the pipe under the dam.
5. Inspect the dam for seepage when the impoundment is full.
6. Investigate freeboard requirements for the dam.

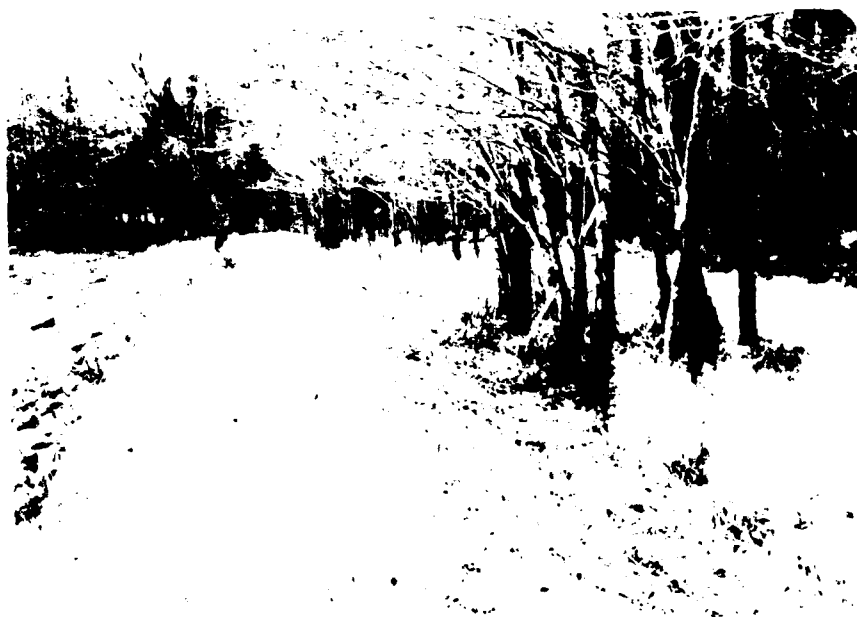
PHOTO NO. 4

LEFT SECTION OF DAM. NOTE SLUMPING  
RIPRAP CUTTING INTO CREST.

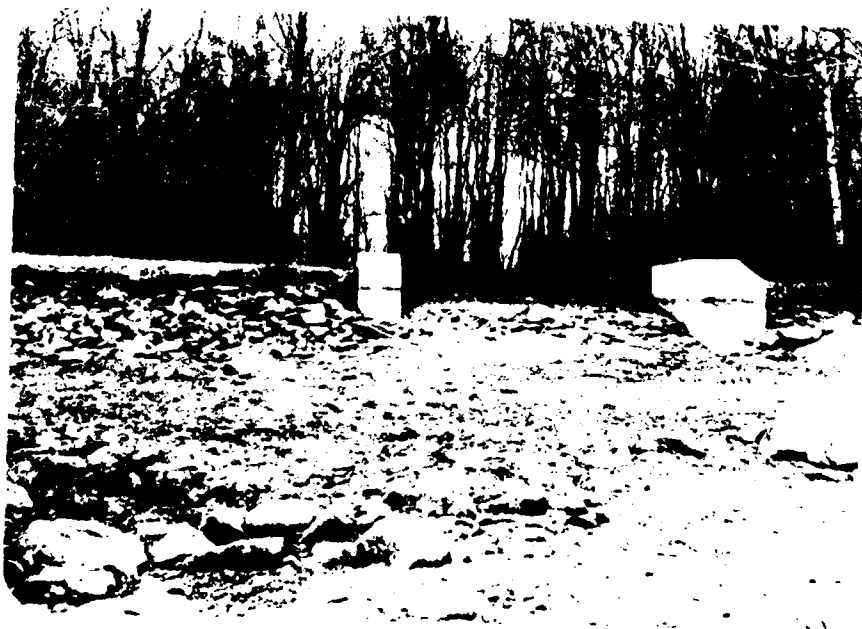
PHOTO NO. 2  
SPILLWAY FROM  
UPSTREAM.

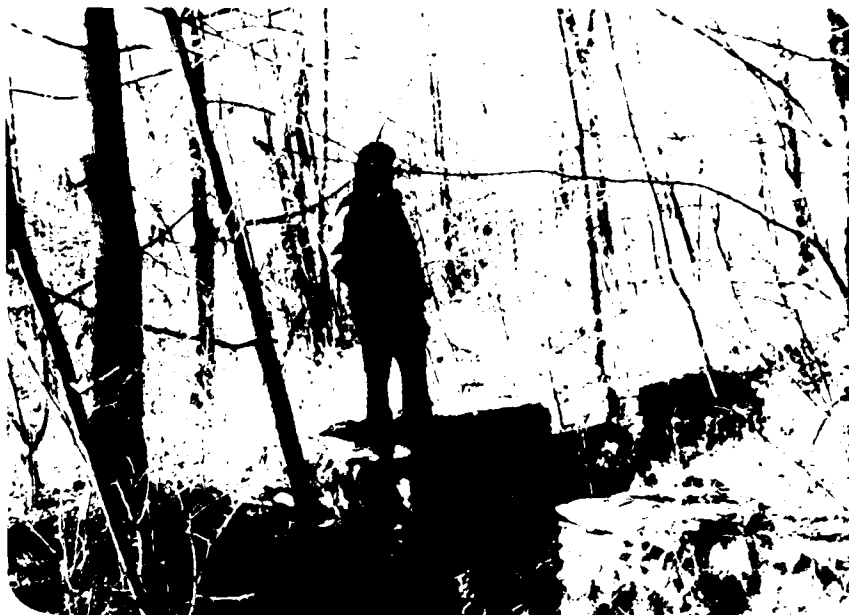
PHOTO NO. 11

DIVERSION STRUCTURE. FLASHBOARDS IN BACKGROUND  
DIVERT WATER FROM NATURAL STREAM TO WHIST POND.

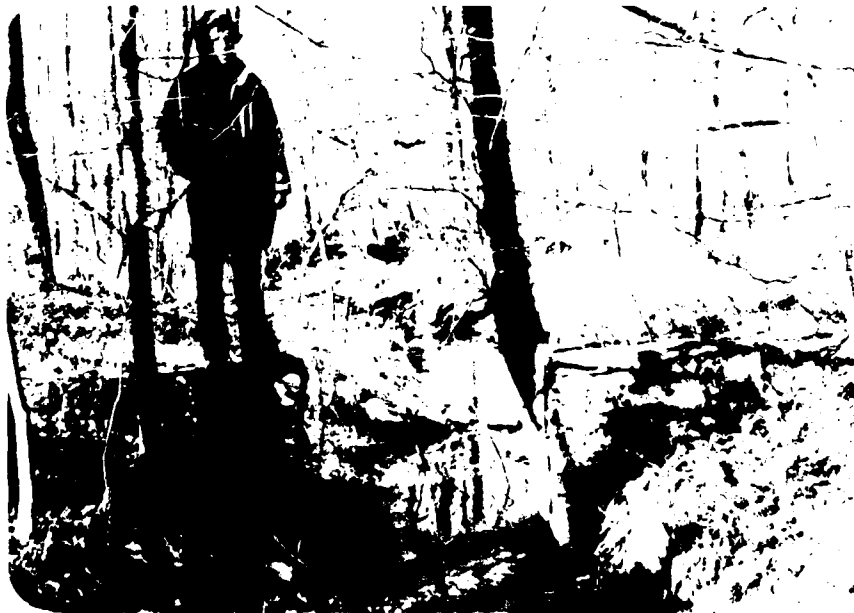
PHOTO NO. 12

DIVERSION STRUCTURE. LOOKING  
DOWN CHANNEL TOWARD WHIST POND.
