NATIONAL PROGRAM FOR INSPECTION OF NON-FEDERAL DAMS  
UPPER LAKE PHIPPS DAM. (U) CORPS OF ENGINEERS WALTHAM  
MA NEW ENGLAND DIV JUL 80

COVE RIVER BASIN  
WEST HAVEN, CONNECTICUT

UPPER LAKE PHIPPS  
DAM NO.1 - CT 00109  
DAM NO.2 - CT 00110

PHASE I INSPECTION REPORT  
NATIONAL DAM INSPECTION PROGRAM

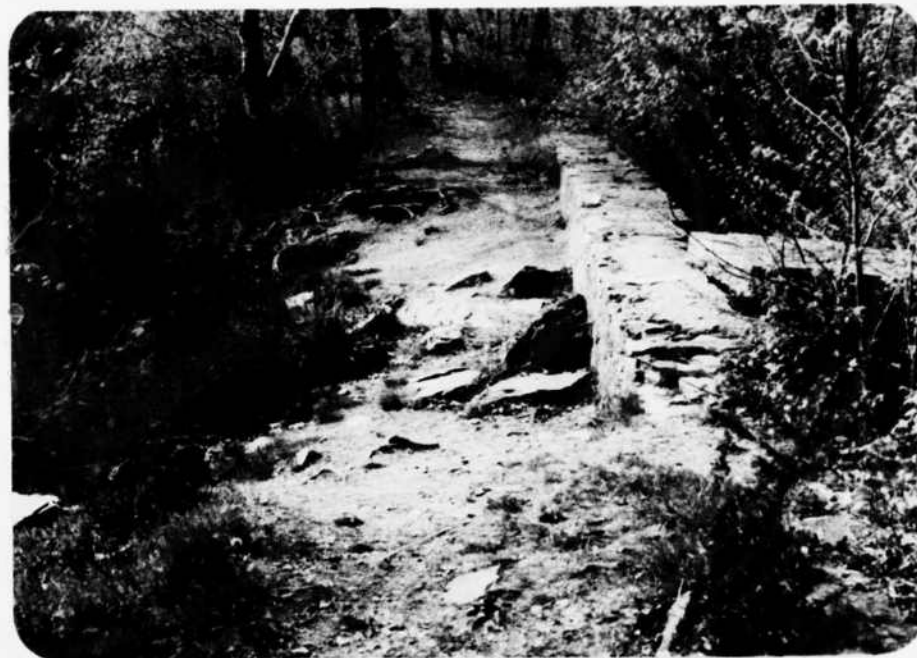
PHOTO NO. 1

The crest of the dam is somewhat irregular with a path worn bare by pedestrian traffic. There is what appears to be a stone masonry corewall, approximately 2.5 feet wide at the top, across the entire length of the dam. The top of the wall is at ground level, Photo 2, with the exception of a 30 foot long section near the downstream stone masonry gate chamber where approximately 2.5 feet of the wall is exposed, Photo 1.

The outlet works are located at the right section of Dam No. 1. The remains of an intake structure are located upstream of the dam, Photo 11. A downstream stone masonry gate chamber, Photo 1, is covered by a concrete slab and steel plate. It is reported that there is a downstream gate on the low level outlet or blowoff line that is operated at least once a year. Other than the manhole noted under section 3.1.b., no evidence of a downstream gate or outlet was observed.

RIGHT SECTION OF DAM NO. 1  
NOTE GATE CHAMBER DOWNSTREAM  
AND EROSION UPSTREAM OF MASONRY WALL

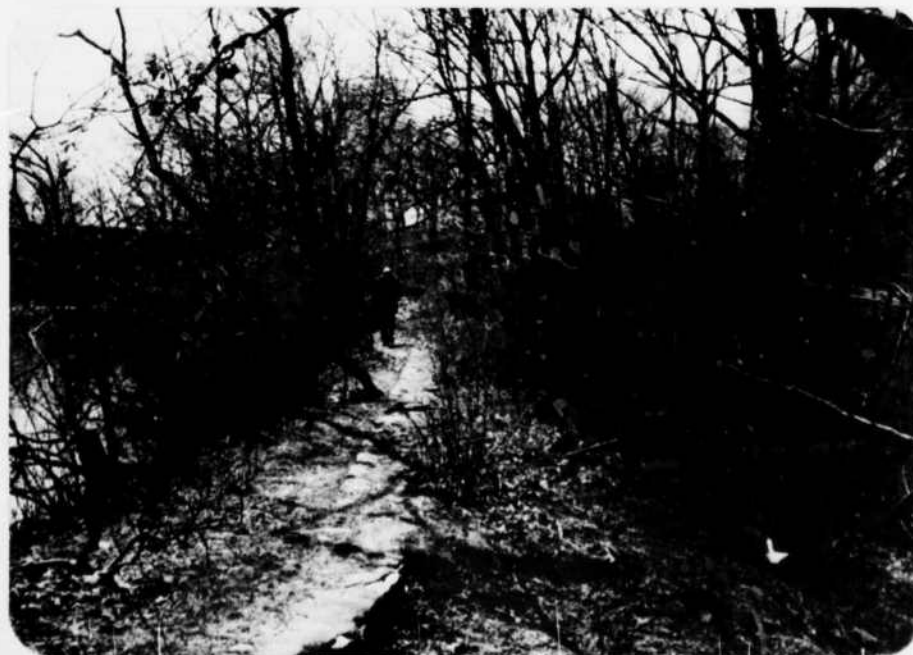
PHOTO NO. 2\*

Brush and small trees growing on the upstream and downstream slopes of Dam No. 1 and Dam No. 2 make it difficult to inspect these areas adequately. Also, if trees are allowed to grow to a large size internal erosion along the root systems may develop or the dams may be damaged by uprooting of the trees during a storm.

LEFT SECTION OF DAM NO. 1  
NOTE BRUSH AND TREE GROWTH  
ON CREST AND SLOPES

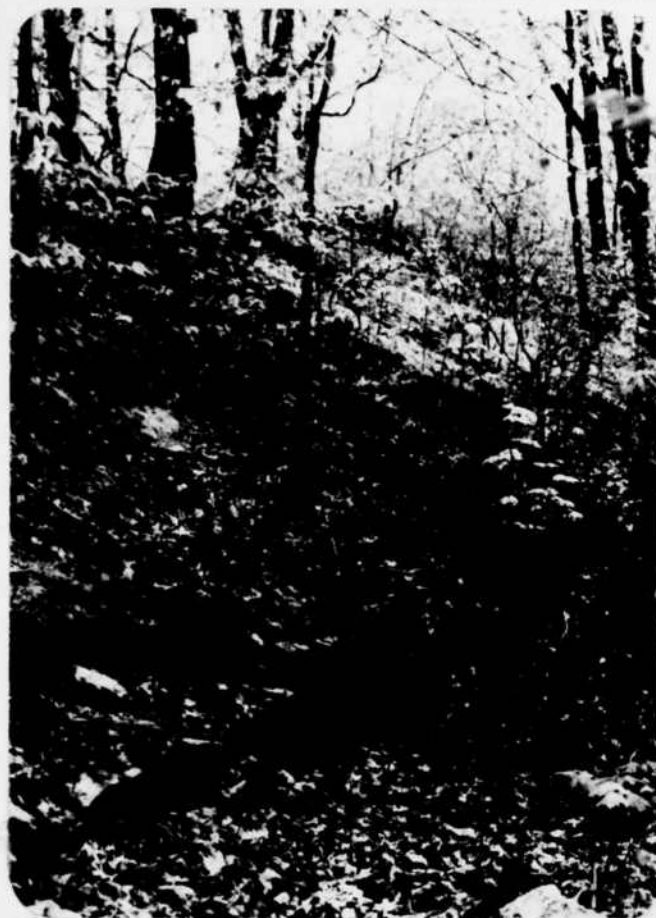
PHOTO NO. 3

Brush, shrubs and small and large trees are growing on the downstream slope of the dam. A small stone wall approximately 40 feet long and 2.5 feet high exists at about the toe of the downstream slope near the left abutment, Photo 3. Seepage was observed discharging at the base of a 3-inch diameter sapling, Photo 4, approximately 10 feet downslope from the small stone wall. The flow was relatively clear with a slight presence of rust-colored floccules. Water was also observed discharging near the toe of the slope in the area of an adjacent sanitary sewer.

STONE WALL ON DOWNSTREAM  
SLOPE OF DAM NO. 1 NEAR  
LEFT ABUTMENT

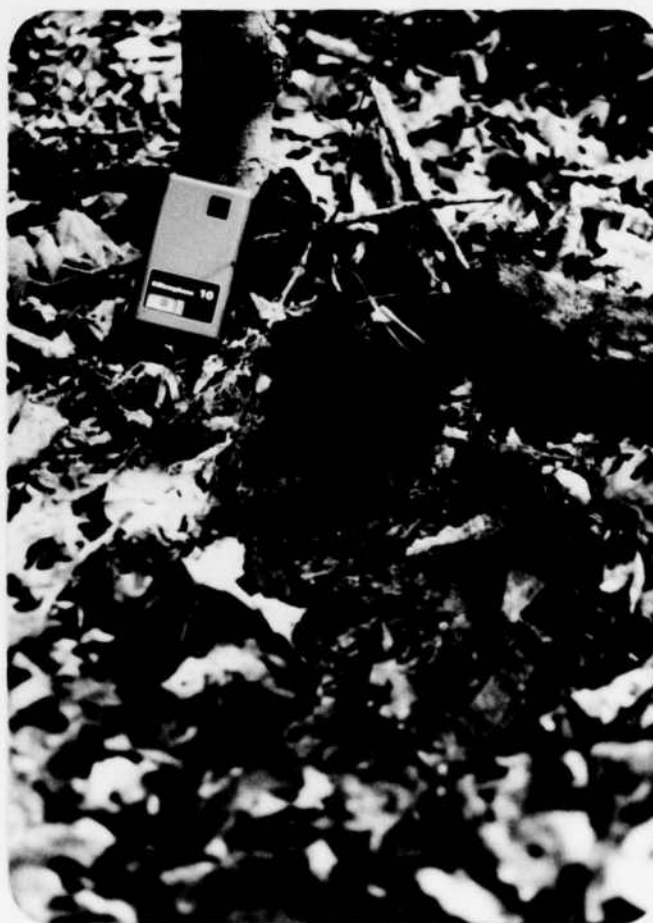
PHOTO NO. 4

Seepage is occurring at the toe of the left section of Dam No. 1. Also, there is discharge of water downstream of the toe of the left section of Dam No. 1, possibly due to seepage through the foundation. Seepage could lead to internal erosion and breaching of the dam if not controlled.

SEEPAGE FROM  
BASE OF SAPLING

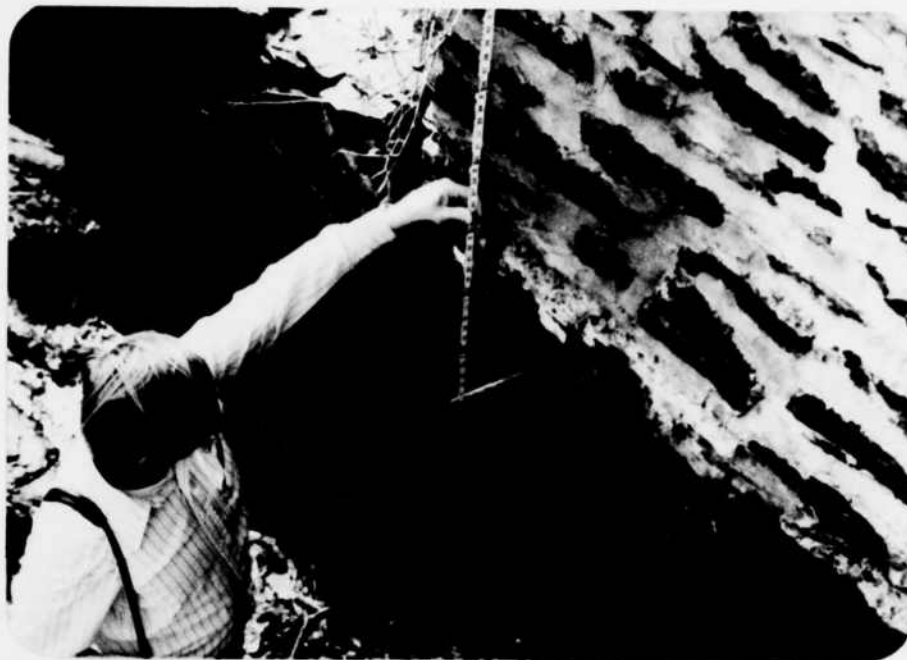
PHOTO NO. 9

The stone masonry and concrete wall appears to have been originally constructed as a stone masonry buttress wall with three stone buttresses. A concrete wall and two concrete buttresses appear to have been added against the stone masonry wall at a later date. The concrete sections are badly deteriorated. The area downstream of the wall is heavily overgrown with brush and appears to be a disposal area for branches and cut brush. Due to the brush and branches it was possible to inspect only the upper 5 feet of the wall. However, seepage was observed through the base of the wall. Several tree stumps up to 6-inches in diameter were observed protruding from the wall. A portion of the wall adjacent to the spillway appears to have been displaced approximately 6 inches laterally, Photo 9.

Continued deterioration and movement of the stone masonry and concrete portions of Dam No. 2 and seepage through the wall may lead to instability of the dam.

MASONRY WALL TO LEFT OF SPILLWAY,  
NOTE APPARENT DISPLACEMENT

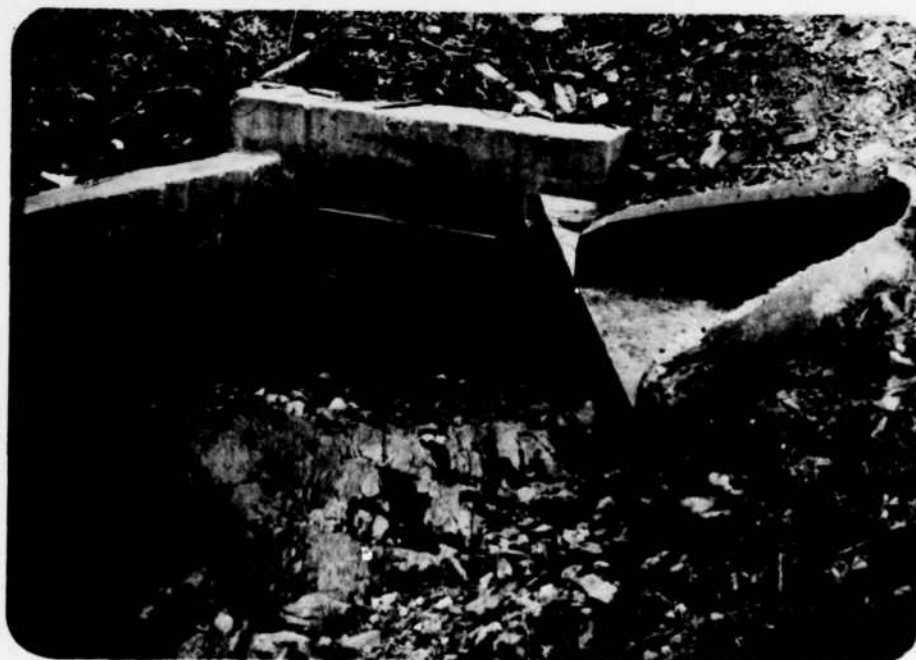
PHOTO NO. 10

30-INCH AND 24-INCH CULVERTS  
UNDER ROADWAY DOWNSTREAM OF SPILLWAY  
NOTE GRATE ON 30-INCH CULVERT

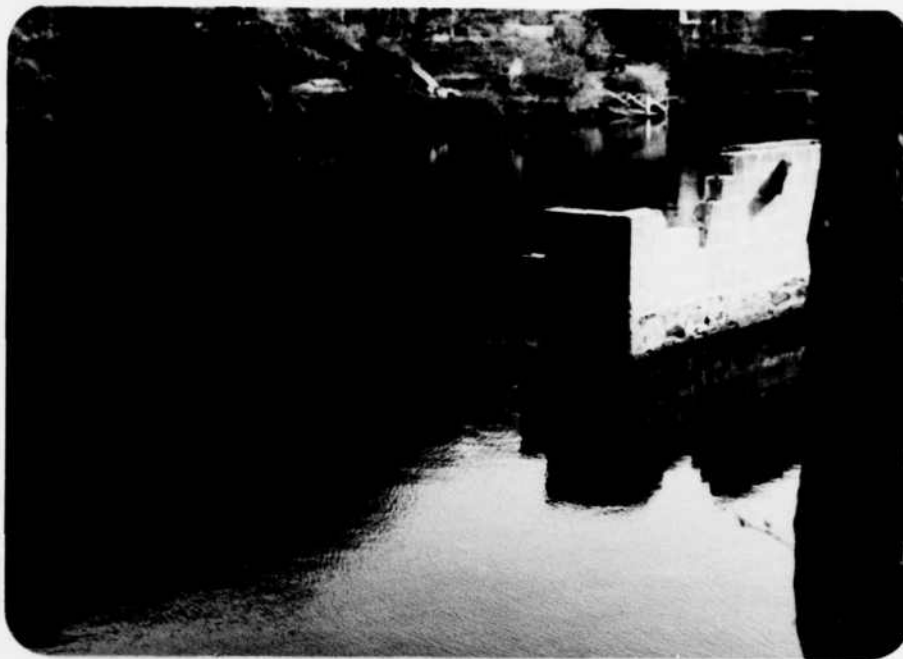
PHOTO NO. 11

REMAINS OF INTAKE STRUCTURE  
UPSTREAM OF DAM NO. 1

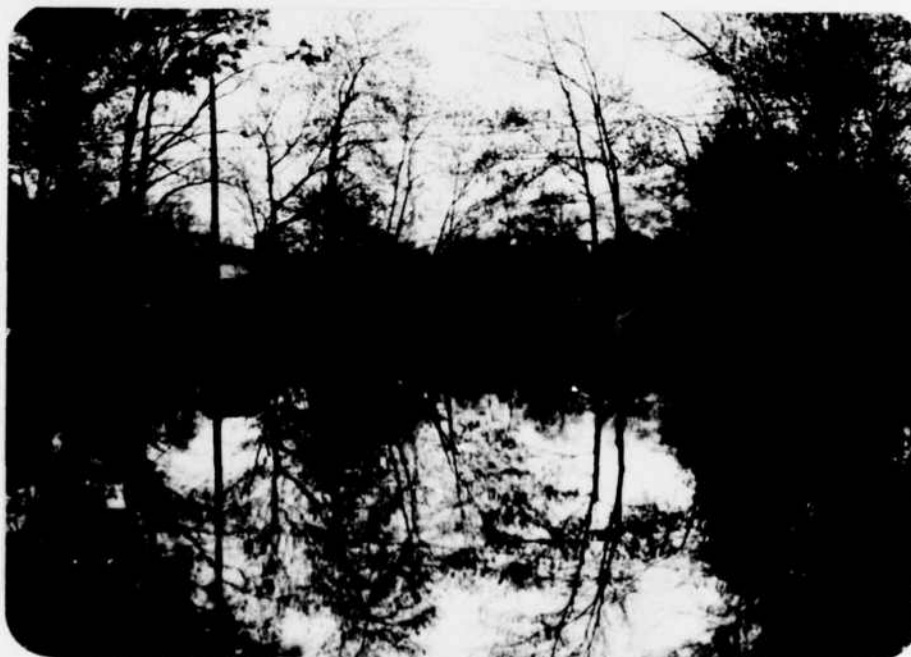
PHOTO NO. 12

At the causeway two 15-inch corrugated metal pipe culverts, Photo 12, discharge into a small pond which discharges to a natural stream through two additional 15-inch culverts.

CAUSEWAY AND CULVERTS  
AT DAM NO. 3
