NAUGATUCK RIVER BASIN  
TORRINGTON, CONNECTICUT

REUBEN HART RESERVOIR DAM

CT 00096

PHASE I INSPECTION REPORT  
NATIONAL DAM INSPECTION PROGRAM

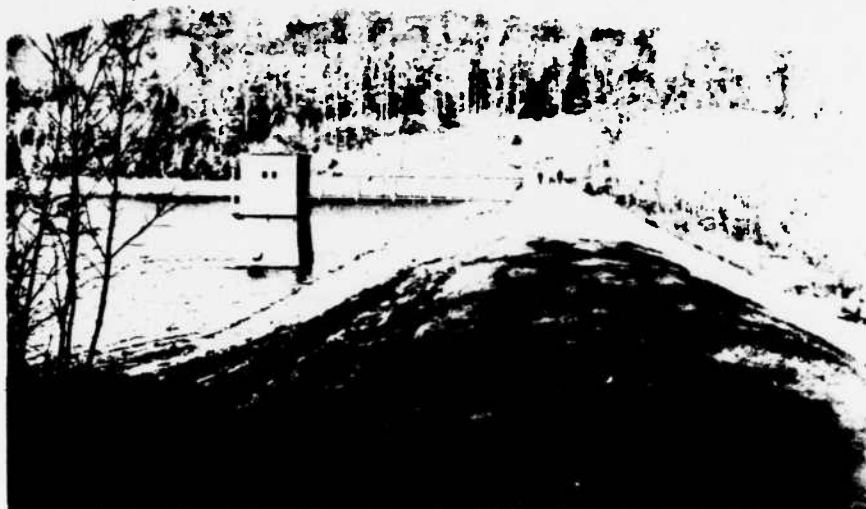
Overview of dam from right abutment.

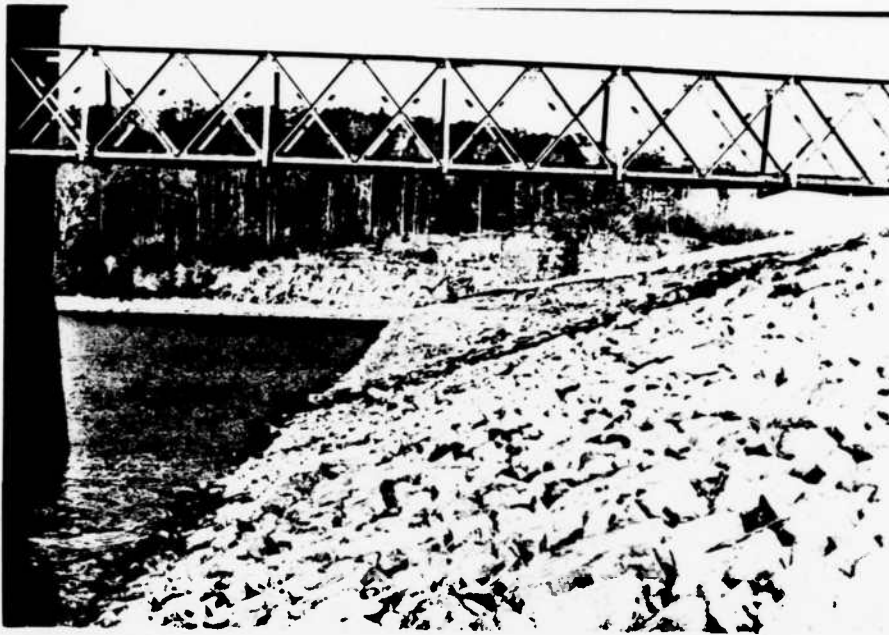
The horizontal and vertical alignment of the dam embankment is good (Overview Photo, p. viii). The upstream slope consists of hand placed riprap, which is in generally good condition (Appendix C, Photo No. 1). At approximately Sta. 5+40 (Plan, Appendix B) about 6 ft. below the crest of the dam, the riprap has been moved by ice jacking and the grass slope above it has moved downwards slightly. Left of the gatehouse structure the upstream edge of the crest of the dam appears to have settled about 6 in. for a distance of 200 to 300 ft. It may be that this apparent settlement has either been caused by ice jacking of the riprap slope or by differential settlement within the embankment structure. This appears to be a shallow phenomenon and of no major consequence.

Good condition. Minor slump of U/S slope due to ice jacking Sta. 4+00 to Sta. 7+00.

1. Hand placed riprap on upstream slope.

2. The disintegrated concrete at the top of the wall between the service spillway and dam should be repaired.
3. The displaced riprap near the top of the upstream slope between Sta. 4+00 and Sta. 7+00 should be repaired or realigned.

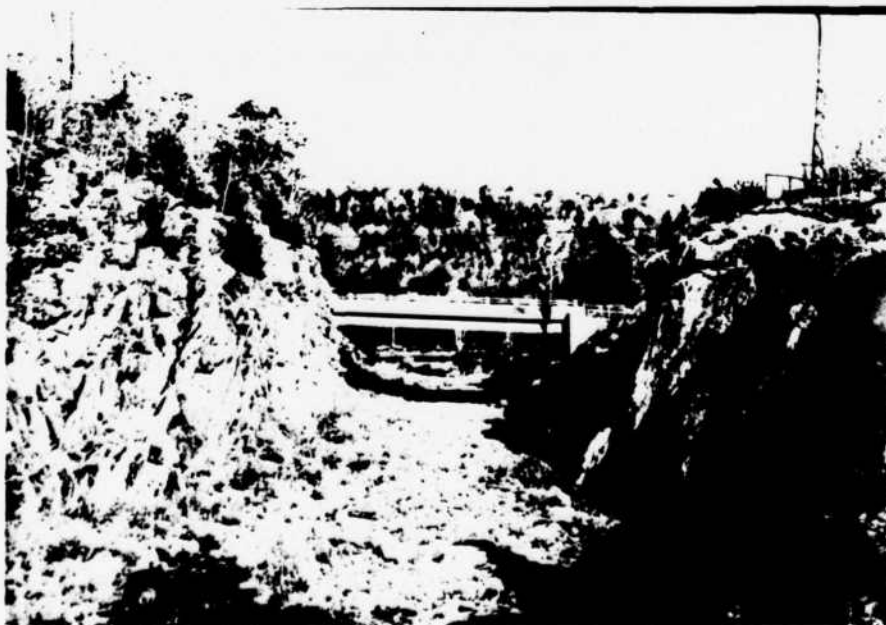
4. Downstream channel and Route 272 bridge.

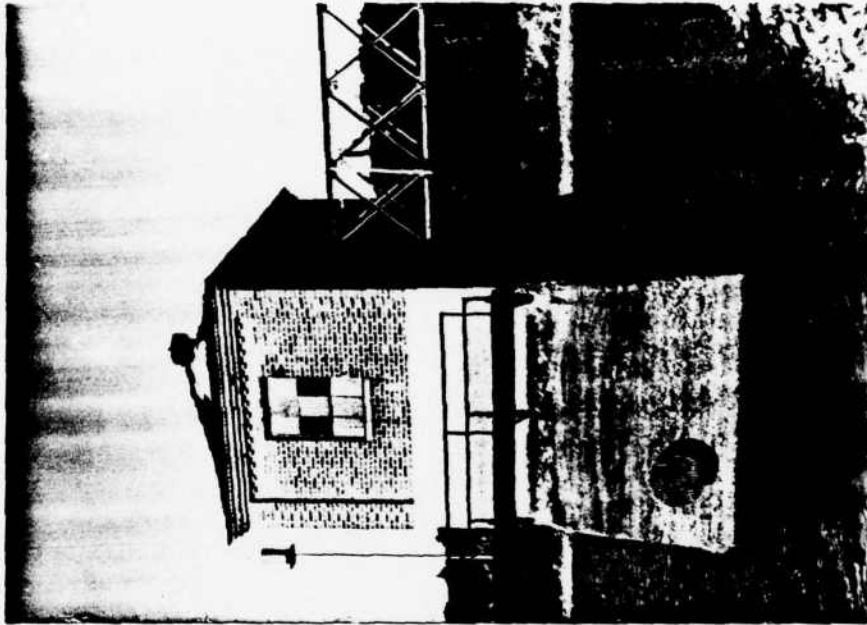
The intake tower is a concrete wet well shaft with three selective level inlet pipes controlled by slide gates (Appendix C, Photo No. 6). Two 18 in. dia. outlet pipes and a 6 in. dia. waste pipe are connected to the tower at approximately original ground level. A brick gatehouse contains the manual gate controls and is connected to the crest of the dam by a bridge. The concrete is in fair condition with some minor cracks and spalling noted. A portion of the roofing requires repair. The gates were not operated during the inspection, but according to Water Company staff all of them are serviceable.

Concrete tower shows some spalling and minor cracking. Roof shingles missing on right side.

6. Outlet tower and gate house.

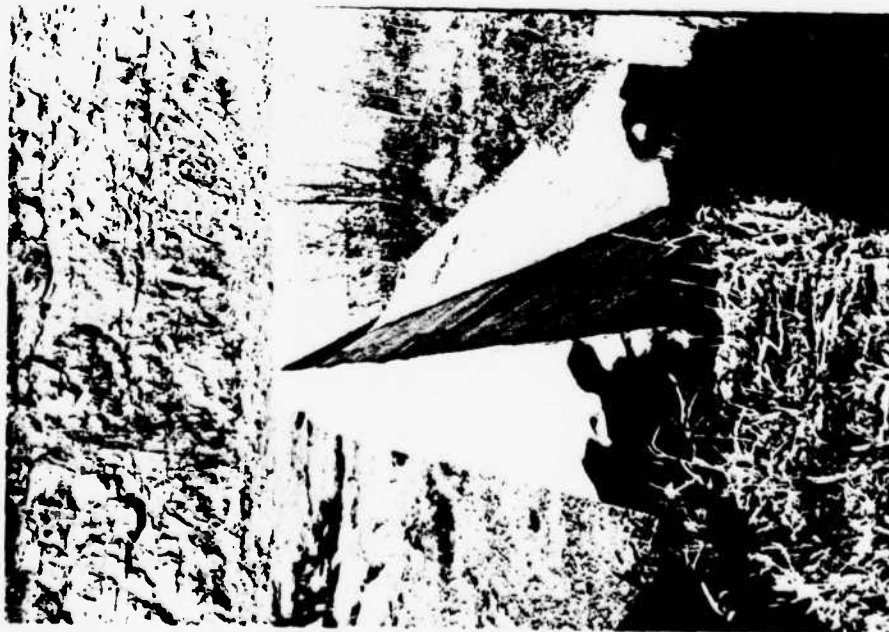
The present auxiliary spillway channel was originally the main spillway channel when the dam was first built. At the weir this channel is also in bedrock, but some distance below the weir it was excavated in earth and riprapped. The riprap has evidently not been maintained recently. The auxiliary spillway weir is in good condition (Appendix C, Photo No. 5).

5. Auxiliary spillway from left  
end of embankment.
