LOWER HOUSATONIC RIVER BASIN
SEYMOUR, CONNECTICUT

GREAT HILL RESERVOIR DAM
CT 00087

PHASE I INSPECTION REPORT
NATIONAL DAM INSPECTION PROGRAM

AUGUST 1978

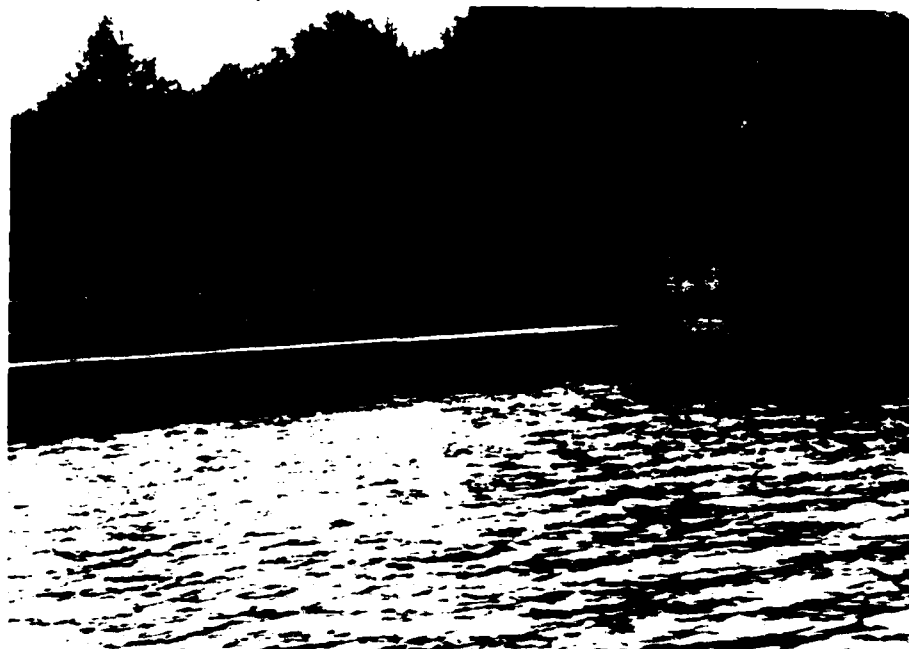
PHOTO NO.1 - Spalling at upstream face of left abutment.

1. Repair of spalled areas along entire length of dam including the crest and up and downstream faces; while establishing a regular maintenance program to resurface reoccurring spalled areas of the dam.
2. Inspection of the dam at least once every 2 years by an inspector qualified in dam inspection.
3. Opening of the low level outlet valve twice a year for a minimum of 6 hours. This would assure that it is operable and that the inlet doesn't clog with sediment.
4. Round the clock surveillance should be provided by the owner during periods of unusually heavy precipitation. The owner should develop a formal system with local officials for warning downstream residents in case of an emergency.
